## SERVICE BULLETIN

**APPLICABILITY:** 2017-2019MY Impreza  
 2018-19MY Crosstrek  
 2018-19MY Legacy and Outback  
 2019MY WRX and WRX STI  
 2019MY Ascent  
 2018-19MY BRZ

**NUMBER:** 15-221-18R

**SUBJECT:** Harman Audio / Infotainment: Harman Generation 3.0 and 3.1 Operating Tips

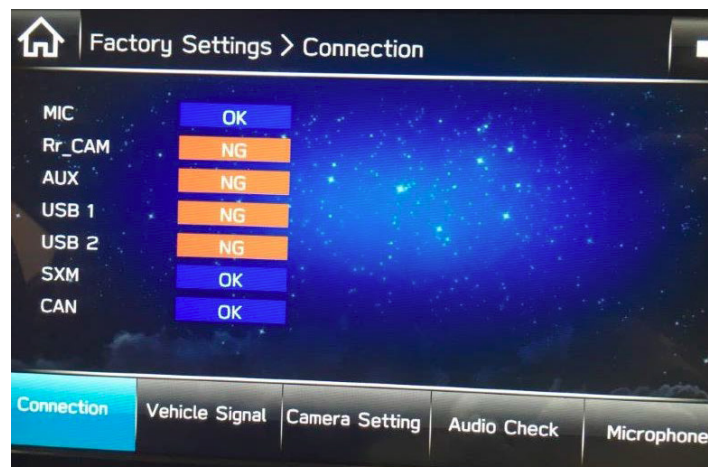
**CONDITION# 1:** Backup camera inoperative after head unit replacement or battery disconnect (2016 Dec TechTIPS).

**CAUSE:** Whenever the Audio / Navigation head unit requires removal on a 2017 Impreza, it is **important** the Service Manual procedure be followed. The Service Manual advises to disconnect the battery before servicing the audio unit. Failure to follow this instruction, can result in a customer concern of the backup camera becoming inoperative since the service. The reason, when connecting power to the unit, a self-check is performed. If the backup camera has not been connected yet, the unit assumes there is no back up camera and renders it inoperative.

Below is an image of what the screen will look like if a line check is performed before the issue is corrected:

**RECOMMENDATION:** A quick fix for this condition is to remove and reinstall the transit (PDI) fuse or remove and reinstall the negative battery terminal. The situation can be avoided completely by following the Service Manual and disconnecting the battery **before** starting the service.

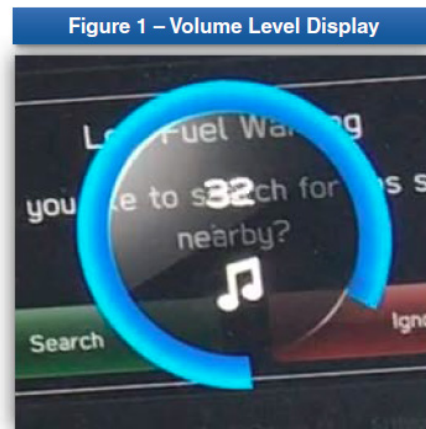
**CONDITION# 7:** Audio Volume is turned to MAX when monitoring infotainment data monitor (March 2017 TechTIPS).

**CAUSE:** If you are monitoring the Infotainment System Data Monitor and the volume level display (see image below) appears showing the volume level increasing but the sound level remains the same, this is a normal operating characteristic of the Harman audio units.

**RECOMMENDATION:** When a Technician accesses the Infotainment System Data Monitor, the unit enters “Diagnostic Mode” and the volume level will be displayed in this manner. No repairs should be performed to address this concern as it is a normal operating characteristic.

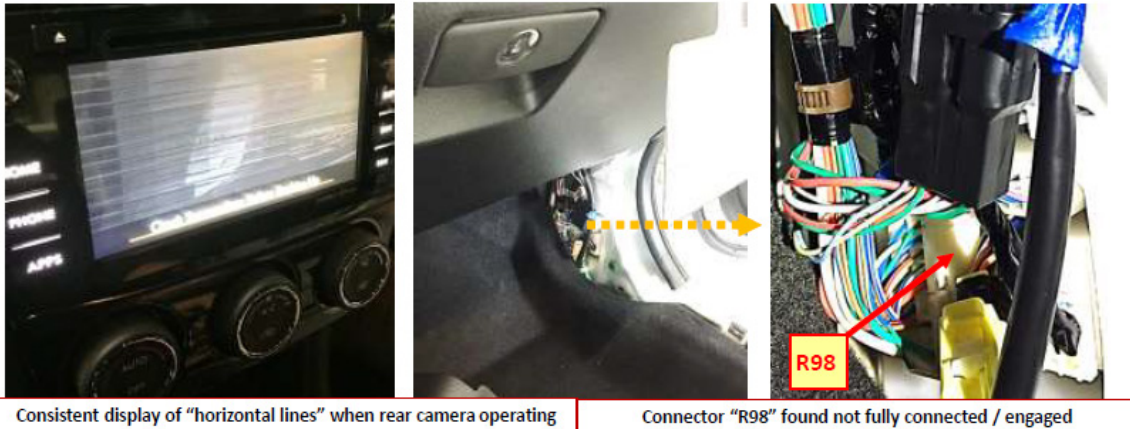
**CONDITION# 8:** Subject vehicle consistently displays multiple horizontal lines across the display screen each time the backup camera feature is operated. **NOTE:** This applies to **2017MY Impreza ONLY**.

Consistent display of "horizontal lines" when rear camera operating

Connector "R98" found not fully connected / engaged

**CAUSE:** Investigation found the cause of this condition to be connector R98 not fully connected / engaged.

**RECOMMENDATIONS:** Access and disconnect R98 and examine closely for any bent or displaced terminals. If OK, firmly reconnect and ensure a solid connection. Retest backup camera operation and confirm a consistent, high-quality image is displayed.

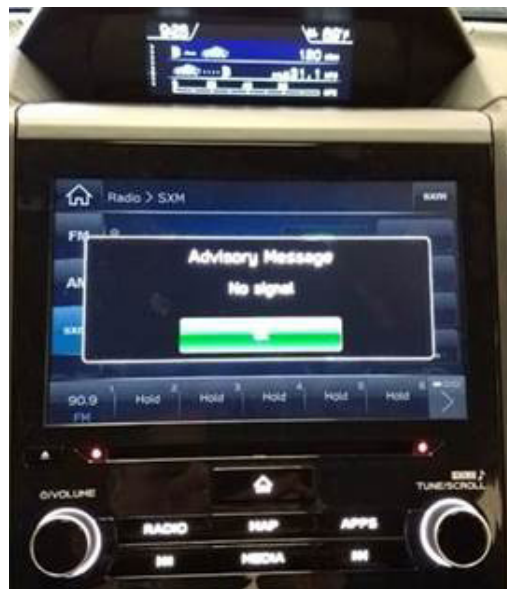
**CONDITION# 9:** Harman Gen 3 Audio/ Navigation head unit shows an "Advisory Message- No Signal" notification on the display.

**CAUSE:** In areas of poor or no SXM coverage, the head unit will display the message as shown above. It is not a failure condition assuming SXM service is not available.

**RECOMMENDATION:** No action should be taken to correct this condition.

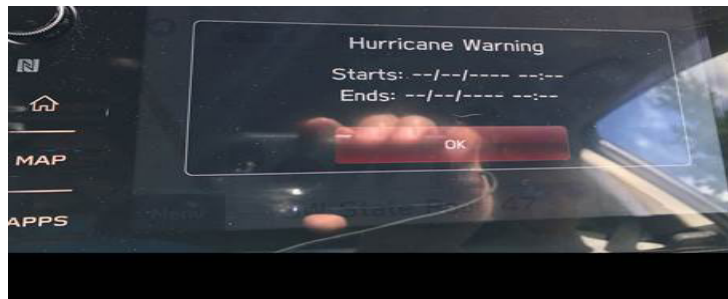
**CONDITION# 10:** Hurricane or Severe Weather warning message is displayed.

**CAUSE:** The head unit receives information from SXM and displays the message whenever there is a signal from SXM. If there is no date information from SXM, the details (dates) will not show.

**RECOMMENDATION:** The display matches data supplied by SXM. **NOTE:** If the concern is the frequency the message is displayed, the frequency was reduced effective with Version 3 software update release.

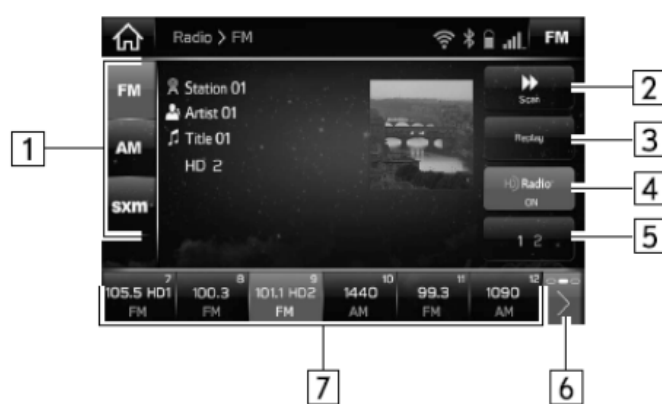
**CONDITION# 14:** Volume fades up and down (FM/AM HD radio).

**CAUSE:** Assuming the audio unit is in HD Radio mode, the vehicle is likely traveling outside of HD Radio coverage area causing the head unit to switch between HD and Analog mode.

**RECOMMENDATION:** Turn HD off as shown in the images below.

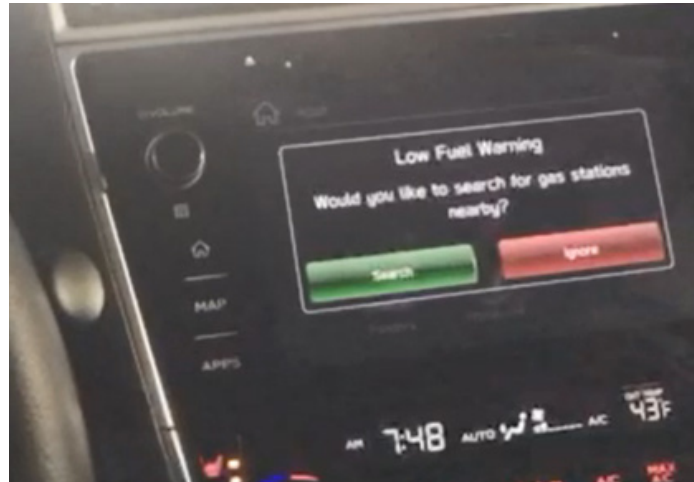
**CONDITION# 15:** Low Fuel Warning advisory message appears on display.

**CAUSE:** The head unit only displays fuel level information sent to it from the combination meter.

**RECOMMENDATIONS:** Confirm combination meter and sender functions are operating properly. Confirm the trip meter is reset following refueling. Confirm ignition key is not being left in the ON / RUN positions during refueling.

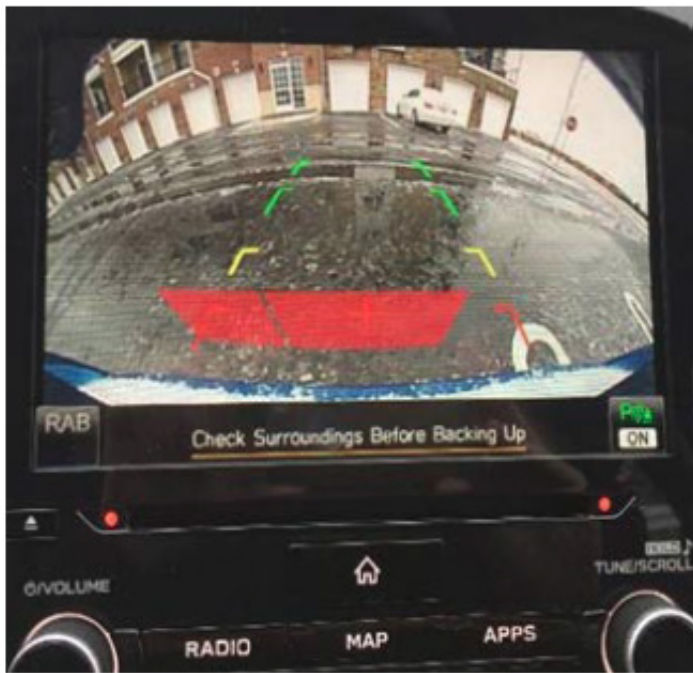
**CONDITION# 19:** On vehicles equipped with reverse automatic braking (RAB), a red area appears in backup camera display.

**CAUSE:** If a customer states they see a red box or area in their backup camera display, the system is most likely operating as designed. Always perform a visual check of the sensors on the rear bumper first. If any of the sensors are covered over or obstructed by ice and / or snow, the RAB system may not function properly and the red area shown in the example photo below will most likely appear.

**RECOMMENDATIONS:** When this condition occurs, the RAB system is unable to properly differentiate between what really is an obstacle and what is not. In the image below, the sensor is iced over and the red area is displayed with no obstacle present. The Owner's Manual provides a list of other potential causes for this condition to occur.

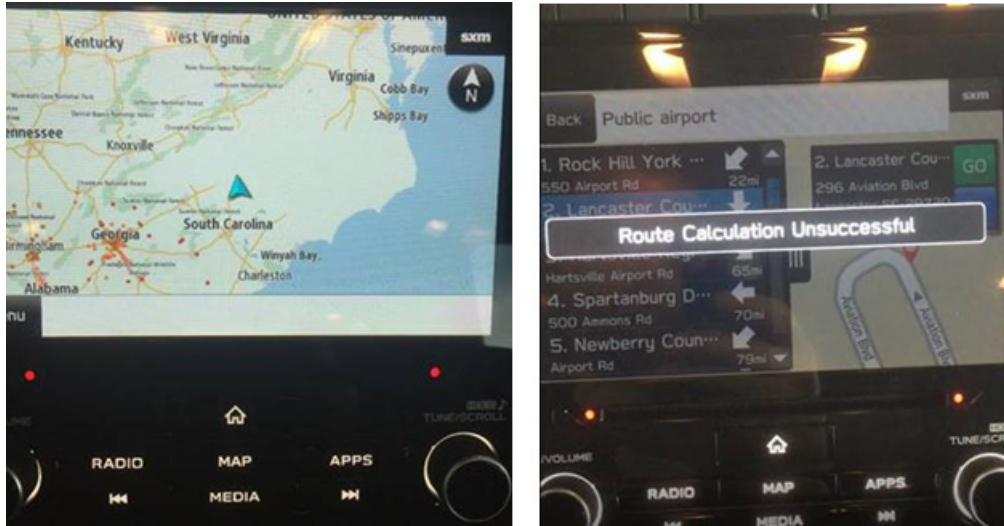
**CONDITION 25:** Map Display “Whiteout”. Map display is either white (blank) or, an incomplete screen (no roads) is displayed. “Route Calculation Unsuccessful” message is displayed when trying to calculate a route.

**CAUSE:** If a MOTA (Map Over The Air update) was performed or attempted previously, the state map data may have become corrupted. This can occur due to weak a WIFI signal during MOTA causing the state to disappear (appear white).

**RECOMMENDATION:** Update the map (again) successfully using a strong WIFI signal or via USB.

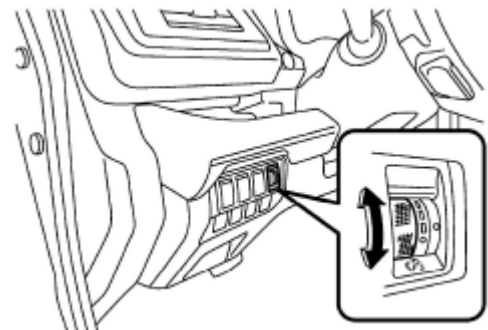
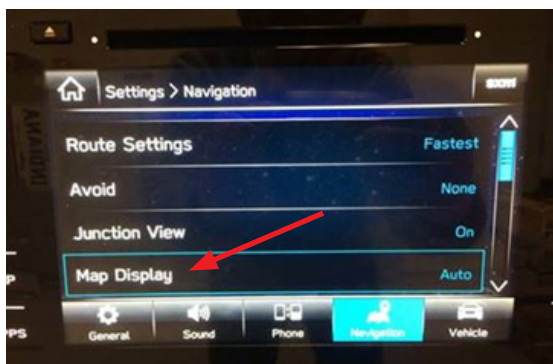
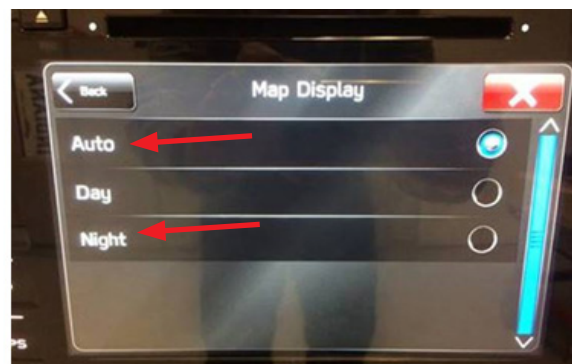
**CONDITION 26:** Map display not going into “Night” mode in low light (night time / dark) conditions

**POSSIBLE CAUSES:** Map display setting may be set to “Day” instead of “Night” or “Auto” as shown below. If the instrument panel illumination control knob is set to MAX brightness (all the way up), the map display will not change regardless if “Auto” or “Night” mode is selected in the Settings menu.

**RECOMMENDATIONS:** From the Settings menu, select Map Display and either “Auto” or “Night”. If there is no change, check and lower (if necessary) the illumination control knob as shown in the illustration to the right and “Auto” or “Night” mode operation will be restored.
