SERVICE BULLETIN

APPLICABILITY: 2019MY Forester
SUBJECT: Rattling Sound from Front Door

NUMBER: 12-263-19
DATE: 05/13/19

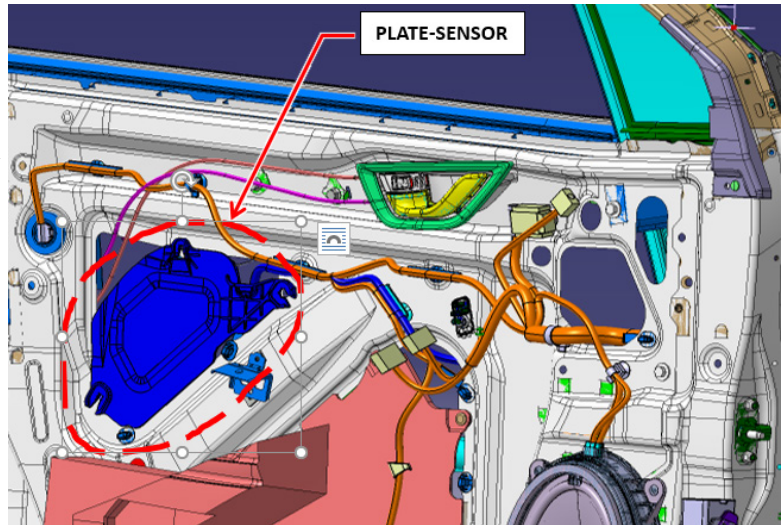
Step 3: CAREFULLY remove the vapor barrier from the inner door structure *only as much as necessary* to access and remove the PLATE-SENSOR as shown here in the illustration.

Step 4: CAREFULLY remove the PLATE-SENSOR from the inner door structure using a trim clip removal tool. **NOTE:** Any damaged retaining clips MUST be replaced before reinstallation.
