ARTICLES CONTAINED IN THIS ISSUE

CODE	ARTICLE	PAGE
(00)	STIS New Releases	8-9
(01)	QMR of the Month	1
(01)	QMR of the Month Award Presentations	2
(01)	Use Of Silicone Spray Precautions	3
(01)	Brake Lamp Switch Replacement Web Based Training	3
(07)	2019MY Forester Manual Override for Power Rear Gate	3
(07)	2019MY WRX, Telematics "i" Button Sticking	4
(12)	2019MY Ascent, Spare Tire Hoist Precautions	5
(14)	WUE-90 Stop Lamp Switch Recall, Special Tool TIP	5
(15)	Telematics Operational Concerns Accompanied By DTC B2A15	6
(15)	Harman Audio / Navigation System Concerns	6-7

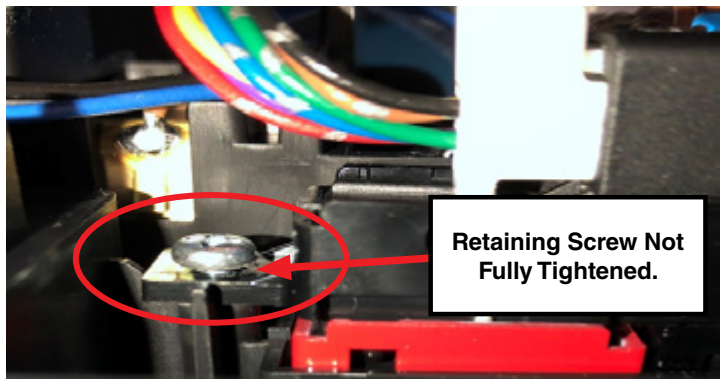
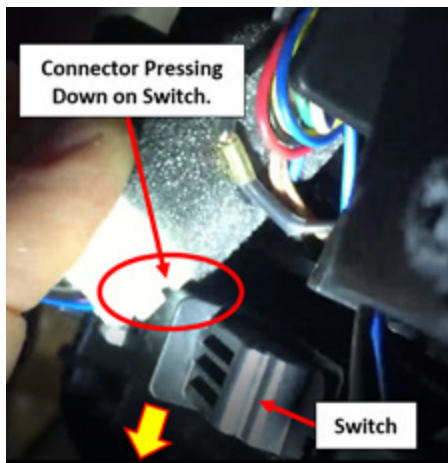
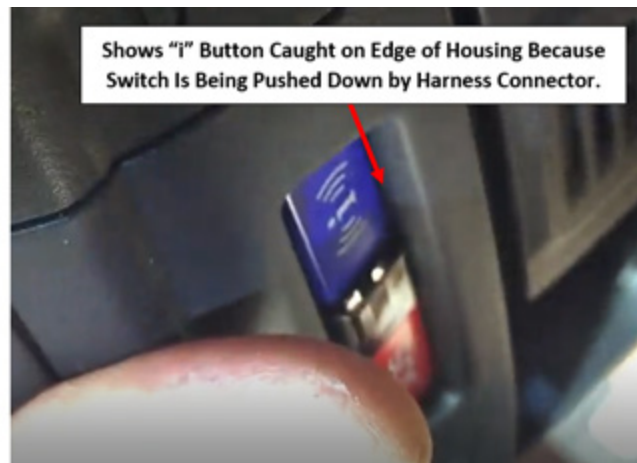
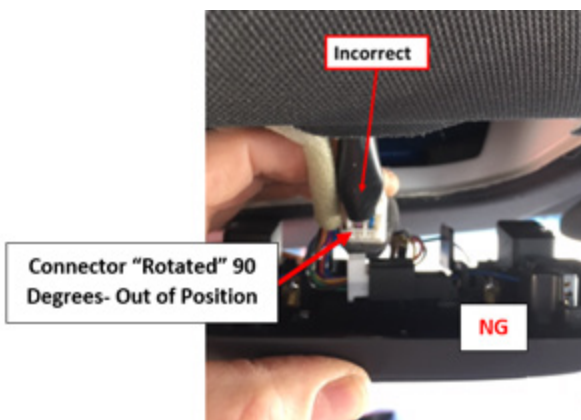
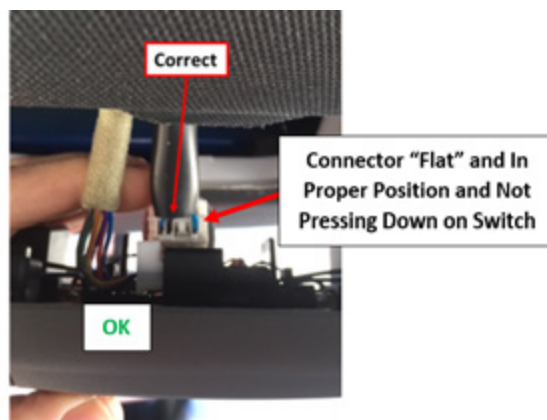
The second concern involves one of the other harness connectors above the housing being out of position and pushing down on the switch. This results in the button getting hung up on the edge of the opening in the housing. This can generally be repaired by simply rotating the connector that is pressing down on the switch as shown below.

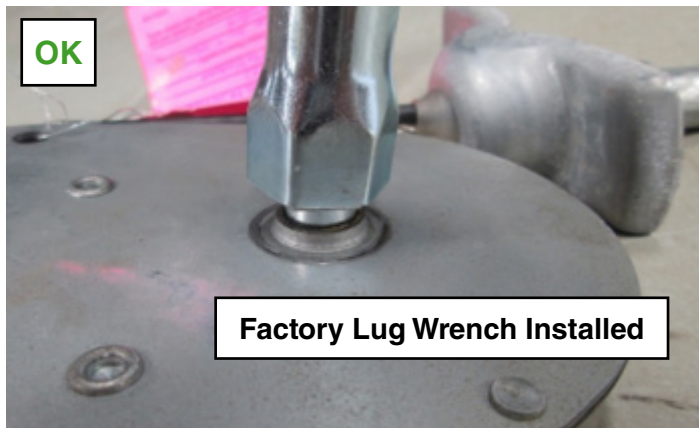
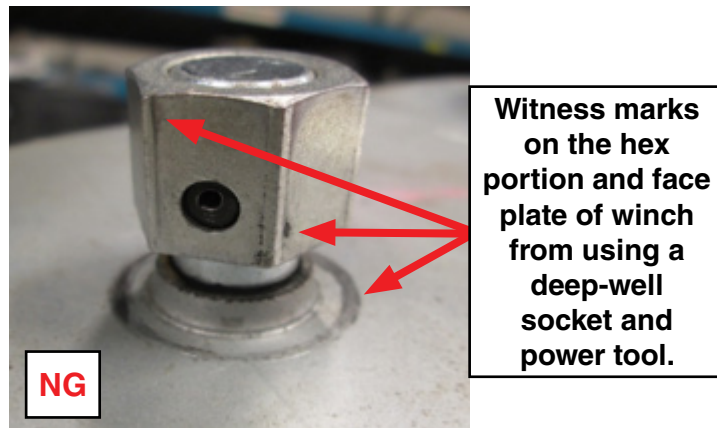
When using the Ascent's spare tire hoist, it is **IMPORTANT** to use **ONLY** the spare tire lug wrench included with the vehicle to operate it. **NEVER** use an electric or air-operated power tool to operate the hoist as damage to the internal mechanism and / or the hoist cable can result preventing the spare tire from being secured fully in place against the underside of the vehicle body. A customer concern of a "clunking" noise may also result from this condition along with sidewall damage to the spare and corresponding vehicle underbody / paint rub-through.

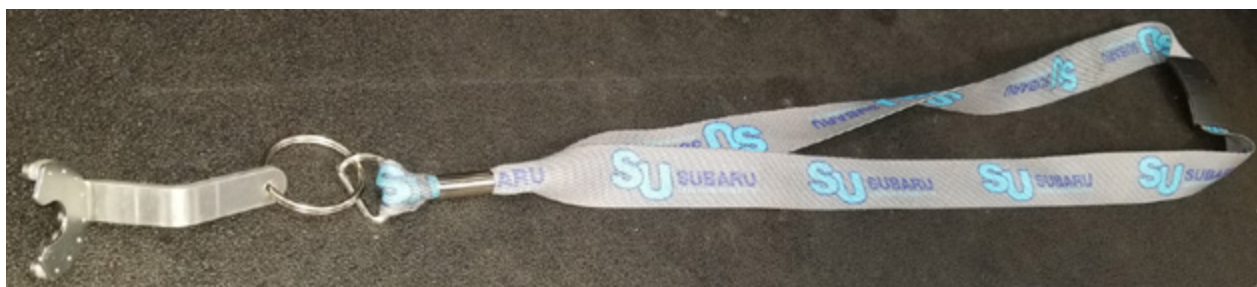
A Technician submitted a QMR with an excellent suggestion to prevent the WUE-90 adjustment nut special tool from being left behind after completing the repair procedure:

Simply drill a hole near the handle end of the tool and install an unused lanyard as shown above. The brighter color the better but, we liked the choice used here too!

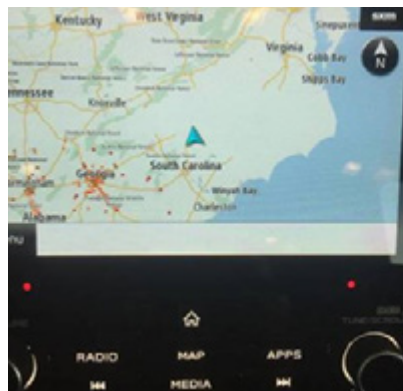
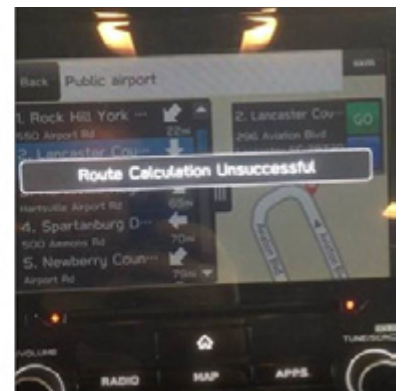
Condition 1: Map Display "Whiteout"

- Map display is either white (blank) or, an incomplete screen (no roads) is displayed.
- "Route Calculation Unsuccessful" message is displayed when trying to calculate a route.

Cause: If a MOTA (Map Over the Air Update) was performed or attempted previously, the state map data may have become corrupted. This can occur due to weak a Wi-Fi signal during MOTA causing the state to disappear (appear white). Updating the map (again) successfully using a strong Wi-Fi signal or via USB will restore the missing map data.

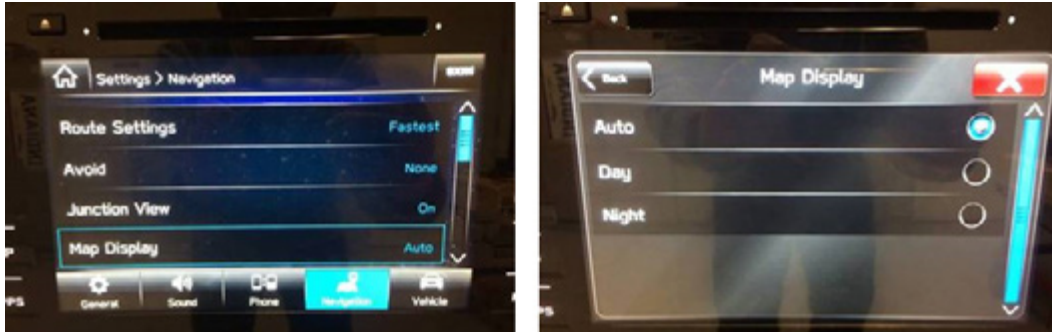
- Map display setting may be set to “Day” instead of “Night” or “Auto” as shown below. From the Settings menu, select Map Display and either “Auto” or “Night”.

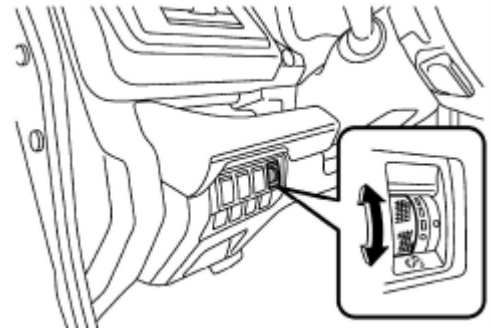
- If the instrument panel illumination control knob is set to MAX brightness (all the way up), the map display will not change regardless if “Auto” or “Night” mode is selected in Settings. Lower the illumination control knob as shown in the illustration and “Auto” or “Night” mode operation will be restored.
