PRODUCT CAMPAIGN BULLETIN

APPLICABILITY: 2009-2013 Forester
 2008-2014 Impreza
 2005-2014 Legacy
 2005-2014 Outback
 2006-2008 Tribeca

NUMBER: WUF-91R
NHTSA: 19V-297
DATE: 04/15/19
REVISED: 05/22/19

SUBJECT: Replacement Ignition Switch Recall

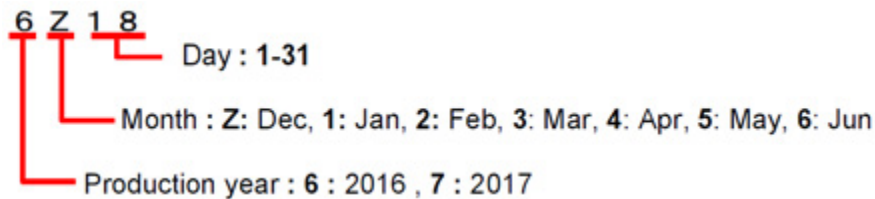
4. Confirm the Lot Number on the face of the ignition switch using the chart below.

Using the chart above as a guide, if the Lot Number is between **6Z18** (December 18, 2016) and **7602** (June 2, 2017), the ignition switch MUST be replaced. If the Lot Number is illegible, **REPLACE** the ignition switch assembly.

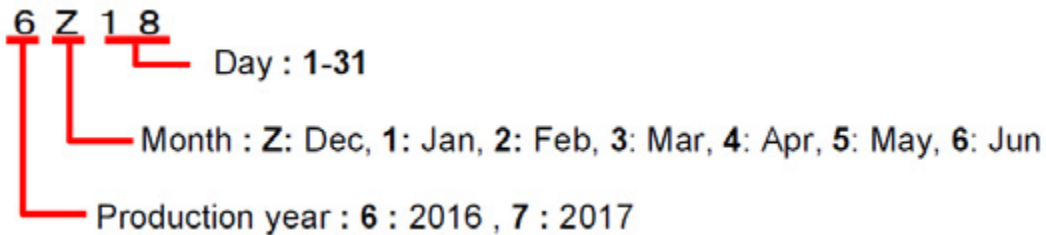
3. Remove the ignition switch from the ignition lock assembly.
4. Confirm the Lot Number on the face of the ignition switch using the chart below.

Using the chart above as a guide, if the Lot Number is between **6Z18** (December 18, 2016) and **7602** (June 2, 2017), the ignition switch MUST be replaced. **NOTE:** If the Lot Number is illegible, **REPLACE** the ignition switch assembly.

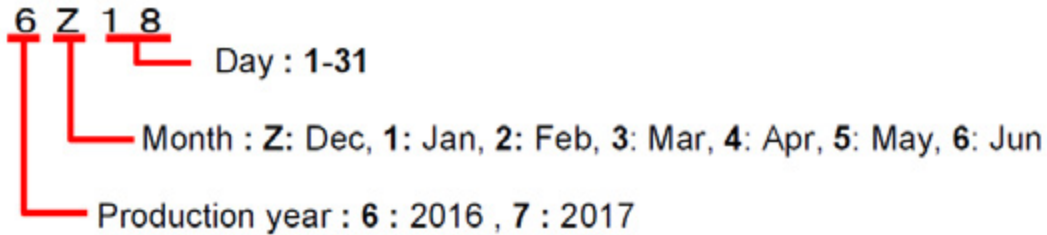
4. Confirm the Lot Number on the face of the ignition switch using the chart below.
NOTE: If the Lot Number is illegible, REPLACE the ignition switch assembly.

Using the chart above as a guide, if the Lot Number is between **6Z18** (December 18, 2016) and **7602** (June 2, 2017), the ignition switch **MUST** be replaced. **NOTE:** If the Lot Number is illegible, REPLACE the ignition switch assembly.
