Field campaign

Topic	Rear Seat Entertainment - field update 2 (SC18/02) (ASW 09.16)
Market area	Bentley: worldwide (2WBE),Hongkong-Macau (5HK)
Brand	Bentley
Transaction No.	2048661/4
Campaign number	EA98
Note	
Type	Service Campaign
US code

Flying Spur

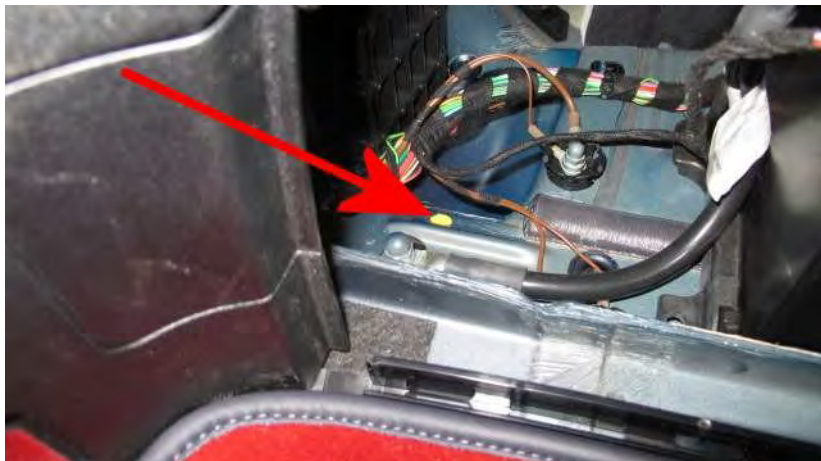
Figure 15

The presence of a yellow completion spot on the left hand side floor pan identifies this campaign has been performed (Figure 15)

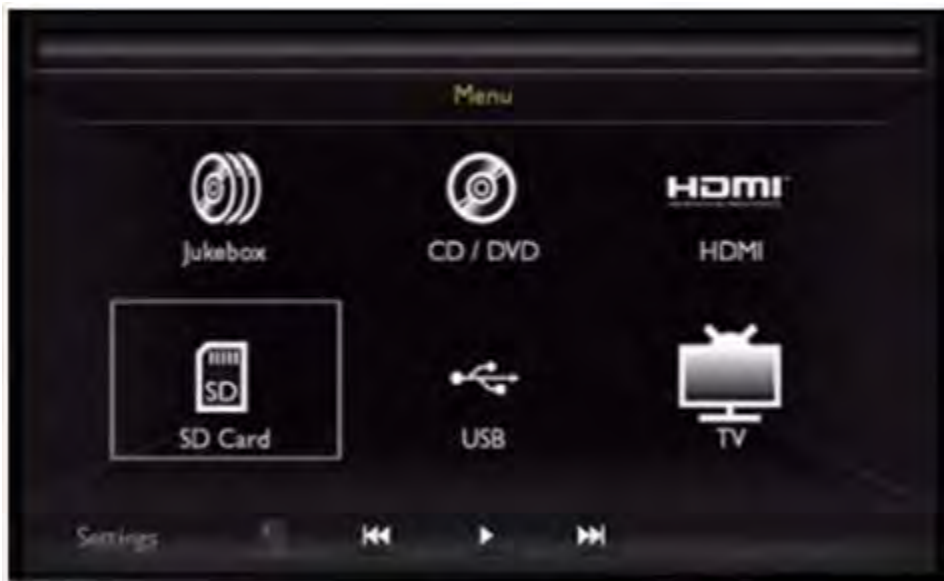
15. Figure 16b for reference shows the screen displayed on RSE systems that have yet to receive this update and therefore do not display any online icons. Car displaying this screen require this Rear Seat Entertainment - field update
