Field campaign

Topic	Rear Seat Entertainment - field update 2 (SC18/02) (ASW 09.16)
Market area	Bentley: worldwide (2WBE),Hongkong-Macau (5HK)
Brand	Bentley
Transaction No.	2048661/5
Campaign number	EA98
Note	
Type	Service Campaign
US code

Flying Spur

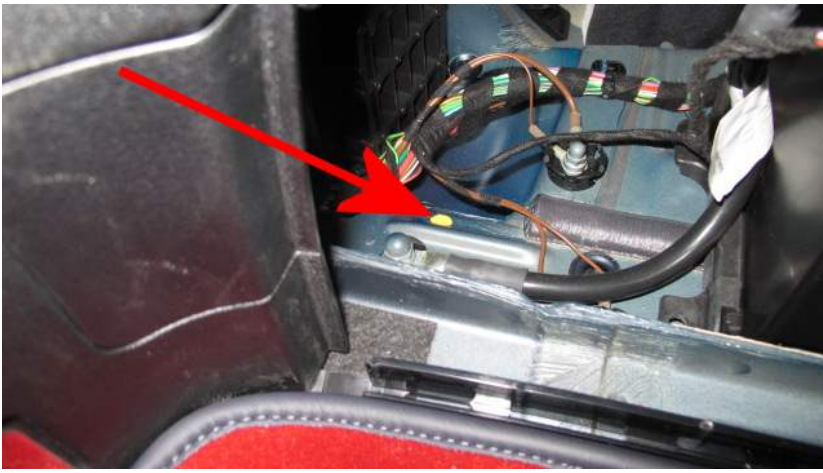
Figure 15

The presence of a yellow completion spot on the left hand side floor pan identifies this campaign has been performed (Figure 15)
