# Technical Service Bulletin

<b>Topic</b>	Emission control warning displayed - (DTC) P227900 - Intake air leak
<b>Market area</b>	Bentley: worldwide (2WBE), Hongkong-Macau (5HK)
<b>Brand</b>	Bentley
<b>Transaction No.</b>	2051205/2
<b>Level</b>	EH
<b>Status</b>	Released for publishing
<b>Release date</b>	May 20, 2019

## Bentayga W12

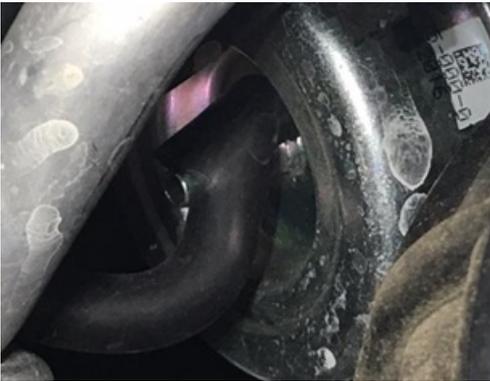
Figure 1

1. Split vacuum hose onto the waste-gate (see Figure 1), confirmed with visual inspection or smoke test. Replace the failed pipe to resolve the issue
2. Failed waste-gate diaphragm, the use of a Mityvac is recommended to confirm the presence of an internal leak in the turbocharger waste-gate or smoke test. Once confirmed the turbo charger assembly must be replaced
