## Technical Service Bulletin

| <b>Topic</b> | Engine difficult to start - Turbocharger damaged - V8 4.0TFSI |
| <b>Transaction No.</b> | 2052085/2 |

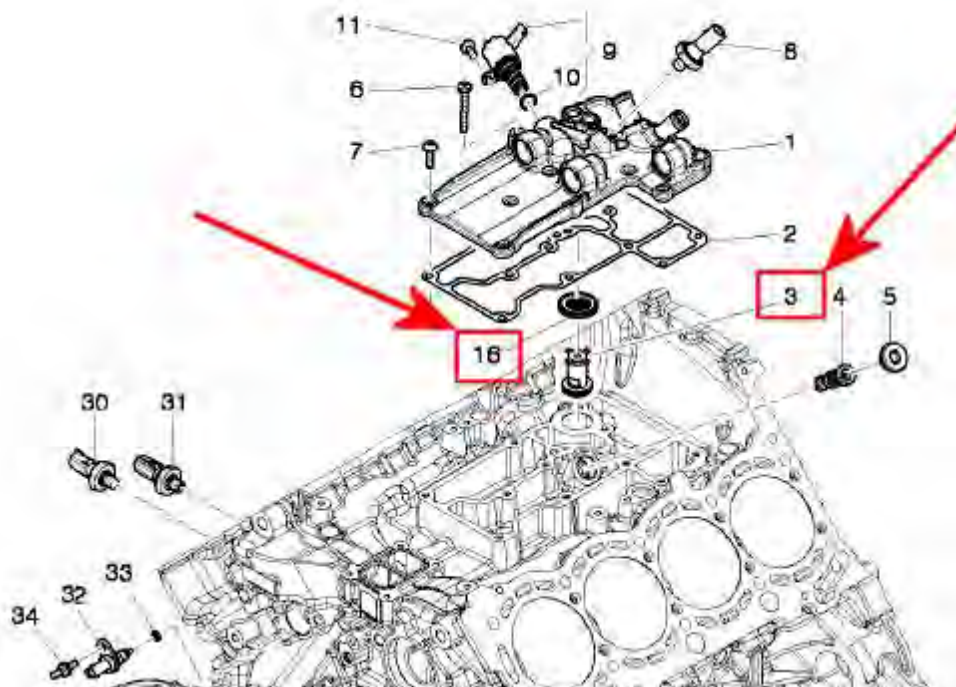
Referring to Figure 1 - Optimized oil strainer (16) for oil supply lines to turbochargers in the cover in the inner valley of engine and the oil strainer and Non-return valve (3) must always be replaced to ensure suitable oil flow to the turbochargers, Over time carbon and soot can build up in the strainer causing reduced oil flow into the turbos. The strainer has now been updated to a larger filter profile to prevent this from occurring.

5. Replace both of the turbochargers as well as the **oil strainer** and **Non-return valve** in the inner valley of engine according to Elsa Pro and observe all instructions
6. Change the engine oil including oil filter.
7. Follow the installation instructions in Elsa Pro for the turbochargers exactly including:
  - Filling the turbocharger at the supply line connections with engine oil.
  - To ensure the turbocharger is supplied with enough oil, let the engine run at idle for approximately one minute after starting, do not increase rpm.
