Field campaign

| Topic | Tailgate hinge bolt (SC18/14) |
| Campaign number | EB11 |

Bentayga

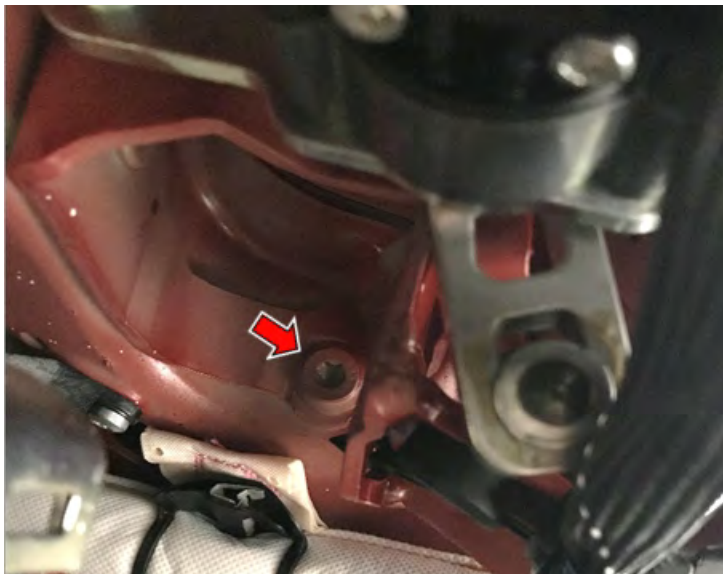
*Figure 1*

The tailgate hinge bolt to the body can experience torque relaxation

Replace the highlighted old bolt (*Figure 1*) with the highlighted new bolt **N 107 884 01** (*Figure 2*) on **both** tailgate hinges

20 Nm + 90°

**The bolt must be tightened to 20Nm + 90° and no more**

**The bolt must be replaced if re-torque is required**

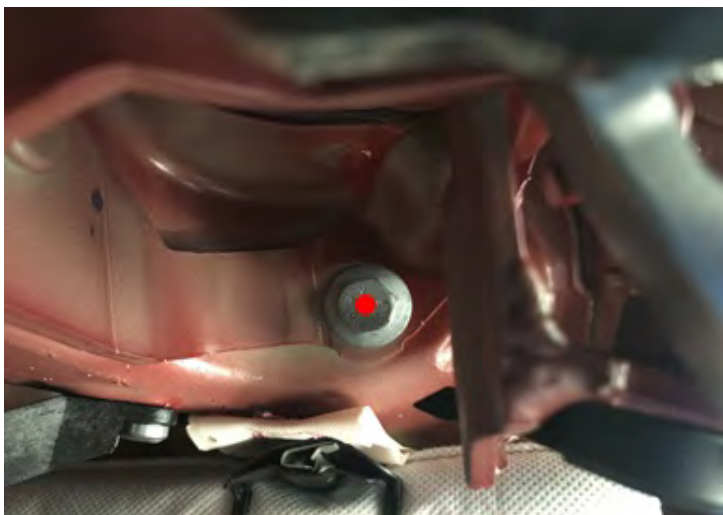
*Figure 3*

If the vehicle is not already listed as repaired in 'Repair history' (in Elsa Pro) check the vehicle has the RED paint mark applied to the new bolts as shown in *Figure 3*. In the event that the campaign has not been applied, please carry out the required work in accordance with these instructions

On completion apply a RED paint mark to each of the new bolts (Figure 3). The presence of the RED paint mark confirms campaign completion
