Technical product information

Topic	Wind noise from the door mirror/s above 30 mph/50 km/h
Market area	Bentley: worldwide (2WBE),Hongkong-Macau (5HK)
Brand	Bentley
Transaction No.	2055069/1
Level	EH
Status	Approval
Release date

Bentayga

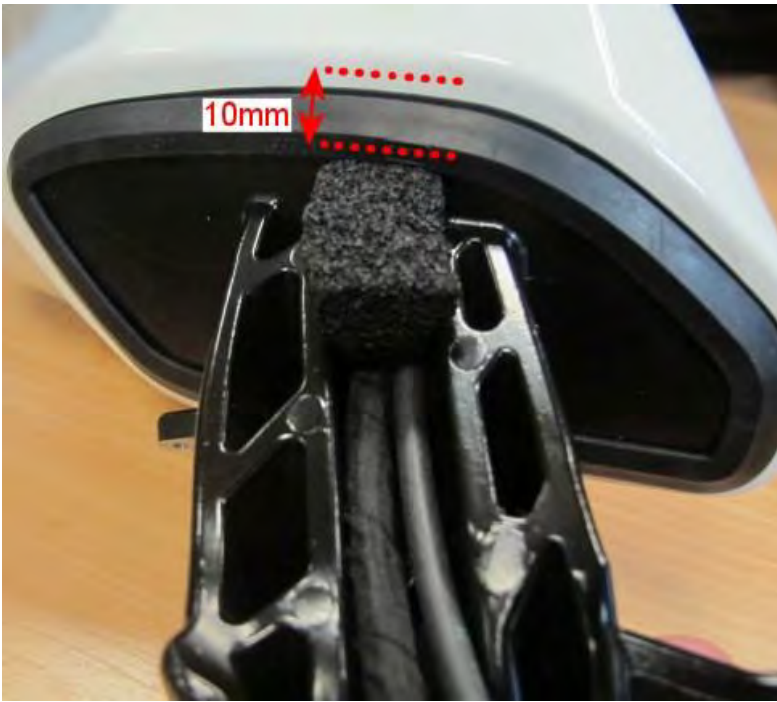
Figure 3

The issue is caused by air flowing through the front door aperture, the air is then channelled into the mirror housing using the route of the door harness as the leak path

- Referring to Figure 3, Insert the foam block 10mm into the mirror housing. The adhesive side of the block when fitted should be stuck to the harness
