Service Bulletin

Bulletin No.: 18-NA-268

Subject: Rattle Noise Heard from Front of Vehicle When Engine is Running at Slower Speeds

Brand:	Model:	Model Year:		VIN:		Engine:	Transmission:
		from	to	from	to		
Chevrolet	Corvette	2014	2019			6.2L (LT1)	8L90 Automatic (M5U)

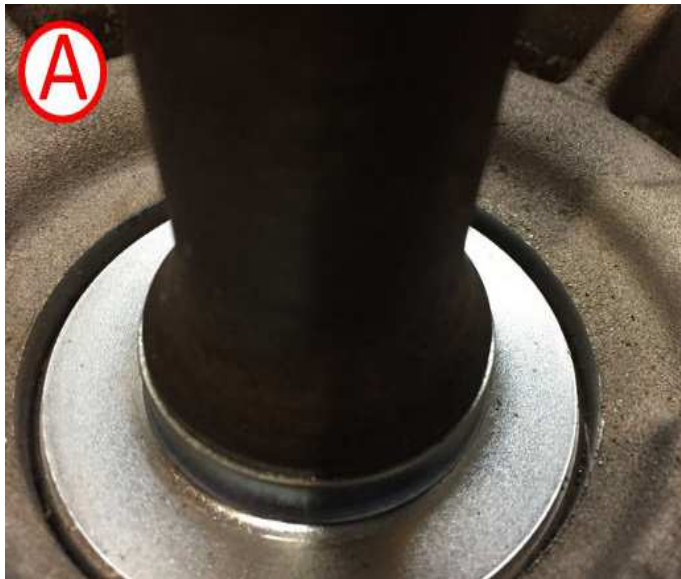
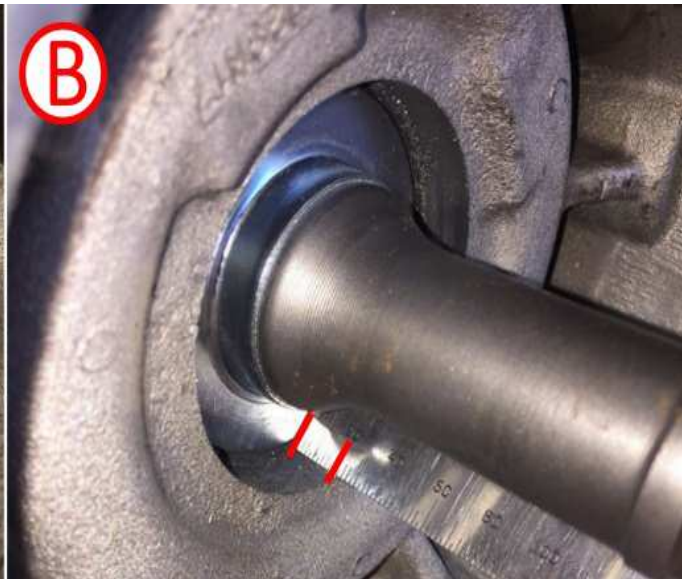
5315085

3. Inspect that the front bearing/slinger is flush (A) with the housing:
 - ⇒ If the bearing/slinger has been validated to be the cause of the noise and/or found to be pushed rearward more than ¼ inch (6 mm) (B), continue with *Propshaft Replacement* procedure in SI.

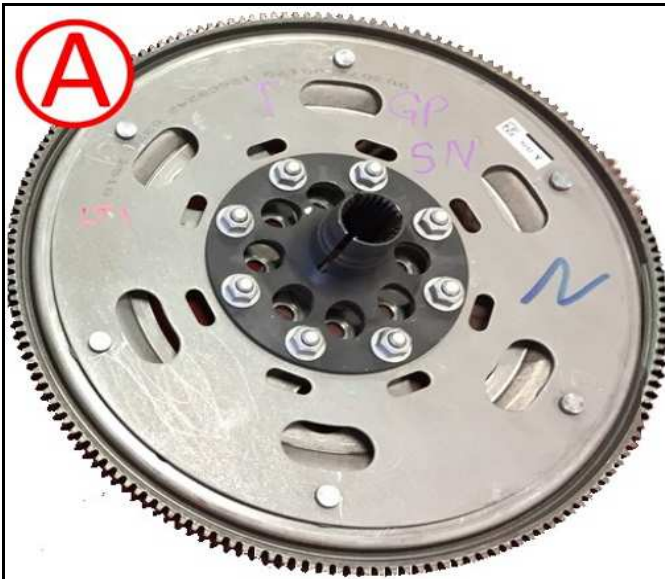
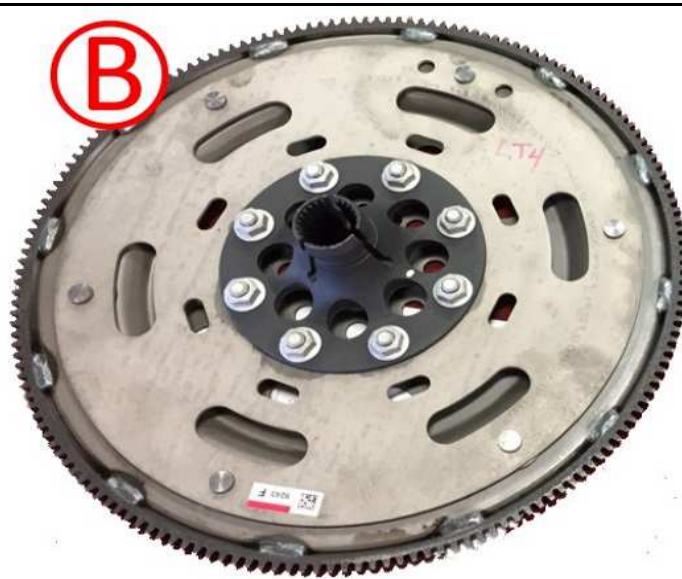
5300907

5. Inspect the flex plate:
 - If an LT1 flex plate is installed (A), it is crucial that the LT4 flex plate (B) be installed.

Note: Add medium strength thread locker to DSA flex plate clamp pinch bolt.

⇒ If the bearing/slinger is found to be pushed rearward more than ¼ inch (6 mm), continue with *Propshaft Replacement* procedure in SI.

- If the LT4 flex plate is installed, but the bearing/slinger is pushed rearward, continue to the next step.
