Service Bulletin

Bulletin No.: 18-NA-367

Subject: Diagnostic Tip for Malfunction Indicator Lamp (MIL) Illuminated with DTC P305F, P058B and/or P058D

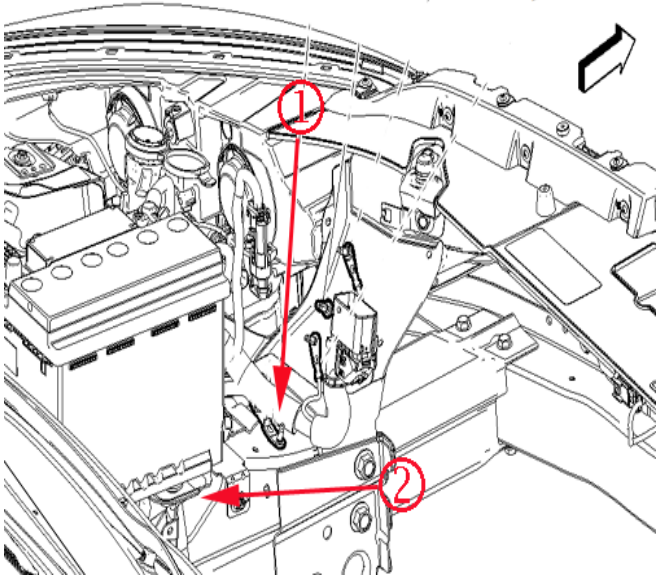
4005667

Inspect the following if DTC P305F has been set:

1. Check state of health of auxiliary battery with the GR8 tester. Not just a state of charge check.
 - If low, replace the battery, clear codes and re-check.
 - If good, proceed to step 2.
 2. Check ground resistance from the Dual Battery Isolation Module (DBIM) to G103. Wiggle the harness (1) and negative battery terminal connections during test to look for varied resistance values.
 - If resistance is greater than 0.5 ohms, or changes more than 1 ohm, then inspect ground connections and/or splice in the harness about 1.5 ft. from the connector end.
- ⇒ Fix poor connections, clear codes and re-check.
- If resistance is less than 0.5 ohms, proceed to step 3.
3. Verify the engine harness is not pinched underneath the main battery tray (2).

Note: The DBIM is located on the fuse block assembly. If found the cause of the concern, the Battery Distribution Fuse Block must be replaced.

4. Replace the battery distribution fuse block and wiring harness connector, clear codes and re-check.

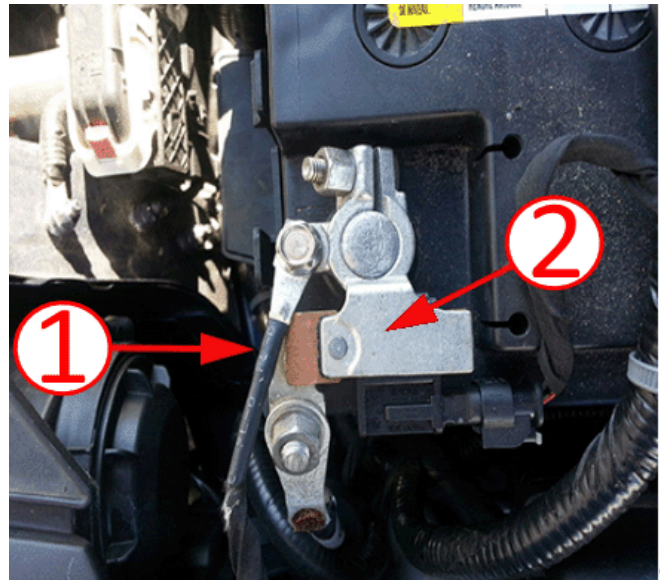
5148609

Inspect the following if DTC P058B and/or P058D is set current or in history:

1. Inspect the orientation of the grounding ring for circuit 150 (1) to the B110 Battery Sensor Module (2).
