# Service Bulletin

Bulletin No.: 19-NA-056

**Subject:** HVAC Pop-Up May Display 61 Degrees and Have Empty HVAC Setting Icons

Brand:	Model:	Model Year:		VIN:		Engine:	Transmission:
		from	to	from	to		
GMC	Terrain	2018	2018			All	All

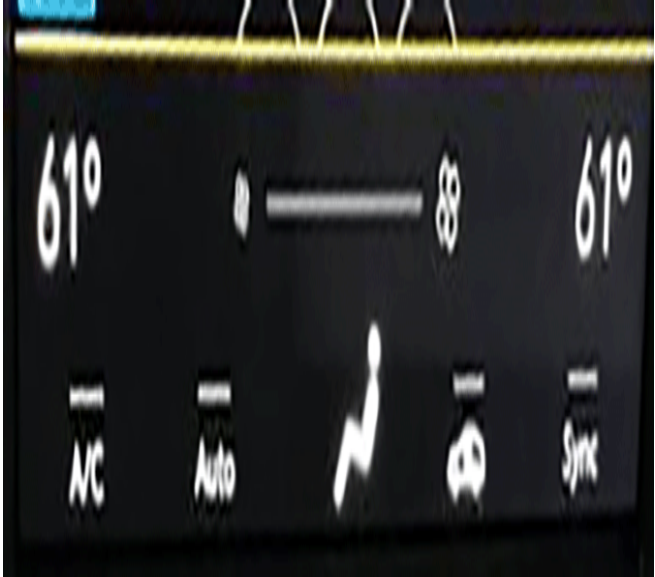
<b>Involved Region or Country</b>	North America, Middle East
<b>Additional Options (RPOs)</b>	Equipped with RADIO (IOR) and HVAC SYSTEM (CJ2)
<b>Condition</b>	<p>Some customers may comment that the selected Heating, Ventilation, and Air Conditioning (HVAC) temperature displayed in the Temperature Control knobs does not match the HVAC pop-up on the radio display.</p>

<p style="text-align: right;">5051568</p> <p>The HVAC pop-up is stuck on 61 degrees F(16°C) although the temperature displayed on the knobs displays the selected temperature. Additionally, the other icons in the pop-up for A/C, Blower Speed and Modes appear empty or blank. The pop-up behaves this way for the entire ignition cycle. Only the information shown in the pop-up is affected, the HVAC system functions properly.</p>
<b>Cause</b>	The cause of the condition may be that the data messages between control modules are not being received properly.

<b>Correction</b>	Replace the A11 Radio.

To replace the radio refer to *Radio Replacement (IO5, IO6, IOB, IOR)* in SI.
