# Service Bulletin

Bulletin No.: 19-NA-089

**Subject:** Click or Tick Noise from Rear of Vehicle at Low Speeds, When AWD is Engaged

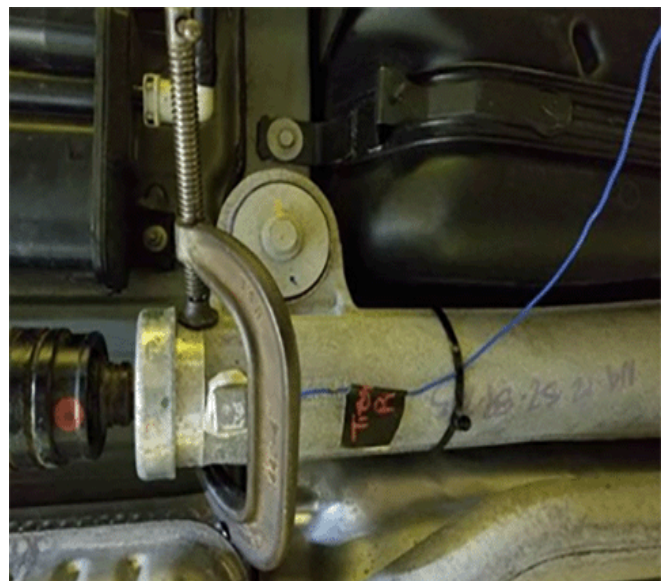
5200227

3. Control/confirm the noise is present by placing a C-Clamp over the torque tube in the location specified in the graphic above. Once noise is confirmed, move ahead to the next step.
