Service Bulletin

Bulletin No.: 19-NA-113

Subject: Erratic Instrument Panel Cluster (IPC) and Gauge Readings, Malfunction Indicator Lamp (MIL) Illuminated - DTC U0073, U0100, U0101 and/or U0121 Set

Brand:	Model:	Model Year:		VIN:		Engine:	Transmission:
		from	to	from	to		
Chevrolet	Trax	2015	2019			1.4L (LUV)

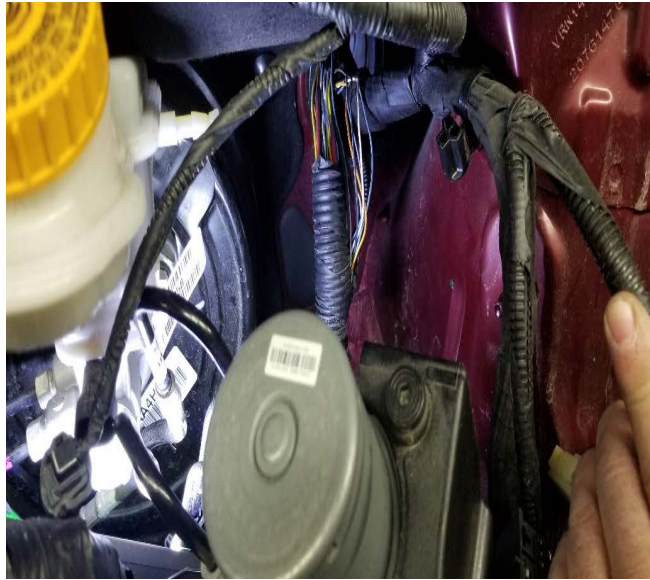
5335570

Note: This is a multi-wire bundled harness and, depending on which wire is damaged, can set a variety of DTCs.

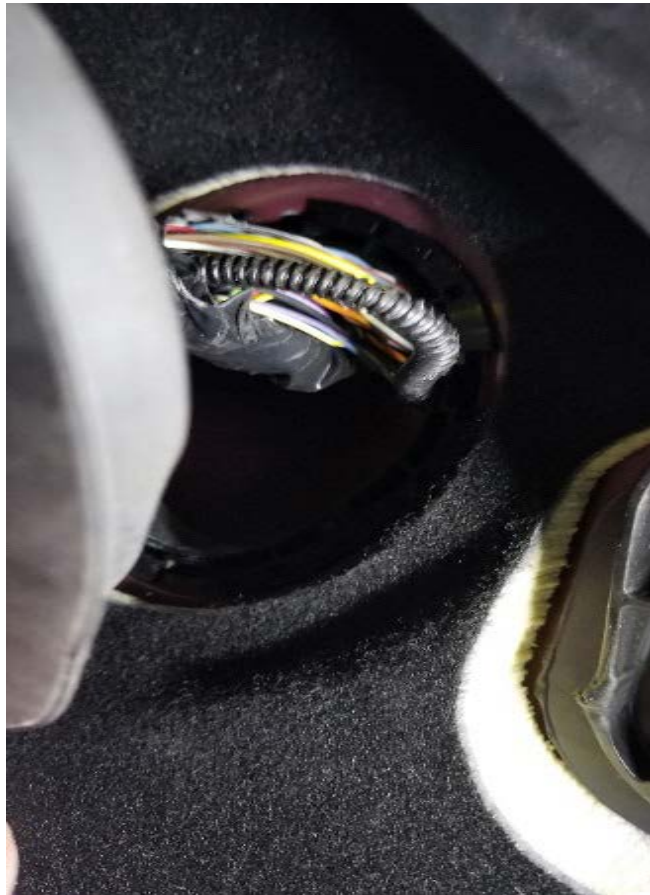
5331426

This condition may be caused by the engine harness chaffing against the bulkhead.

If the above condition has been validated, inspection of the engine wiring harness must be done.
