# Service Bulletin

Bulletin No.: 19-NA-111

**Subject:** Ticking Noise from Upper B-Pillar Area

Brand:	Model:	Model Year:		VIN:		Engine:	Transmission:
		from	to	from	to		
Chevrolet	Blazer	2019	2019			All	All

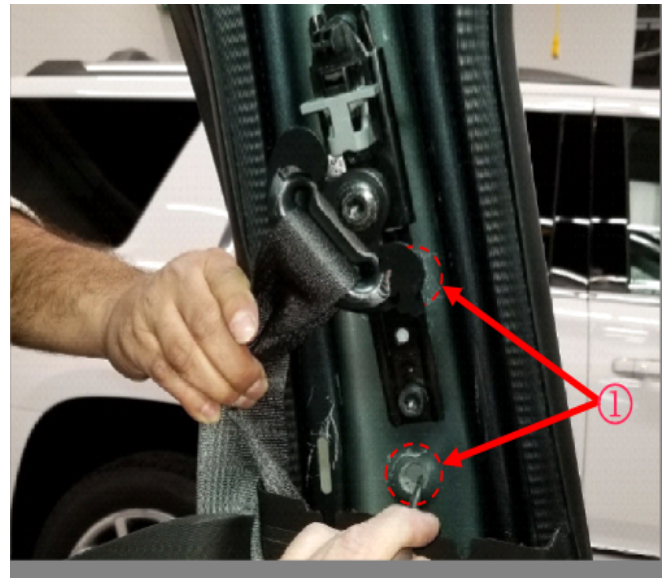
5336799

2. Pulling the seat belt aside, locate the 2 holes (1) in the center pillar. Note that at each hole, an inner sheet metal sheer plate is visible.

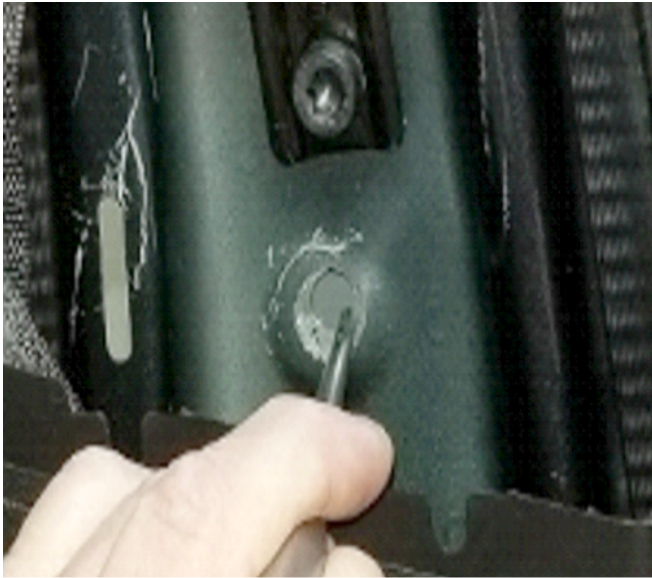
5336800

**Note:** The intent on using the punch is to increase clearance between the inner shear plate and inner sheet metal, to avoid the rub condition.
