# Service Bulletin

Bulletin No.: 18-NA-172

**Subject:** Rattle Type Noise Heard from Rear of Vehicle

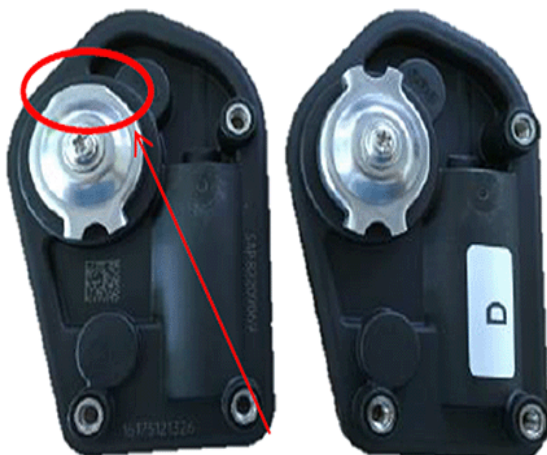
5080869

<b>Involved Region or Country</b>	North America and N.A. Export Regions
<b>Additional Options (RPOs)</b>	Vehicles equipped with EXHAUST SYSTEM-PERFORMANCE (RPO NPP)
<b>Condition</b>	Some customers may comment on a rattle type noise heard coming from the rear of the vehicle.
<b>Cause</b>	This condition may be caused by the right rear exhaust control valve actuator.
<b>Correction</b>	Modify the right rear exhaust control valve actuator following the Service Procedure below.

2. Use a vise to hold the actuator and cut off the leg, as shown in the illustration above, using a die grinder or cut-off wheel.

**Important:** DO NOT remove the metal coupling disc from the actuator. If removed, you will disrupt the Loctite'd screw and would need to relearn the valves since the alignment may have changed.
