Service Bulletin

Bulletin No.: 18-NA-195

Subject: Radio Module Software Update 20.11

Brand:	Model:	Model Year:		VIN:		Engine:	Transmission:
		from	to	from	to		
Cadillac	ATS	2018	2018			All	All
	CTS						
	XTS						
GMC	Terrain	2018	2018			All	All

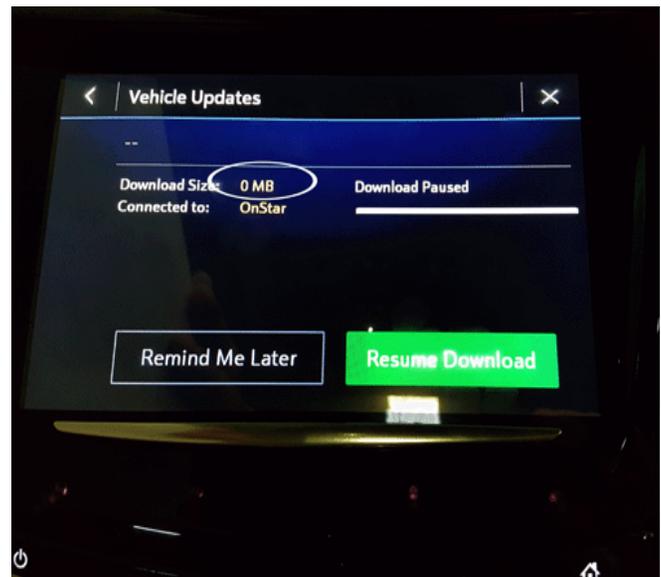
4882429

If a USB was installed during a paused Remote Vehicle Update download, the paused update screen will have a blank update title and a 0 MB file size.

To correct this:

- Turn the vehicle off, and remove the USB device from the vehicle.
- Contact the GM Technical Assistance Center for assistance.
