Service Bulletin

Bulletin No.: 18-NA-221

Subject: Circular Image Distortion in Circle Icons and Buick Tri-Shield Start-Up Screen

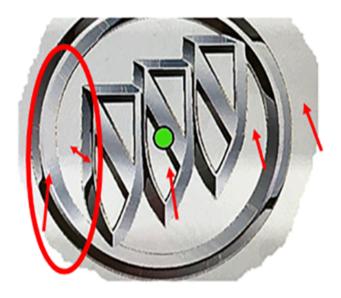
5091330

· Circular image distortion, Including the Buick tri-shield boot-up screen

This condition may be caused by a software anomaly in the internal radio control (also known as ICS – Integrated Center Stack).

If this concern is experienced, compare the radio control assembly (ICS) calibration/software part numbers to those in TIS2Web to determine if any updated radio control assembly (ICS) programming updates are available.

If radio control assembly (ICS) updates are available, program the radio control assembly by following the Radio Control Programming and Setup procedure in SI, making sure to complete all required programming events outlined.

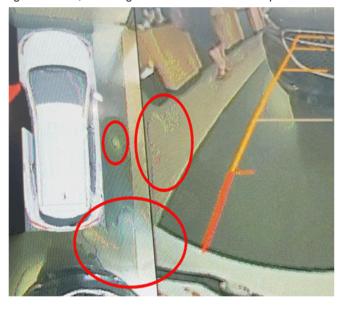
5096158

Video image distortion

Some customers may also comment that the concern was not apparent until being operated in high ambient temperatures.
