Service Bulletin

Bulletin No.: 18-NA-246

Subject: Malfunction Indicator Lamp (MIL) Illuminated - DTC P0172 Set (North America Vehicles Only)

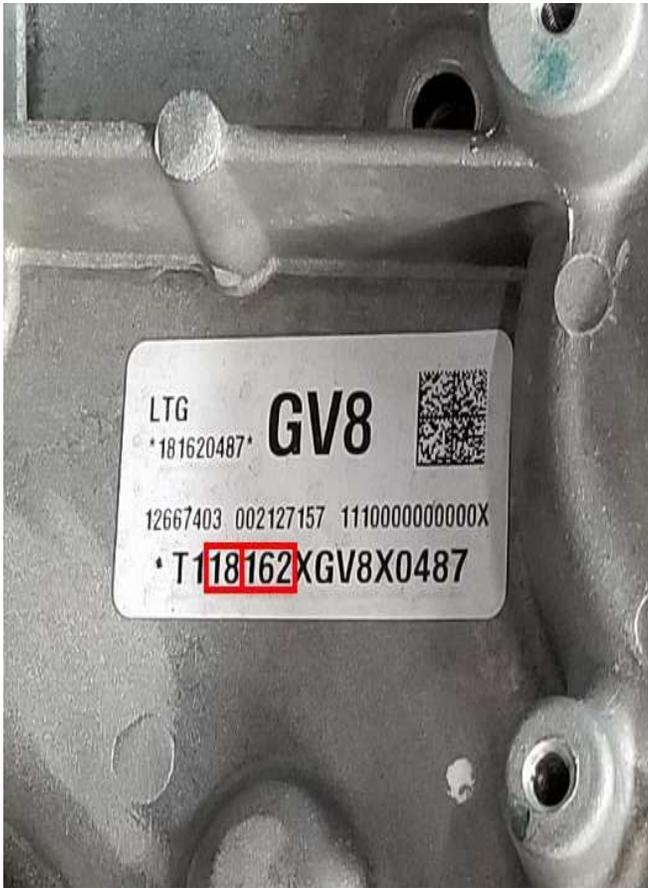
5336723

- The first digit reflects the engine plant (in this case T = Tonawanda).
- The second digit reflects the shift (in this case 1 = First Shift).
- The third and fourth digits reflect the calendar year (in this case 18 = 2018).
- The fifth, sixth and seventh digits reflect the day of that calendar year (in this case 162 = 162nd day of 2018 calendar year (build date)).

If the engine you are working on was built on or after Julian Date **19127** (May 7, 2019), EUN# T**119127** XHXTX0251, the PCV does not need to be replaced. The new revised PCV is already installed in the camshaft cover. Refer to SI for further diagnostics.

Engines built prior to Julian Date 19127 (May 7, 2019), EUN# T**119127** XHXTX0251, have the old style primary PCV valve installed and will need to be replaced. Continue with service procedure below.

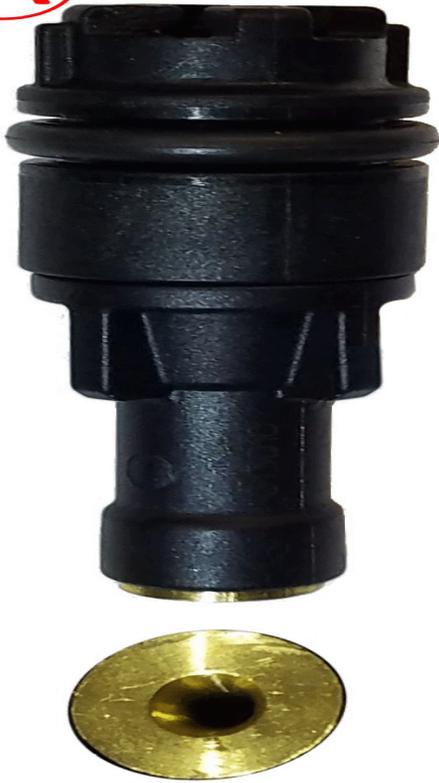
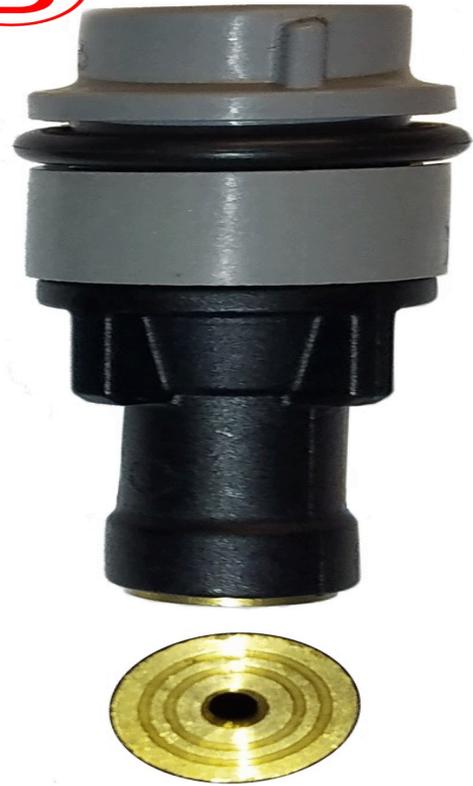
Note: The graphic above compares the old style primary PCV valve (A) to the **new** revised PCV valve (B).
