# Service Bulletin

Bulletin No.: 19-NA-107

**Subject:** Extended Cab Rear Door Ajar Indicator Displayed Intermittently, Rear Door Hard to Close, and/or Rattle Noise from Lower Rear Door

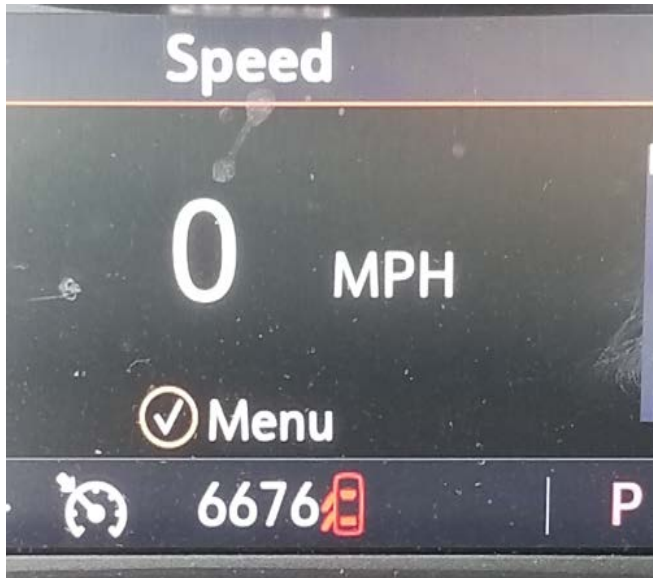
5335735

1. Open the front door on the affected side.
2. Turn the ignition key on, so that the front door appears **ajar** on the dash.

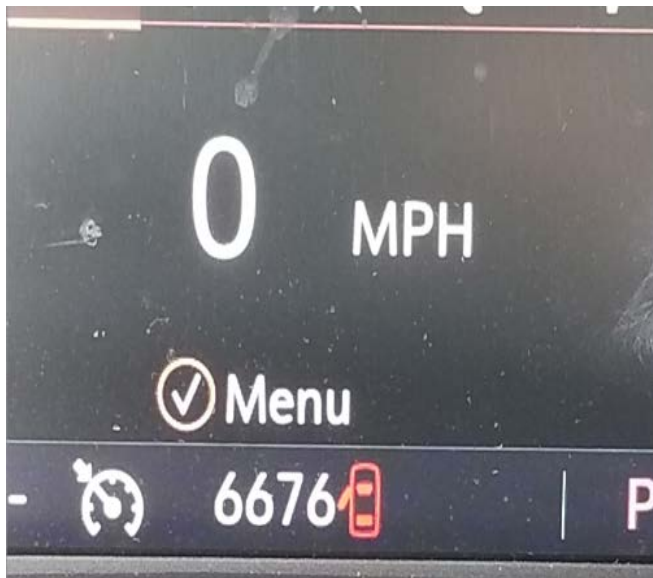
5335736

5. Continue shutting the door, and gradually increase the force until you reach the **minimum force** when the rear door **ajar** lamp first turns off. The lamp is now off as in the graphic example above.
6. Pull outboard on the top edge of the door to ensure that the top latch is in primary position, and is secure.

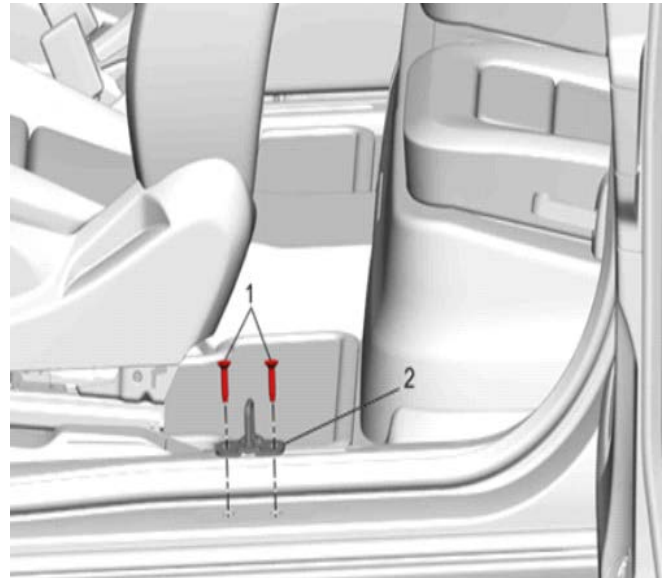
5335738

7. Pull outboard on the bottom edge of the door to ensure the bottom latch is in primary position, and is secure.
  - If both latches are secure, with no cross-car movement, **NO further action is required**.
  - If the bottom edge is NOT secure, you will notice movement (cross-car slack) and the **ajar** lamp will intermittently go **ON** and **OFF** as you move the door **OUT** and **IN**. If this condition still exists, proceed to step #8.

8. Loosen the bottom striker bolts (1) and leverage the striker wire to pull the striker (2) location cross-car in the outboard direction, at least 2 mm (0,08 in).

9. While the striker is still floating/loose, forcefully shut the door in order to have the door drag the striker into proper position.
10. Open the rear extended door and torque the 2 bolts at the bottom door striker.

Tighten the bolts to 24 N•m (18 lb ft).
