**Subject:** Engineering Information – Burning Smell, Potential Loss of Driveability, No Start/Crank and/or Unwanted Windshield Wiper Activation

Brand:	Model:	Model Year:		VIN:		Engine:	Transmission:
		from	to	from	to		
Chevrolet	Malibu	2016	2019

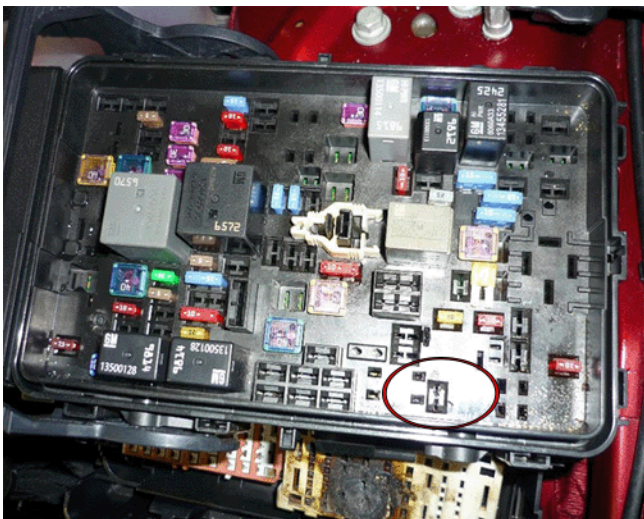
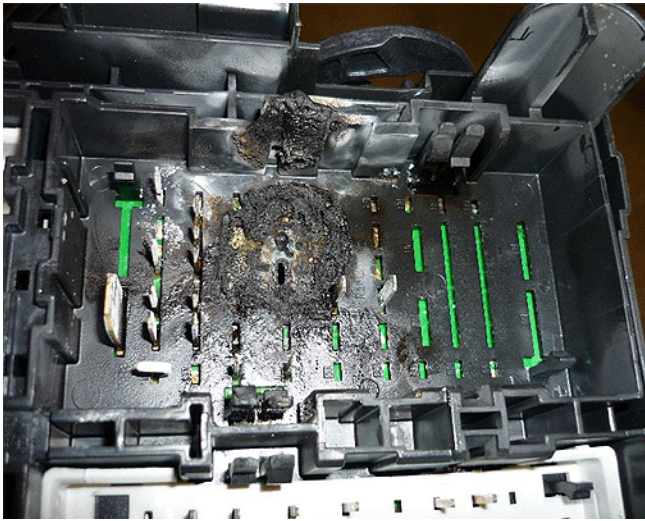
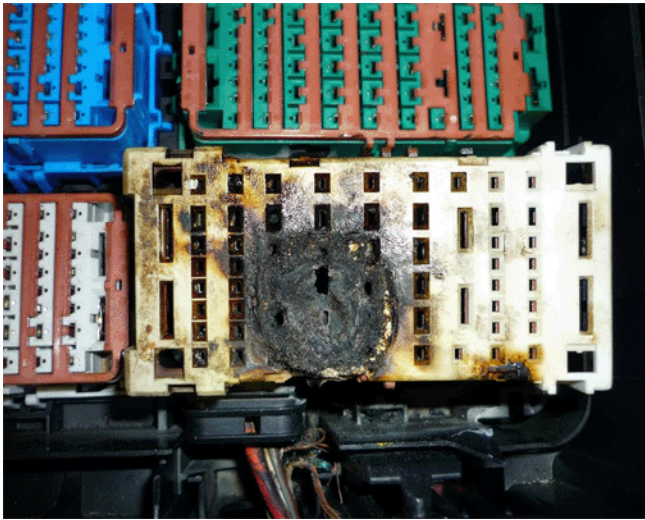
If you encounter a vehicle with the above concern, visually inspect the wiring harness and X5 connector that is plugged directly into the UBEC for signs of a thermal event, as shown in the photos above, and contact the engineer listed below with your findings.
