Technical Service Bulletin

Subject: FRONT SEAT CUSHION TRIM COMING OFF SEAT FRAME	Bulletin No.: 09-025/19
	Last Issued: 06/17/2019

2014-2018 Mazda3 (Mexico built) with VINS starting with 3MZ

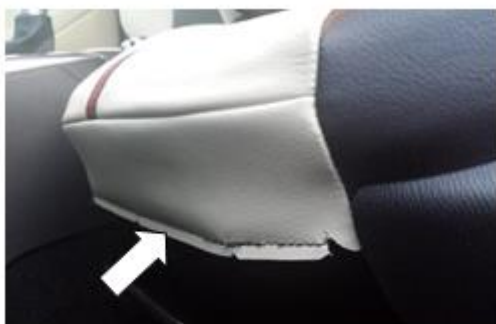
Some vehicles may exhibit a condition where the front seat cushion trim comes off the seat frame at the front end. This may be found on vehicles with all types of the seat trims (leather, leatherette and fabric). The front seat cushion is attached to the seat frame using folding collars.

This is caused by the collars slipping out of the seat frame when an excessive force is applied to the seat cushion.
