CR178 Ducati Quick Shift sensor cable re-routing

Multistrada 950 S MY 2019

Multistrada 1260 S (all model versions) MY 2019

Technical Service Bulletin SRV-TSB-19-007

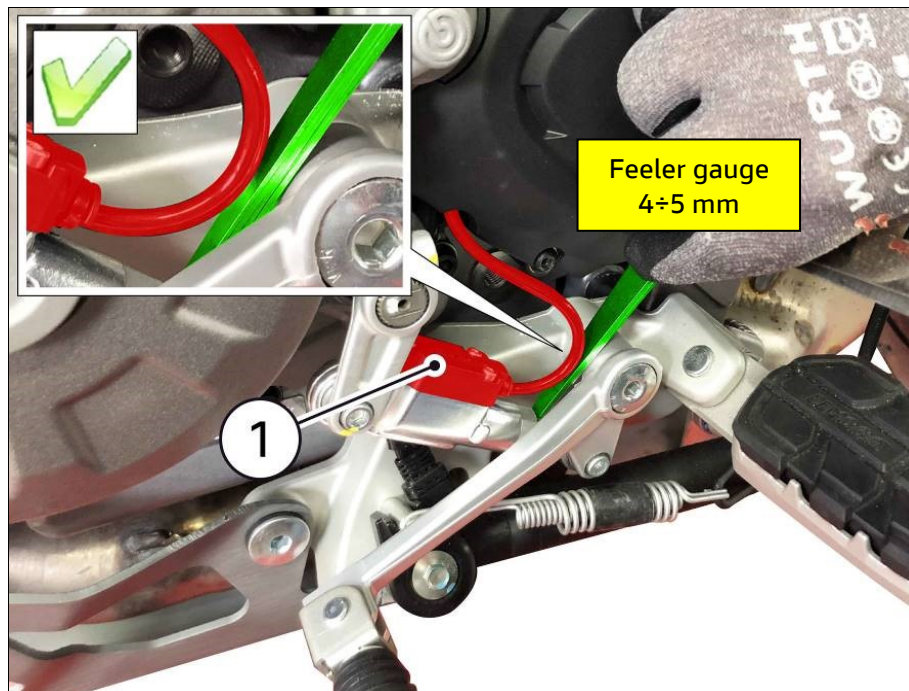
COMPLIANT DQS sensor cable routing

For the correct routing of the DQS sensor cable, you will have to check the distance between the **DQS sensor cable (1)** and the gearchange lever; carry out this check using a **4 - 5 mm** feeler gauge, as shown in the figure.

If the distance between the DQS sensor cable and the gearchange lever is between **4 - 5 mm**, cable routing is COMPLIANT and no corrective action is required.

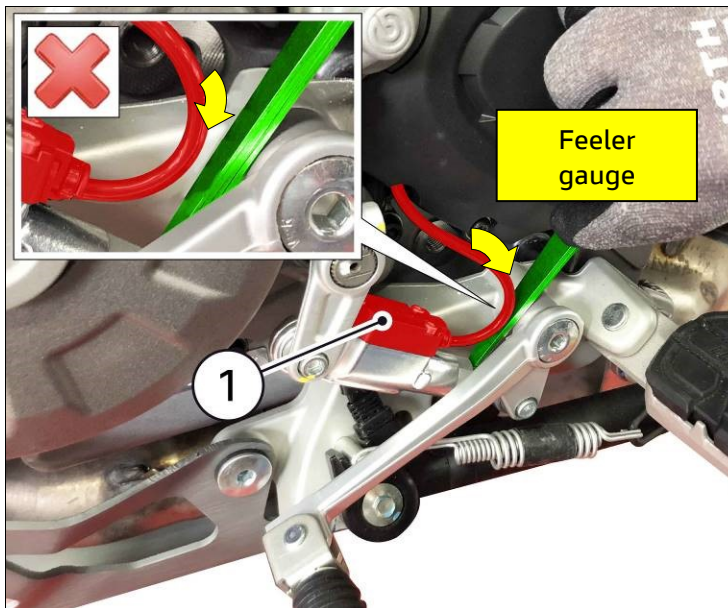
NON-COMPLIANT DQS sensor cable routing

If the distance between the DQS sensor cable and the gearchange lever is more than the **4 - 5 mm** specified above, cable routing is NOT COMPLIANT.

Restore the distance between DQS sensor cable and gearchange lever by slightly pulling, without forcing, the cable downwards, as shown in the figure.
