Countries: CANADA, UNITED STATES Document ID: IK1300176
 Availability: ISIS, IsSIR Revision: 1
 Major System: TRANSMISSION Created: 6/5/2019
 Current Language: English Last Modified: 6/10/2019
 Other Languages: NONE Author: David Horner
 Viewed: 120

Title: MV Cluster Transmission Gear Monitor displays "--"

Applies To: Allison 2000 Series Transmission

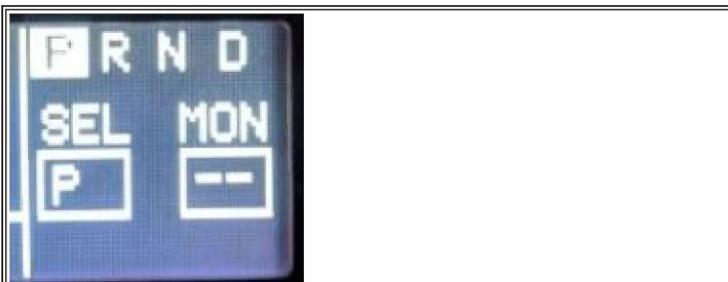
Navistar has identified an incorrect TCM parameter configuration that was configured during vehicle end of line programming which causes transmission gear range monitor to display dashes "--" (*Figure 1*) instead of transmission current range / gear (*Figure 2*). International dealers who are authorized by Allison for TCM reprogramming may complete the repair below. International dealers not authorized by Allison for TCM reprogramming must transfer the repair to an authorized Allison facility to configure the TCM to allow the EGC to monitor transmission current range via J1939.

Figure 1: EGC Transmission Gear Monitor (MON) displaying dashes "--" for transmission range / gear

- Transmission Gear Range Monitor displays dashes (*Figure 1*) instead of current transmission gear range (*Figure 2*)

1. Bring vehicle into shop and park on a flat surface
2. Shift transmission into park or neutral, set parking brake, and install wheel chocks
3. Loosen TCM harness jack screw, remove connector from TCM
4. Remove TCM mounting bolts
5. Locate & transfer TCM to authorized Allison TCM reprogramming location
6. Configure TCM parameter; J1939 Broadcast: ETC2 Range Parameter Format (30210), from 4th Gen Compatible (0), to 5th Gen Format (1)
7. Install TCM mounting bolts
8. Install 80 Way harness connector
9. Tighten 8mm hex head jack screw to 2.0 - 3.2 Nm (18-28 LB-IN)
10. Remove wheel chocks
11. Return vehicle to service

1. Bring vehicle into shop and park on a flat surface
2. Shift transmission into park or neutral, set parking brake, and install wheel chocks
3. Configure TCM parameter J1939 Broadcast: ETC2 Range Parameter Format (30210) from 4th Gen Compatible (0), to 5th Gen Format (1)
4. Remove wheel chocks
5. Return vehicle to service
