# PREVOST

## WARRANTY BULLETIN

**WB19-11**

DATE :	June 2019	SECTION :	06 ELECTRICAL
EXPIRATION:	June 2021		
SUBJECT :	<b>ISM IMPROVEMENT (VEHICLE PROGRAM UPDATE)</b>

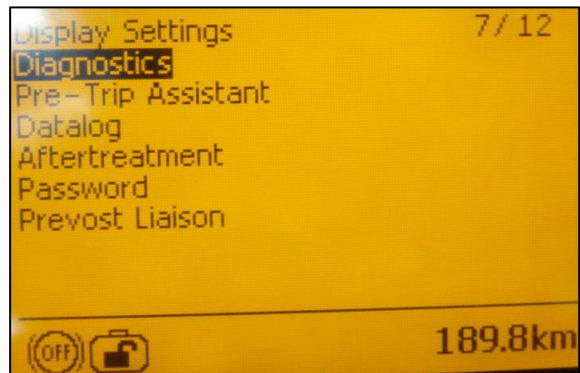
Figure 1

1. Check the vehicle program revision number with the Driver Information Display (DID) in the dash.
2. Select the Diagnostics menu.

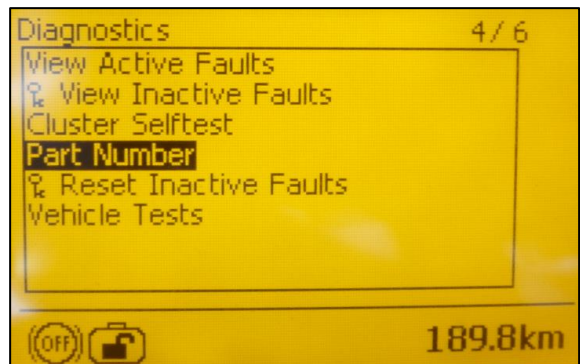
Figure 2

3. Select Part Number menu.

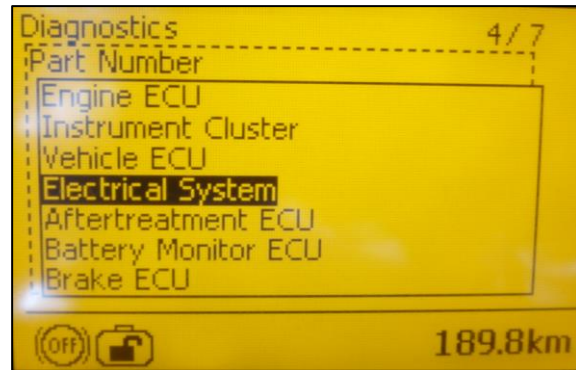
Figure 3

- Select Electrical System menu.

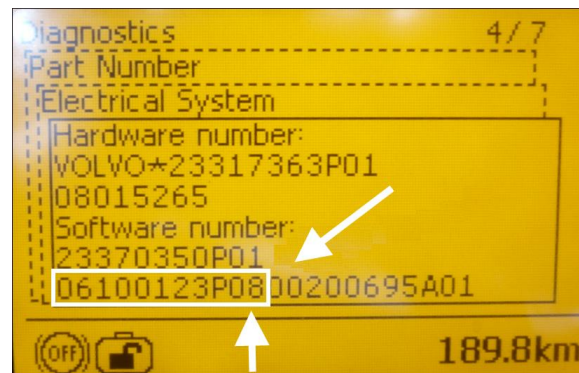
Figure 4

- The DID shows the software number (program number) and the actual revision number just after the "P" letter for the vehicle.
- Note the program number and the revision number.

- Table 1 shows the minimum revision number needed, according to the program number.
- Compare the vehicle program number and revision number shown in the DID with the corresponding numbers in Table 1.
- If the vehicle has the program revision number shown in Table 1 or a higher number, the bulletin is complete.
- If you need your vehicle program to be upgraded, move next section of the bulletin.

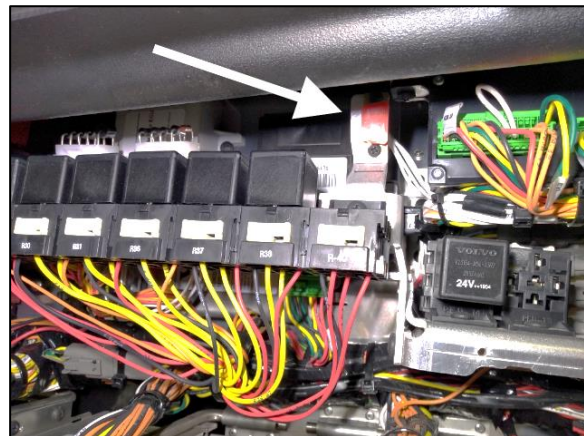
**Figure 5**

11. If a program upgrade on the vehicle is needed, make an appointment in a Prevost Service Center or contact a Prevost Service representative.
12. If you have the special tools required and you want to process the vehicle program upgrade on your own, you will need the vehicle last version program file. Contact your Prevost Service representative to have the vehicle program last update and refer the personal for the procedure shown bulletin SCI19-20, how to send you the file.
13. Connect the 110 power line on the vehicle.
14. Turn the ignition to "ON" position.
15. Activate the Hazard flashers.
16. Locate the RS232 serial port into the front service compartment at the right top corner.

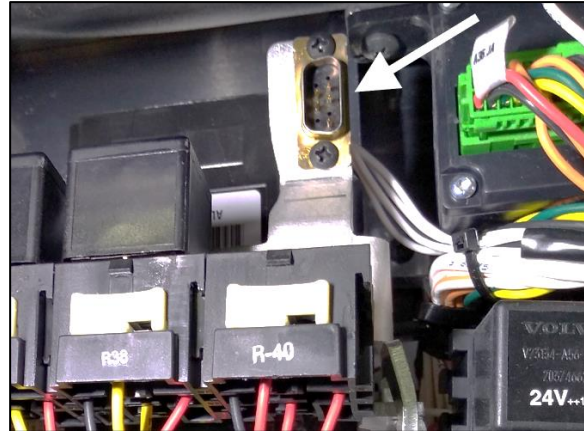
Figure 6

17. Remove the cap and keep in a safe place.
18. Connect the computer on the vehicle into the RS232 port.
19. Open the computer management application on your computer.
20. Right click on "My Computer" on the desk and click on Manage menu.

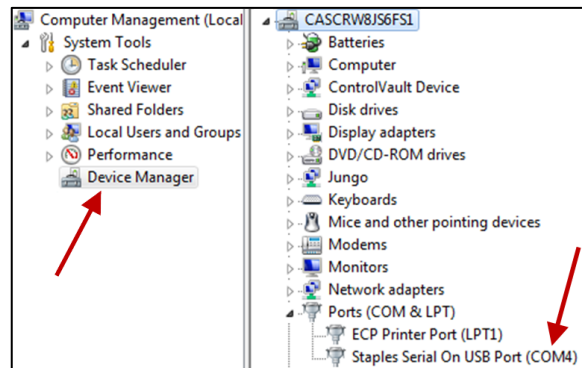
Figure 7

21. Click on "Device manager".
22. Expand the ports list.
23. Check the COM port number and note the number.

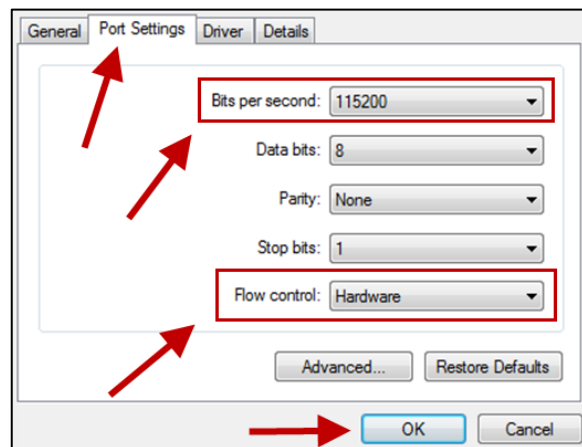
Figure 8

24. Double click on "COM" element to open the properties dialog box.
25. Click on "Port Setting" tab.
26. Select 115200 for the Bits per second.
27. Select Hardware for the Row control.
28. Click "OK".

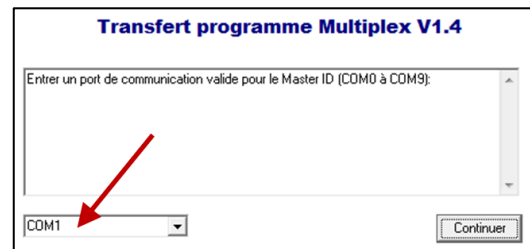
Figure 9

31. Launch the vehicle program (double click on the file name or right click on the file name and select Open).
32. Select the port number noted before.
33. Click "Continue" button.

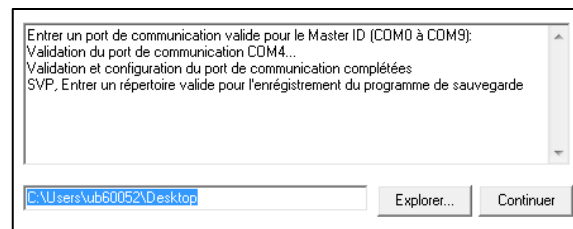
Figure 10

34. Select the destination of the backup file that will be generated with the update processing.
35. Click on "Continue" button.

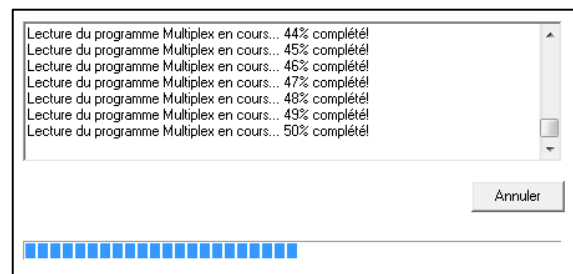
Figure 11

36. Program processes.

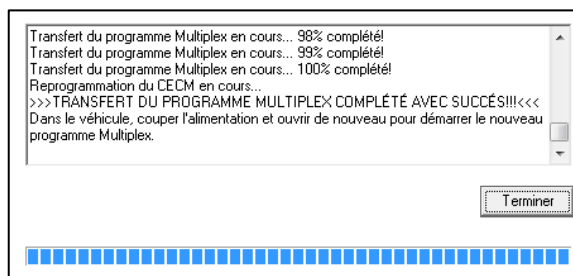
Figure 12

37. Wait until you get the message "TRANSFER COMPLETED".
38. Click "Finish" button.
