MODEL
2020MY Sportage (QL)

NUMBER
PS612

DATE
June 2019

SUBJECT: LANE KEEP ASSIST – LOOSE CONNECTION

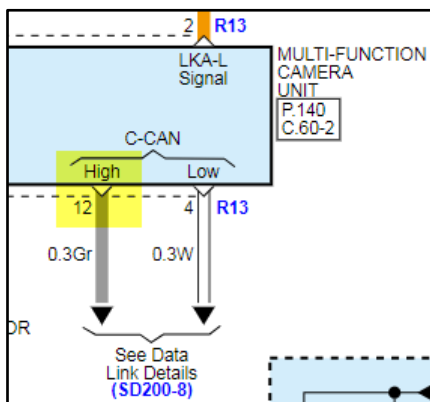
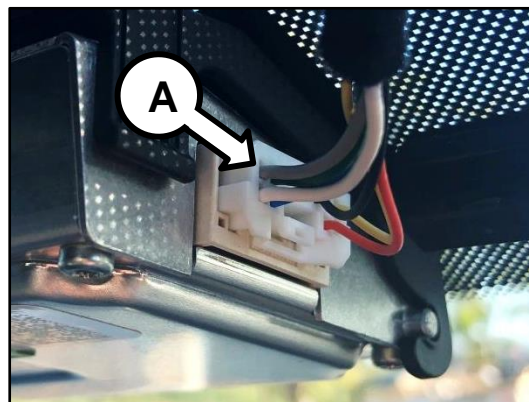
This Pitstop provides information regarding a loose connection at the Lane Keep Assist (LKA) multi-function camera on some 2020MY Sportage (QL) vehicles, equipped with LKA. The vehicle may have a LKA, Forward Collision Avoidance-Assist (FCA), and/or High Beam Assist (HBA) system warning(s) on the instrument cluster. There may be several active DTCs related but not limited to AEB/FCA and CLU systems (screen sample shown below).

System	DTC	Description	State
AEB	C160C87	Local CAN Time-Out	Active
AEB	C180487	CAN time-out LKAS	Active
AEB	C163881	SCC Communication Error	Active
AEB	C16B881	AEB Communication Error	Active
CLU	B104052	LKAS/LDWS Missing Error - without LKAS/LDWS unit or connector fault	Active

To correct this concern, inspect and ensure that the gray pin 12 (A) is secured at the LKA multi-function camera connector (R13). Confirm all pins at connector R13 are secured and then clear all DTCs. If any DTCs are still active, perform further related diagnostics and repair as needed.
