| | GROUP ELE | MODEL 2011-2013MY Optima (TF, TF-HEV) |
| | NUMBER 181 | DATE June 2019 |
| TECHNICAL SERVICE BULLETIN | | |
| SUBJECT: TF/TF-HEV HEADLAMP INSPECTION AND/OR REPLACEMENT | | |

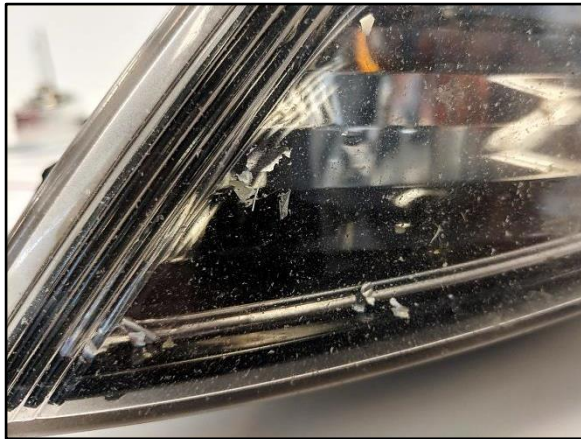
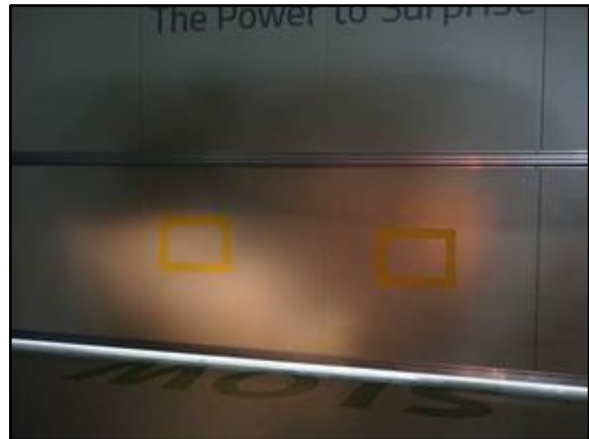
Bad Headlamp Assembly Sample Images:

This bulletin provides the procedure to inspect and/or replace the headlamp assembly on some 2011-2013 MY Optima (TF, TF-HEV) vehicles produced from August 12, 2010 to December 12, 2013. The internal reflective chrome film in the low beam headlamp housing may deteriorate over time, resulting in gradual dimming of the low beam headlamp(s).

- Reflective chrome debris present inside the housing
- Left headlamp with poor light output/intensity

Follow the headlamp assembly inspection and/or replacement outlined in this bulletin to correct this concern.

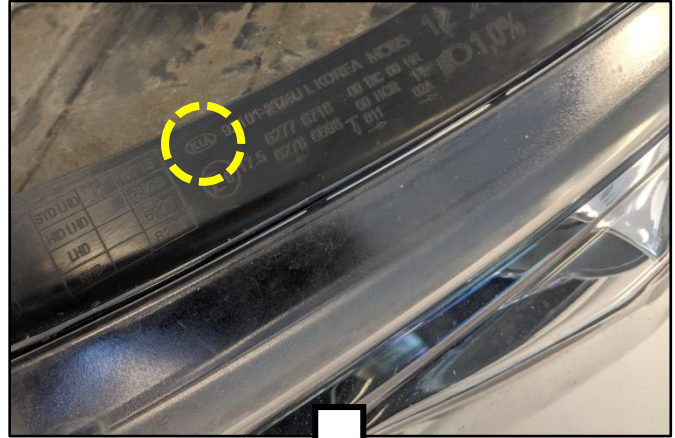
- 1a. Inspect the RH & LH headlamp assemblies and confirm the headlamp(s) are genuine OEM Kia part by confirming the Kia logo is present on the original part. (May require to wipe with a shop rag to make visible)

Sample: Manufactured by Kia with logo.

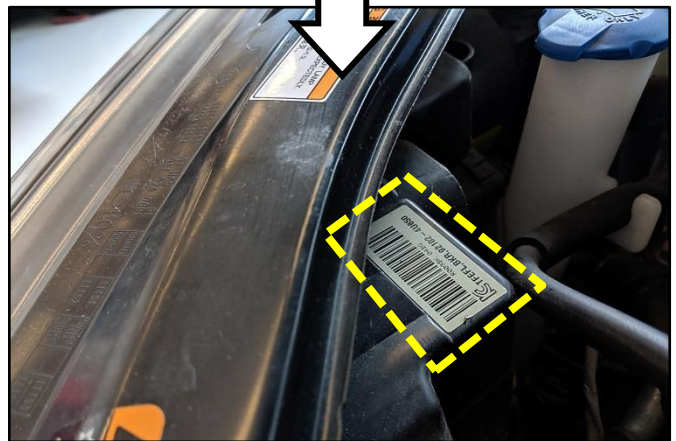
- 1b. If the headlamps are genuine assemblies, proceed to step 2. If headlamp(s) is/are NOT a genuine Kia part, the inspection is complete & NO further repairs are necessary.

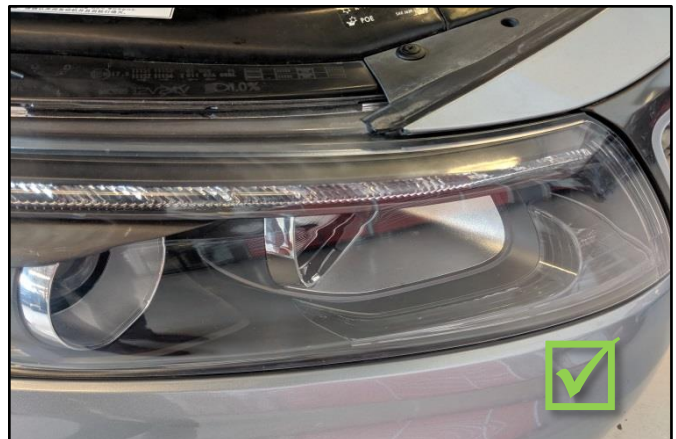
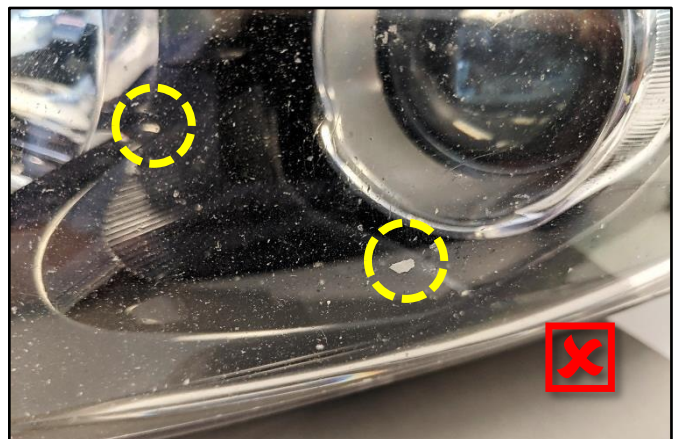
2. Inspect the headlamp(s) for reflective chrome debris inside the housing.

- A. KIA logo stamping.
B. Reflective chrome debris.

If reflective chrome debris is present, (as shown) document each RH/LH headlamp in the vehicle with KVID photos (stamping & reflective debris) & proceed to the “**Headlamp(s) Replacement Procedure**” outlined on page 3 of this bulletin.

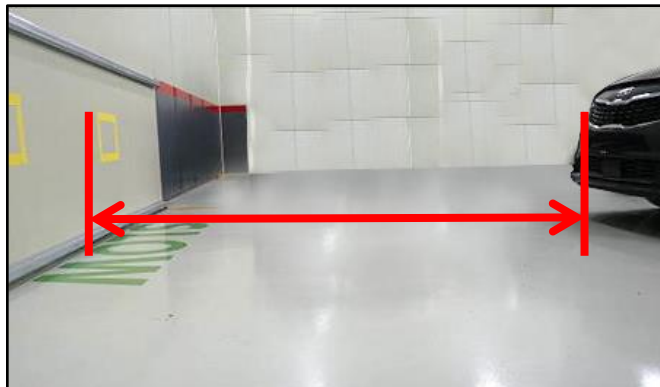
1. Align the steering wheel straight.
2. Place the vehicle 9.8 feet (3 meters) off the wall to inspect the headlamp light intensity.

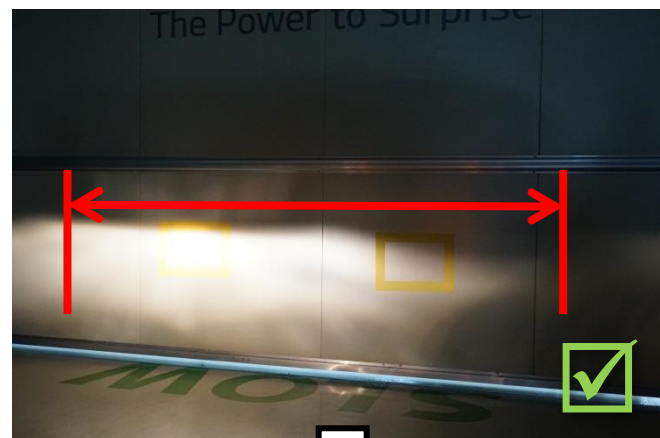
- 3a. Turn the low beams ON and block one headlamp to visually check the light intensity of the other headlamp low beam. Repeat this step for the other headlamp.

- A. KIA logo stamping.
- B. Headlight pattern on the wall.

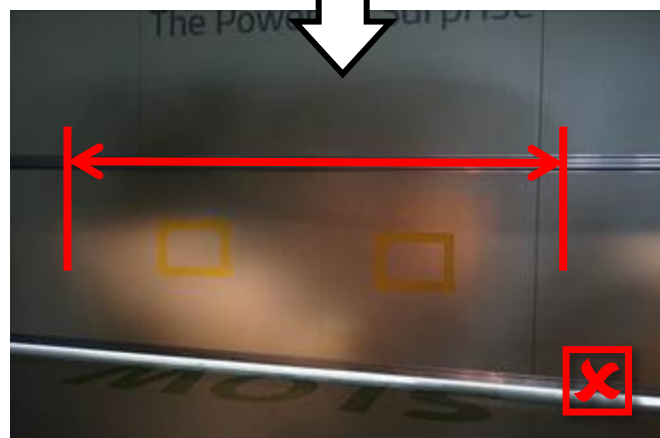
- 3b. Replace the headlamp(s) if the light intensity is poor and a non-continuous line (as shown in pictures on the right)

Image note: Left headlamp output is low while right side is covered.

1. Replace headlamp(s) by referring to “body electrical system → lighting device → headlamp → repair procedure” chapters in the applicable workshop manual on KGIS. Ensure to follow “**Head Lamp Aiming Instructions**” on KGIS after replacement.
