Attached is a drawing showing the tolerance allowed for the 6" X 4" aluminum hot product valve. Which is plus or minus 5 degree.

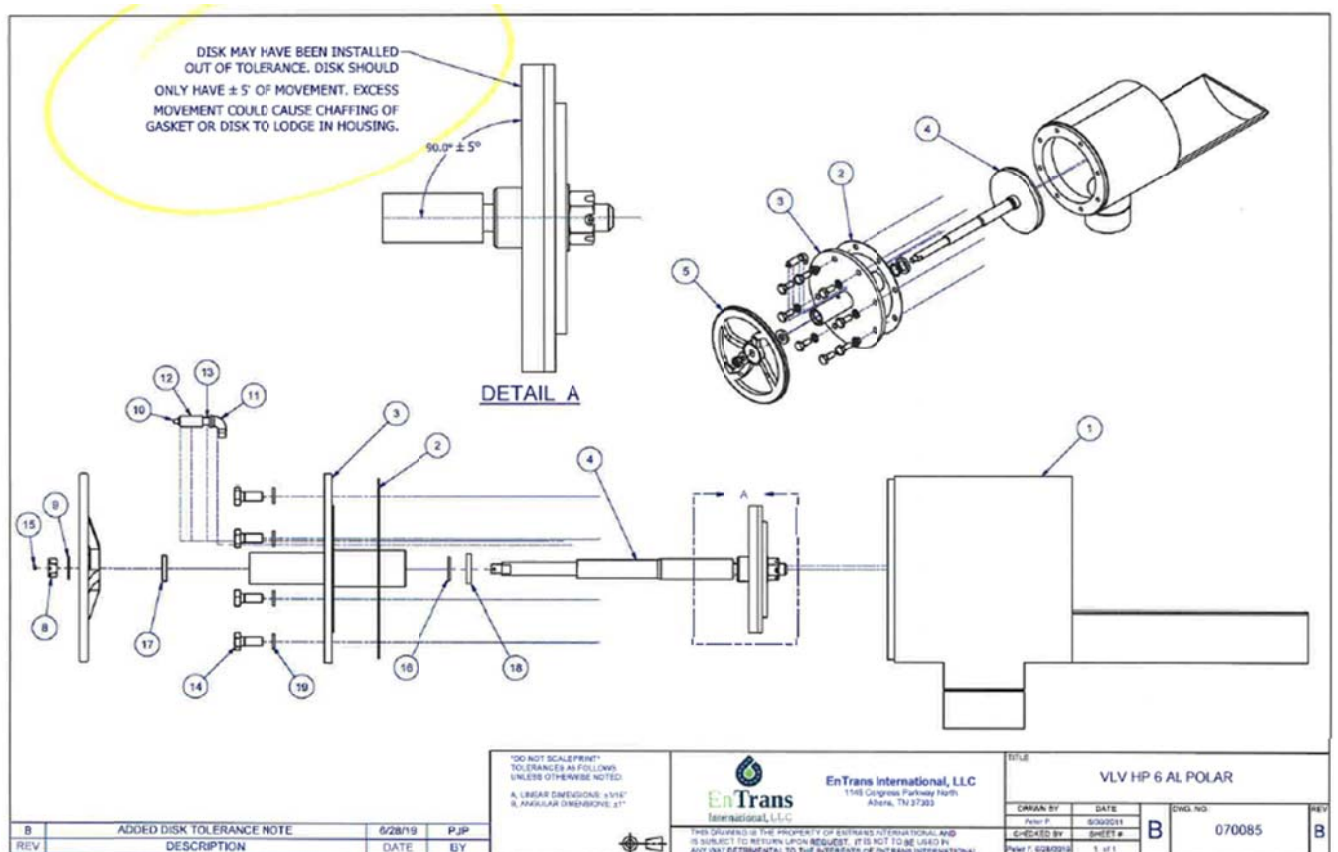
We have found that there were some plunger assemblies install out of tolerance.

The gasket could chaff or lodge in the valve housing set if not corrected.

Please inspect the stem plunger assembly and contact me for replacement parts if needed.

Please send me the address where I can send the mounting flange gasket so the discharge valve can be opened to inspect the plunger valve.
