TECHNICAL SERVICE BULLETIN Glove Compartment Misaligned

19-2206
27 June 2019

Ford 2015-2019 F-150

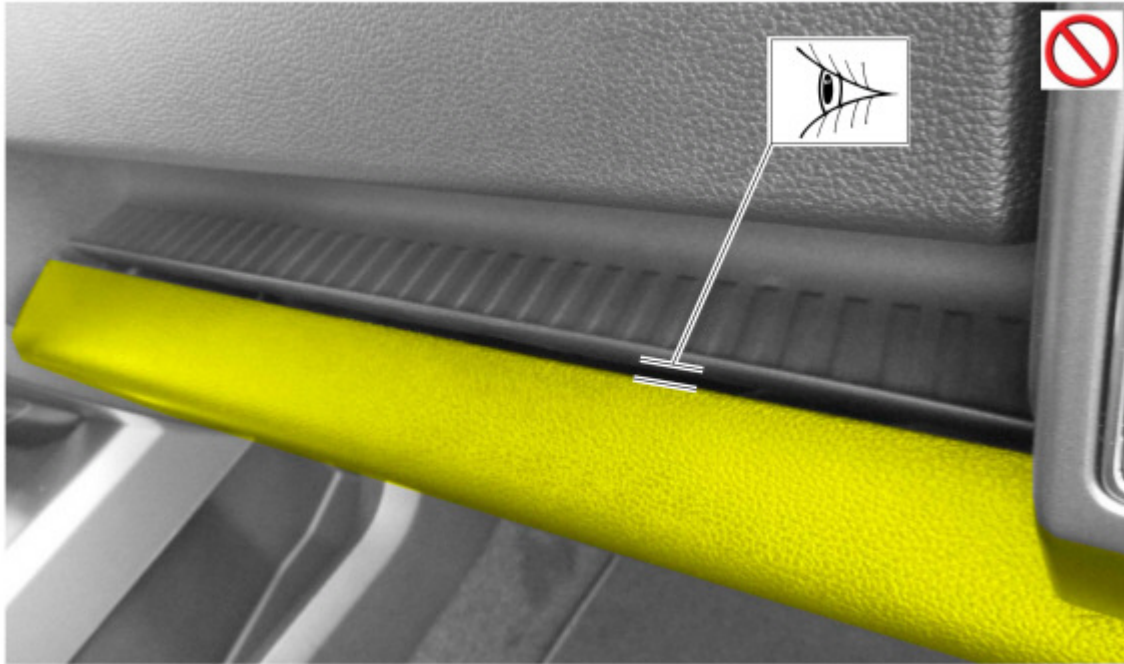
1. Inspect the glove compartment door in the closed position. Does the glove compartment exhibit a misalignment at the storage tray and/or right side instrument panel with no other visible defect? (Figures 1-4)

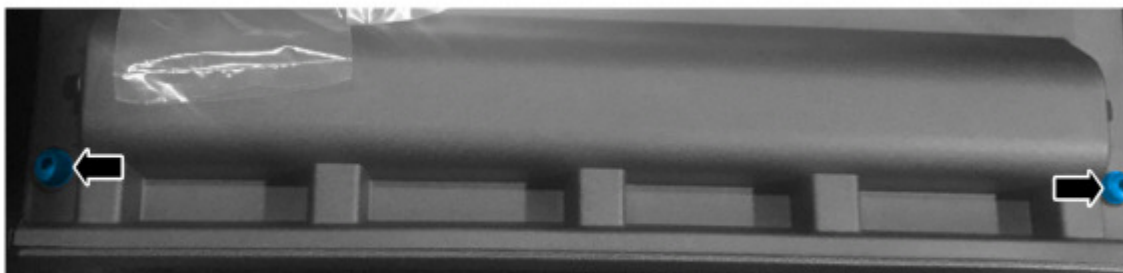
Figure 11

- (1). Yes - repair is complete.
 - (2). No - proceed to Step 9.
9. Remove the bumpers from the glove compartment door and close it. Does the glove compartment door latch properly? (Figure 11)

- (1). Yes - if the glove compartment door closes properly with the bumpers removed, the bumpers have taken a set in the door open position giving the appearance the glove box is warped. Bumpers that have taken a set in the open position increase closing force and inhibit proper latching.

- Install the bumpers and close the glove compartment door fully. Make sure both sides are latched. Increased closing force may be required to properly latch the glove compartment door. Inform the customer that it takes 2 to 24 hours for the bumpers to become set in the closed position depending on ambient temperature. Repair is complete.

10. Replace the glove compartment door. Refer to WSM, Section 501-12.
