Bulletin No.: PIT5689
Published date: 06/4/2019

PIT5689 No Restart after an Auto Stop Event

Brand:	Model:	Model Years:	VIN:		Engine:	Transmissions:
			from	to		
Chevrolet	Silverado 1500 (New Model)	2019	All	All	L84 L87	All
GMC	Sierra 1500 (New Model)	2019	All	All	L84 L87	All

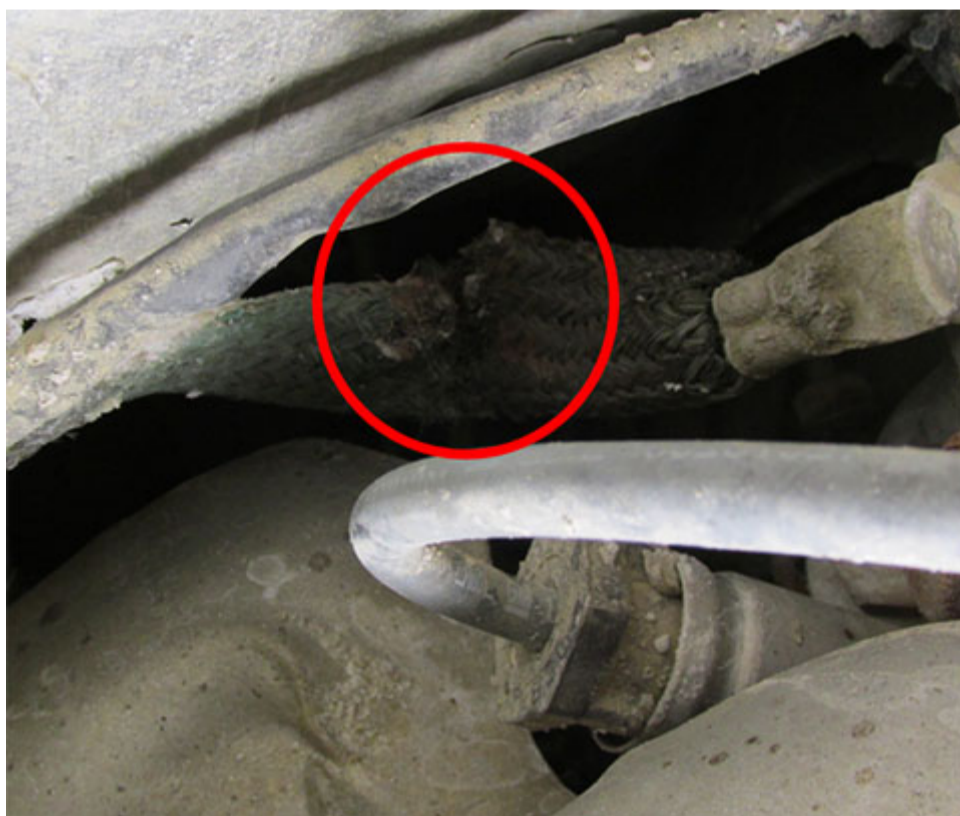
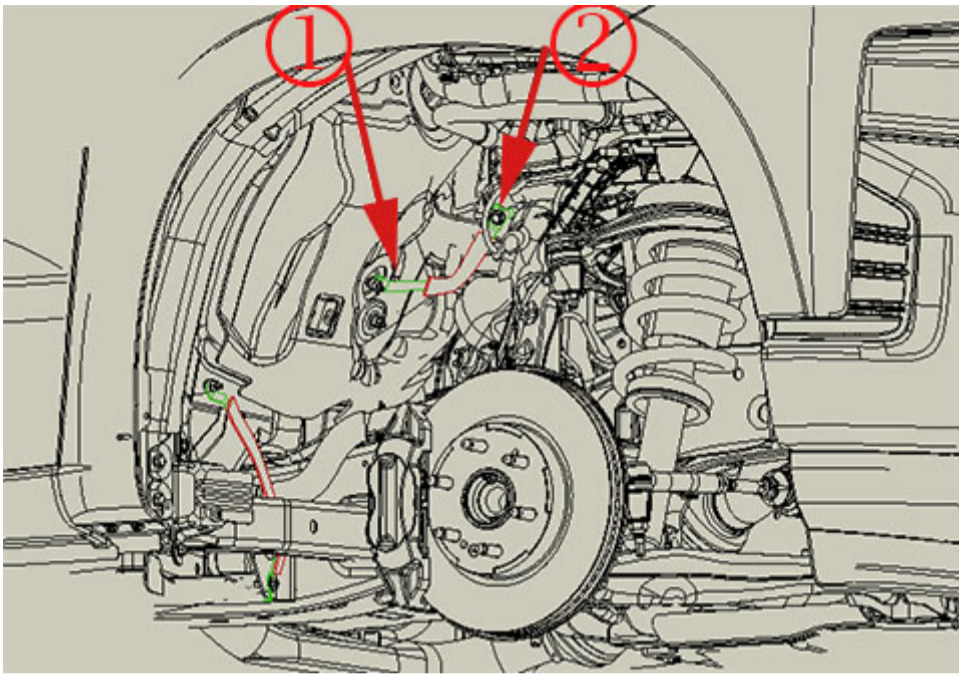
- 1 - G132
- 2 - G134

Involved Region or Country	North America
Additional Options (RPO)	L84 or L87
Condition	Some customers may comment that after an auto-stop event the engine does not restart.
Cause	This concern could be caused by a broken engine ground strap, which grounds the engine (2) to the body (1), as shown below.

Replace the engine ground strap and confirm that the strap is properly orientated to prevent damage to the strap caused by powertrain movement.
