PIC6163B Normal Characteristic - Fasteners Under the Hood Appear to be Loose

Brand:	Model:	Model Years:	VIN:		Engine:	Transmissions:
			from	to		
Chevrolet	Camaro	2016 - 2019	All	All	All	All

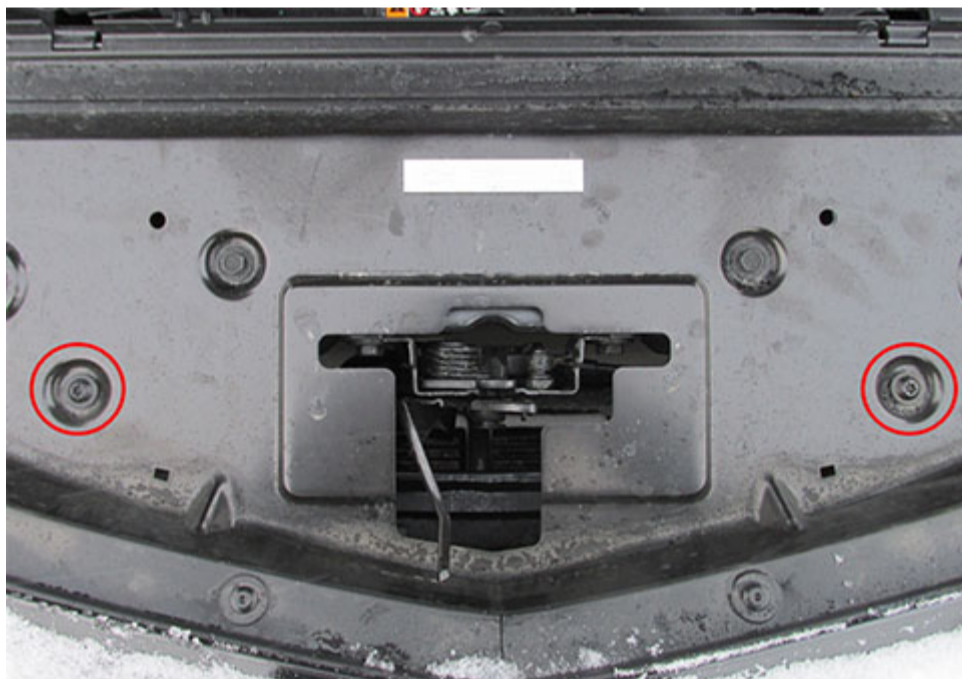
Some customers / technicians may comment that several fasteners, located on either side of the hood latch, appear to be loose.

The first photo shows both fasteners as a point of reference in relation to the hood latch.

IMPORTANT: Do NOT tighten, or otherwise move these two fasteners.

These fasteners are part of the front fascia support bracket.

They have a preset gap by design, and they have Loctite applied to the threads of the fastener so that this preset gap does not change.

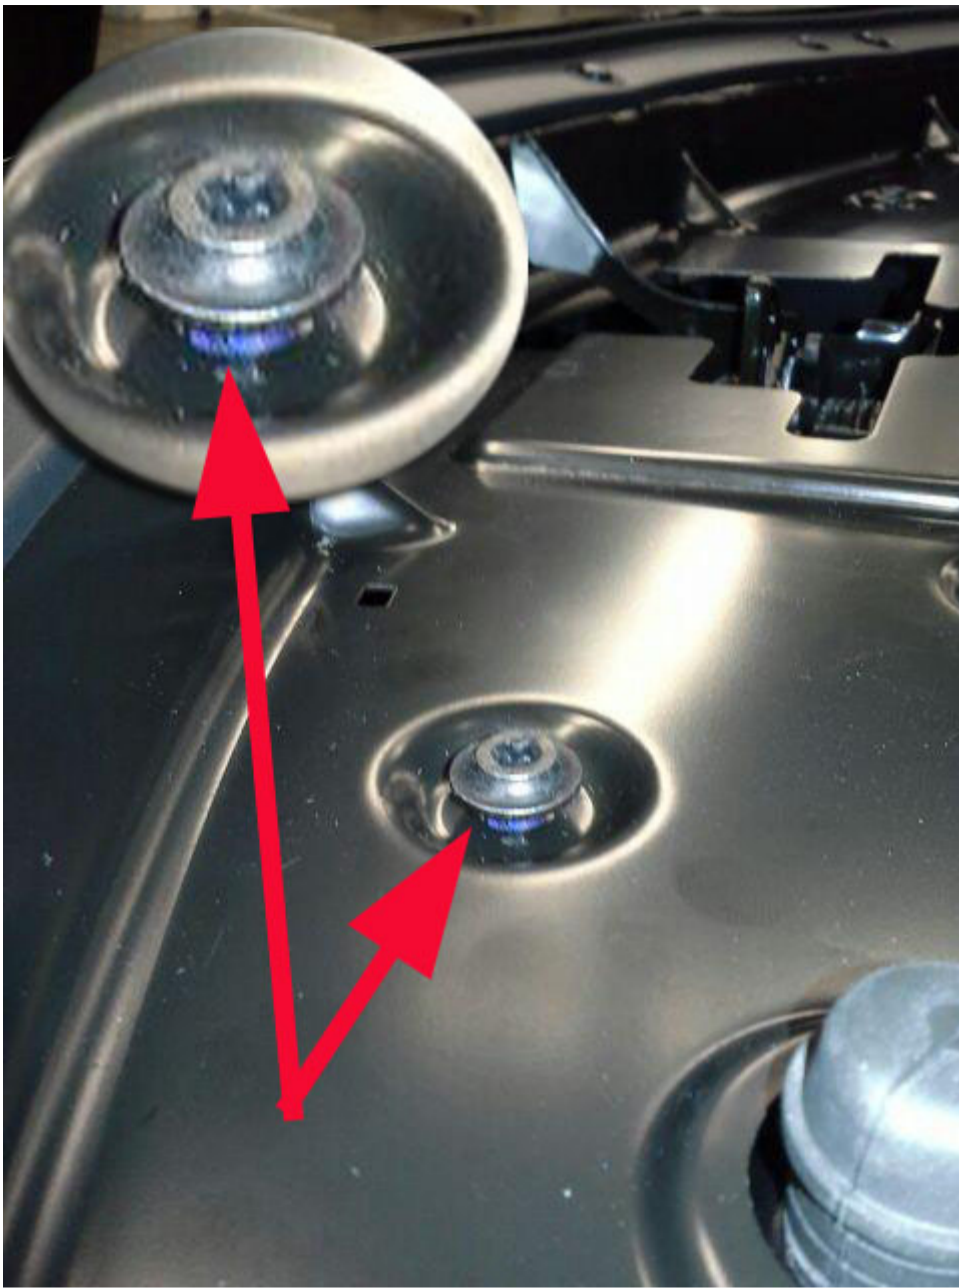
The second photo is a close-up of these fasteners to clearly show the gap that exists between the head of the fastener and the plastic trim panel underneath.

These two screws are adjustable to allow for hood to fascia alignment, but they should only be adjusted if the fascia is too high or too low in reference to the hood.

When these fasteners are adjusted, the vertical clearance of the front fascia to hood gap will be changed.
