Preliminary Information

PIT5682A Sunroof Sunshade Will Not Latch

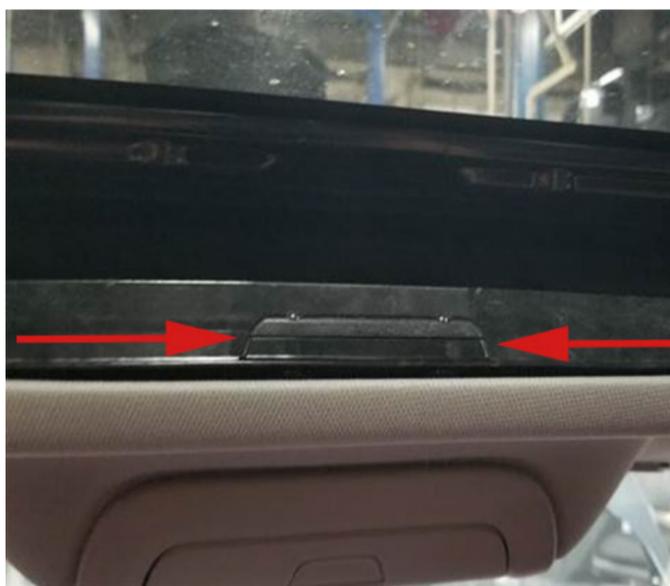
| Condition | Some customers may comment that the front sunroof sunshade will not latch in the closed position. |
| Cause | The sunroof sunshade catch on the sunroof housing may be broken. |

Replace the front sunroof sunshade catch with P/N 84691055.
Do NOT replace the Sunroof Housing for this condition.
