Preliminary Information

PIP5295B Chevrolet Spark EV (BEV) 1ET35 Transmission Fluid Appears Overheated Or Dark In Color

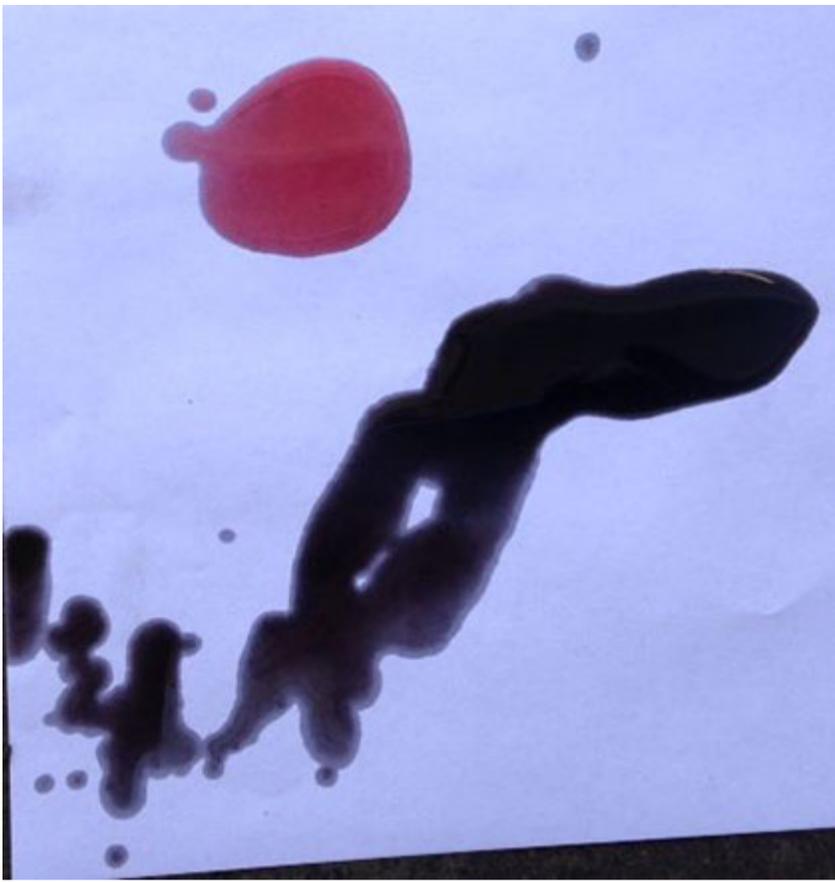
The Transmission Fluid in the 1ET35 may turn dark after mileage is accrued on the vehicle. If the transmission fluid appears dark, do not assume that the transmission is damaged internally.

The photo below is an example showing a comparison between new and used Dexron HP fluid and extreme discoloration found in a perfectly operating unit after 15,000 miles of operation.

DO NOT replace the Transmission, Transmission Cooler or recommend flushing the Transmission or Transmission Cooler based only on the appearance of the Transmission Fluid.

Please Take a Sample and compare it to the Picture.
