## Preliminary Information

### PIP4964D SES Light With A P2097 Or P2099

Some customers may complain of an SES light with no drivability concerns.  
The technician will find a DTC P2097 or P2099 set.

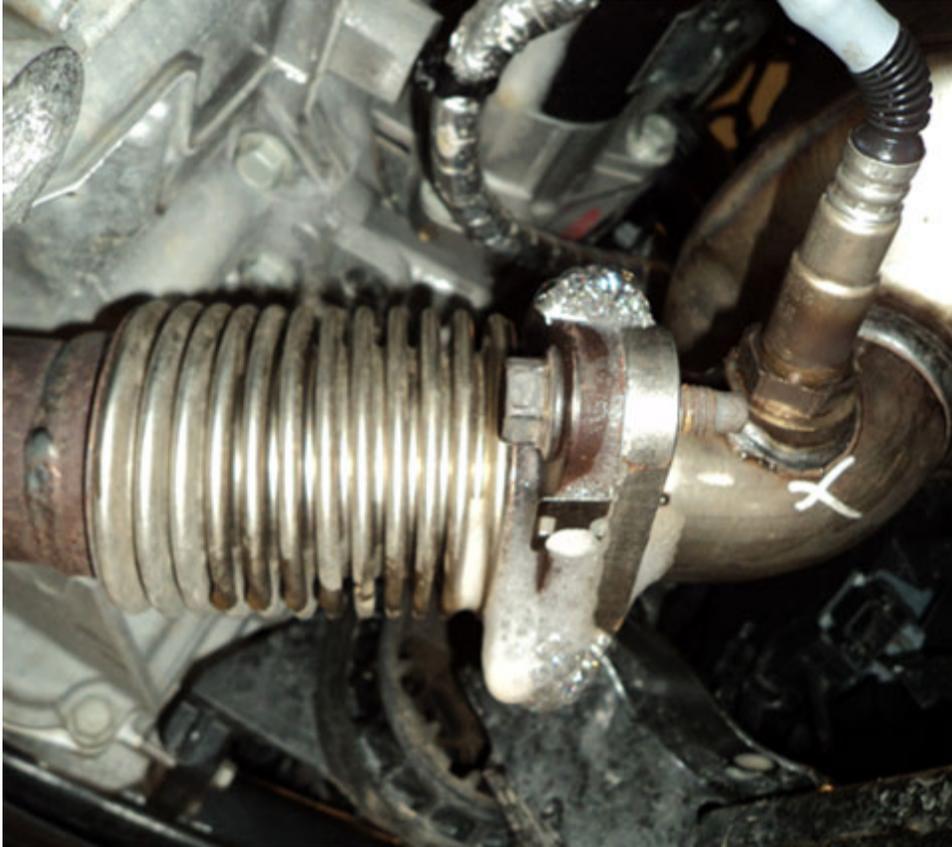
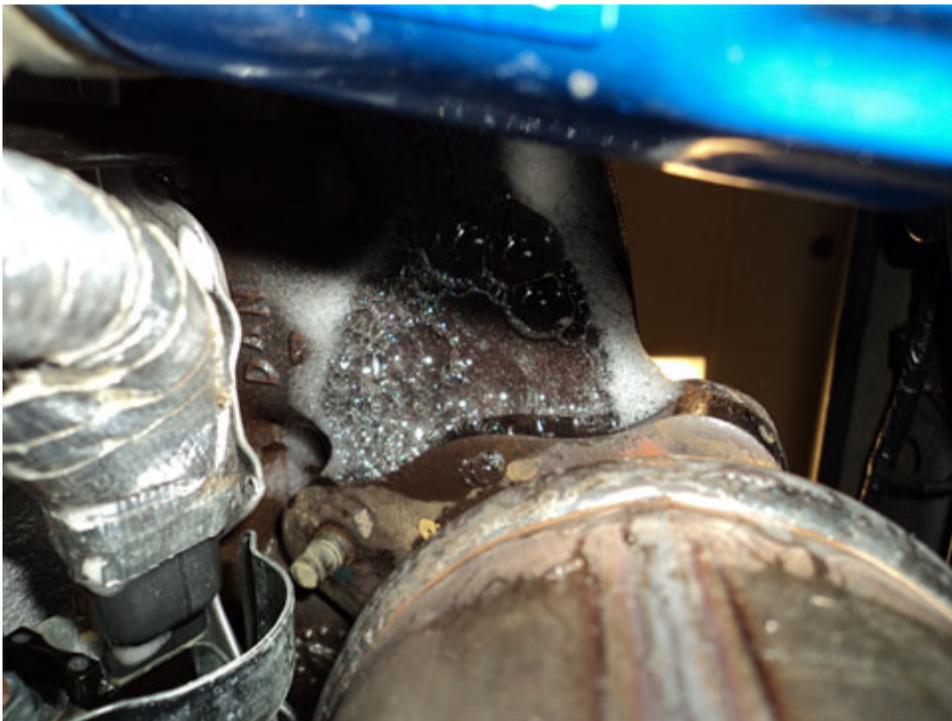
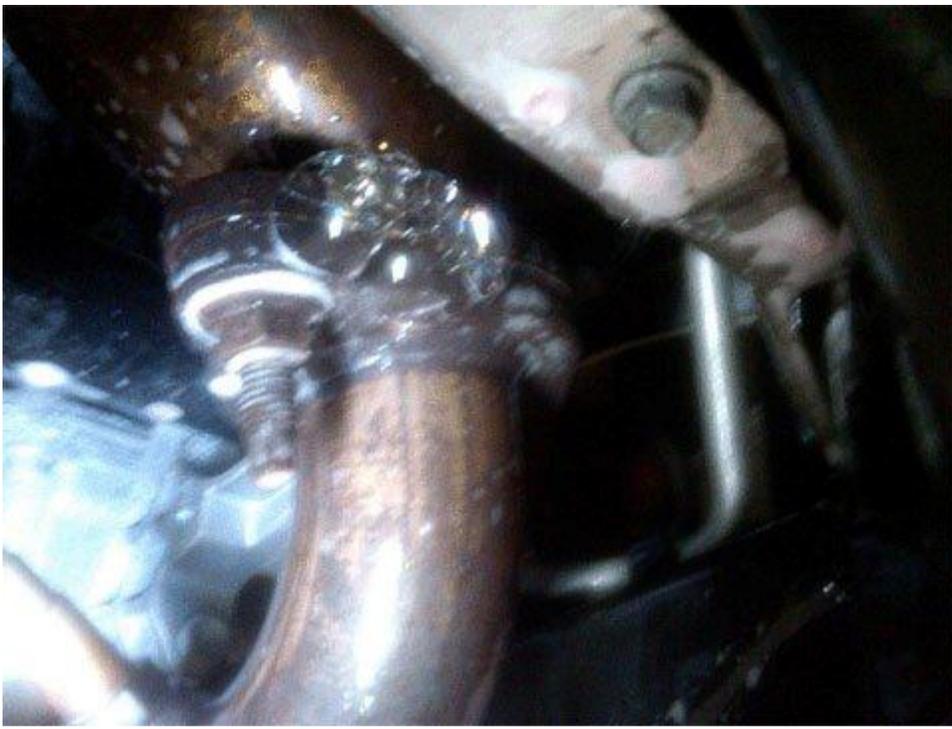
If normal SI diagnostics does not lead to a resolution for this code, then look for a small leak in the exhaust, usually at the outlet to the engine converter

This leak will allow air to be pulled into the exhaust and cause a false lean concern at the post O2 sensor. To diagnose this leak we recommend applying air to the rear of the downstream converter or to the tail pipe on single systems @ 5psi to 8 psi.

Apply a soapy solution to the gasket areas and the O2 boss.

Leaks in these areas that will cause the code will be larger bubbles.

**If a leak is found in these areas alongwith gasket replacement, filing themating surface of the pipe is suggested.**

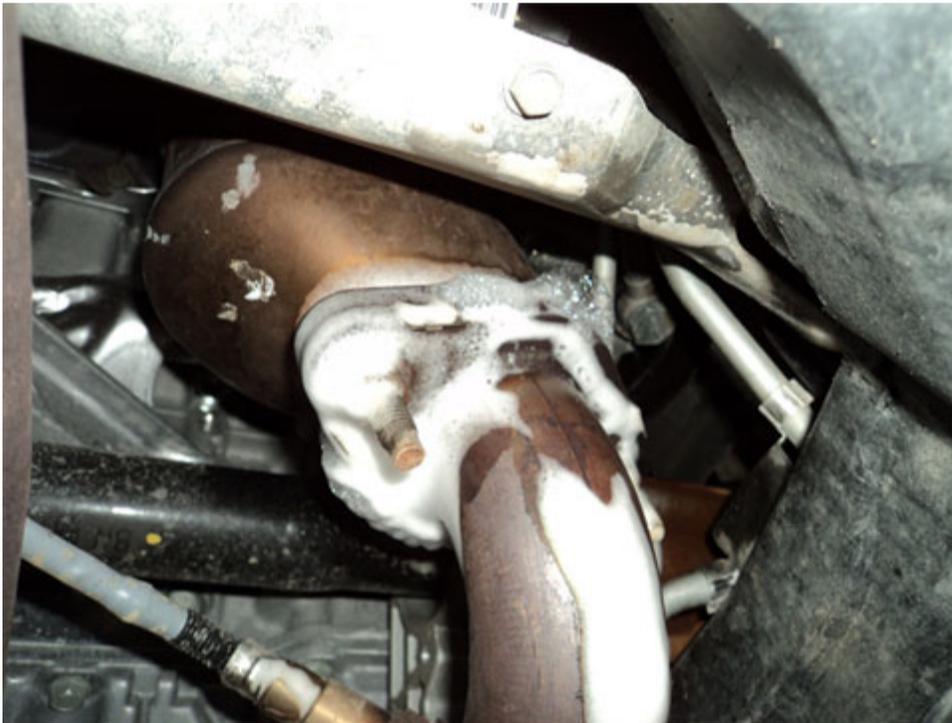
**Foam leaks are considered normal.**

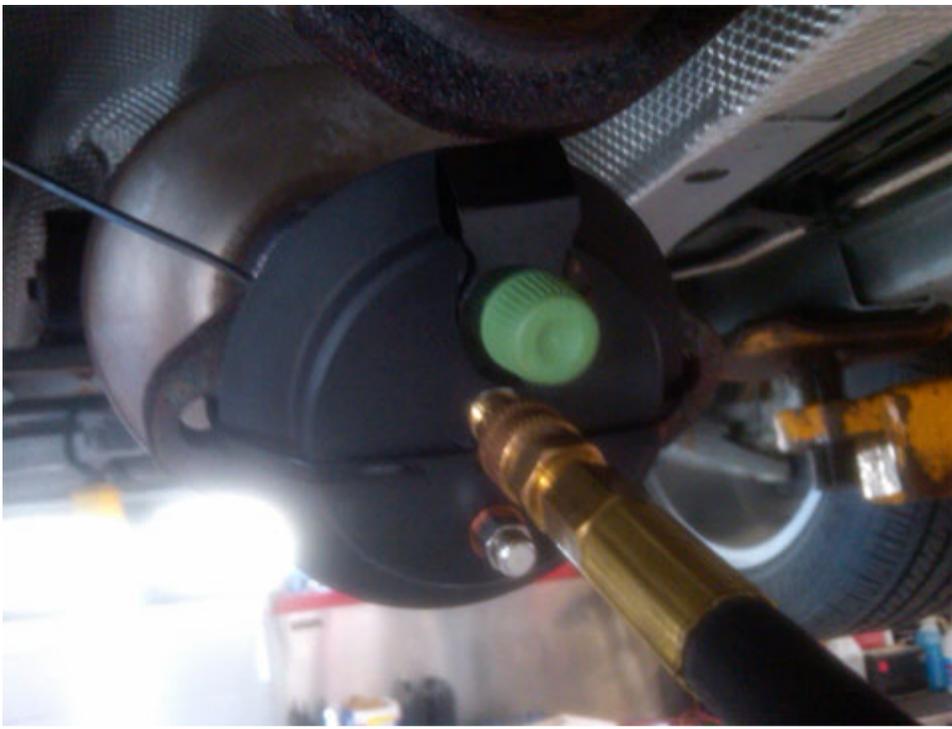
**If available CAC leak tester J-46091-1 and adapter can be used with a modification using wire ties to hold it to the pipe.**

**Or GE-52250 - Tool For Leak Testing Charge Air Cooler / Turbo System will work also.**

**DO NOT APPLY FULL SHOP AIR as converter and engine damage can result.**
