Preliminary Information

PIC6065C Diagnostic Tip: Performance Data Recorder SD Card Not Recognized

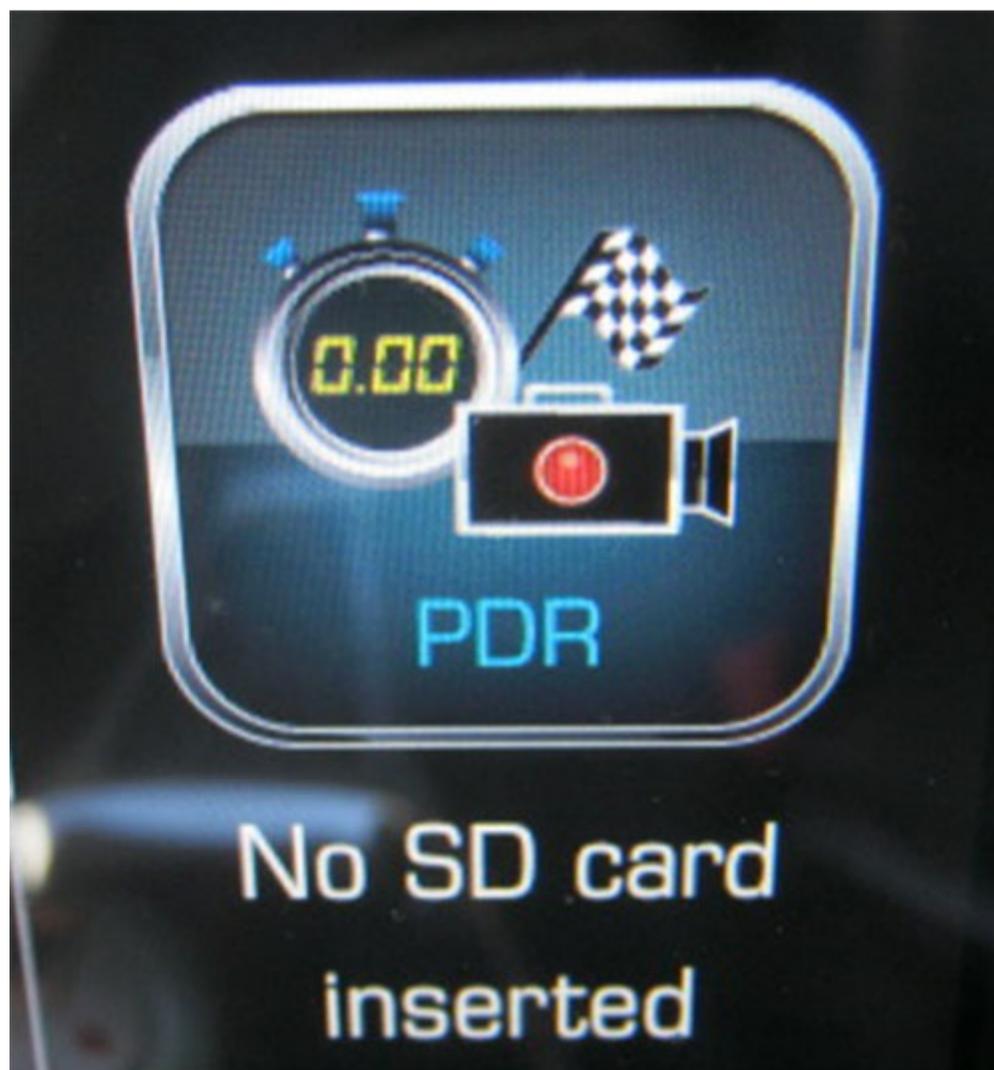
Customers may comment that the vehicle does not recognize the SD card when it is inserted into the card reader. The Performance Data Recorder (PDR) menu will also display the message, "No SD card inserted" as seen in the photo below.

When diagnosing this concern, the first thing that should be checked is which SD card reader has been used by the customer. On most vehicles with the PDR system, there are multiple SD card readers. Dealership technicians are to visually inspect the vehicle for multiple SD card reader locations. As an example, the Corvette has a media SD card reader in the center console. The SD card reader for the PDR system however, is located in the glovebox. The Camaro only has one SD card reader and it is located on the driver's side knee bolster. Refer to published Service Information (SI) to be certain the correct SD card reader location is being used for the vehicle that is being serviced.

Note: The SD card needs to be formatted to FAT32 and also have a class 10 designation in order to be compatible with the system.

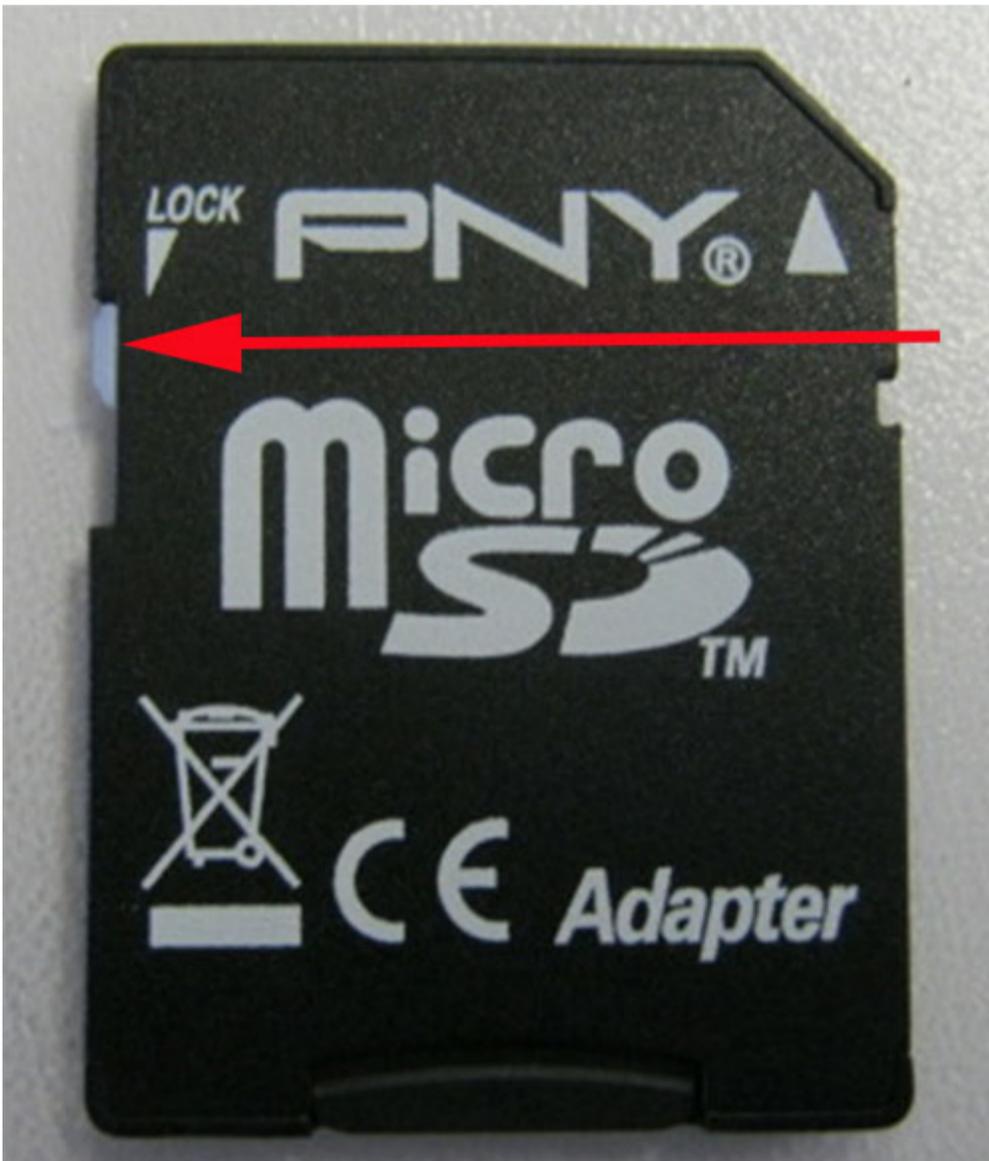
If the vehicle is intermittently losing connection with the SD card, there may be several possibilities as to why. There may be an issue with the connector at the back of the SD card reader. The USB cable that connects the card reader to the PDR module may be stressed, causing a poor connection at the hub. Also, if there is a self-stick paper label applied to the SD card, this may prevent the SD card from being fully inserted and locked into the card reader. The label may also inadvertently cover the lock tab on the side of the SD card. Both of these instances may cause the card reader to interpret the situation as the SD card itself being locked. This lock tab can be seen in the photo below. Please verify that the "Lock" tab on the SD card is in the unlocked position.

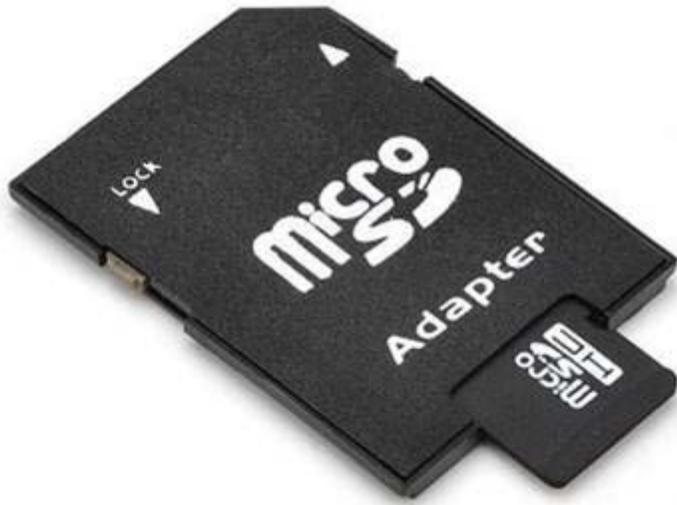
Note: While this system is capable of operating correctly with a micro SD card that has been inserted into a full sized SD card adapter, it has been found to work more reliably when a full size SD card used. Customers are strongly encouraged to use a standard size SD card with the PDR system in these vehicles.

Micro SD card with Adapter shown

Please try a different, known good SD card before replacing ANY parts in the PDR system.

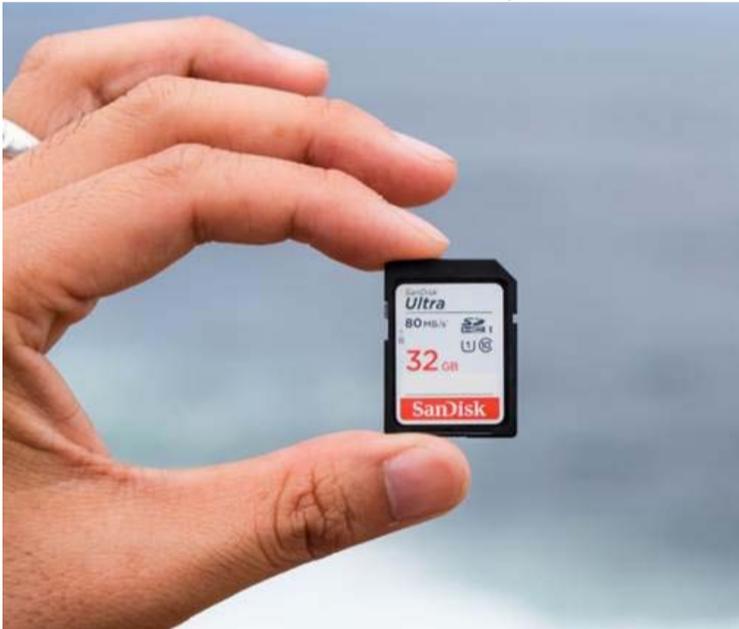
Standard SD card shown
