BR205 Facelift - Blind Spot Assist may activate without obvious cause

Topic number	LI54.71-P-068935
Version	3
Function group	54.71 Camera and radar-assisted assistance systems
Date	05-02-2019
Validity	The topic only affects BR205 as of facelift (YoM 809) with code 234 (Blind Spot Assist) or code 23P (Driving Assistance Package).
Reason for change	Update validity
Reason for block

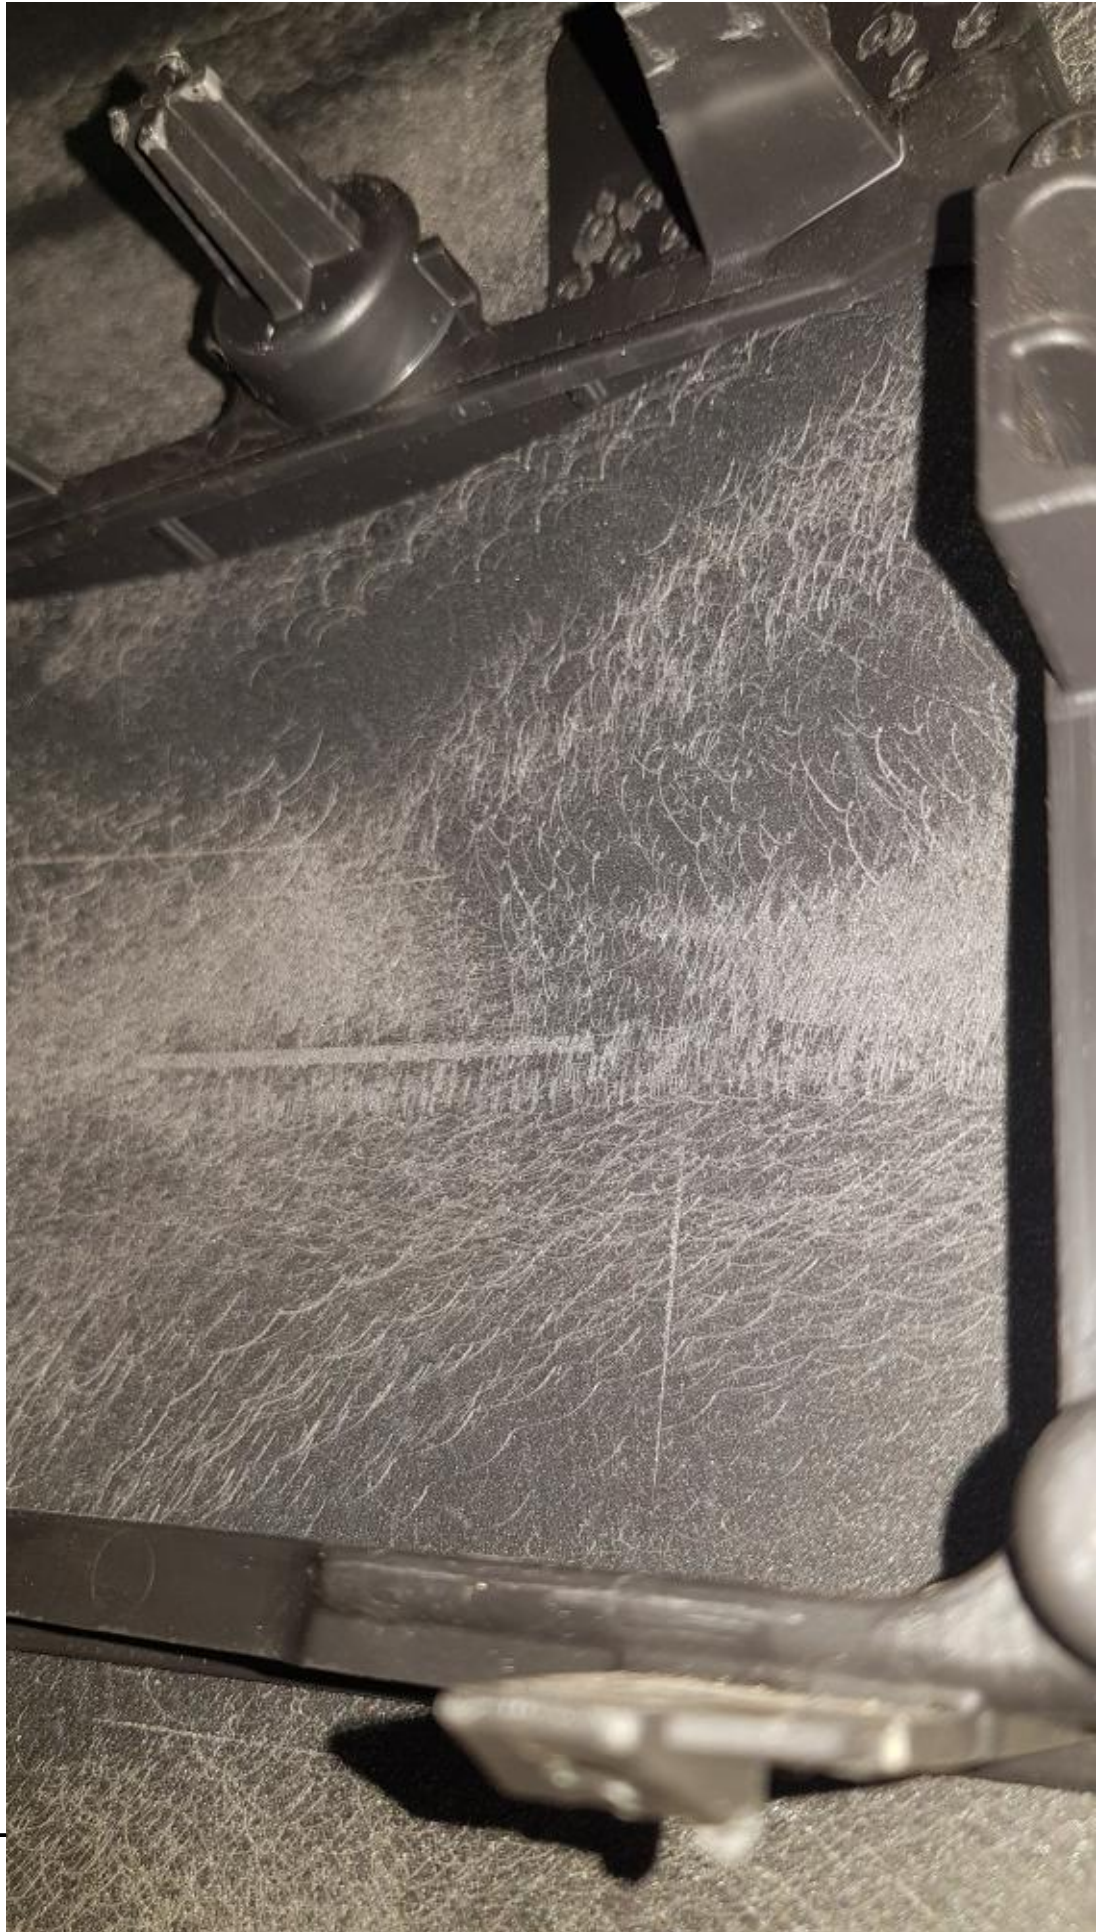
Sichtfeld Sensor.jpg:

The inside of the rear bumper may have been ground down or scratched in front of one of the rear radar sensors (see example pictures).

Under certain circumstances, the score marks in the plastic could reflect the radar signals emitted by the sensor.

Attachments	
File	Description
Sichtfeld Sensor.jpg	Swirl marks in front of sensor
Sensor montiert.jpg	Bumper with mounted sensor
Sensor demontiert.jpg	Bumper with removed sensor
Markierung.jpg	Example of a permissible mark
Markierung2.jpg	Example of a permissible mark

Check rear bumper for swirl marks on inside.

If any are found, replace bumper as per the EPC.

In this case, do not replace the rear radar sensors.

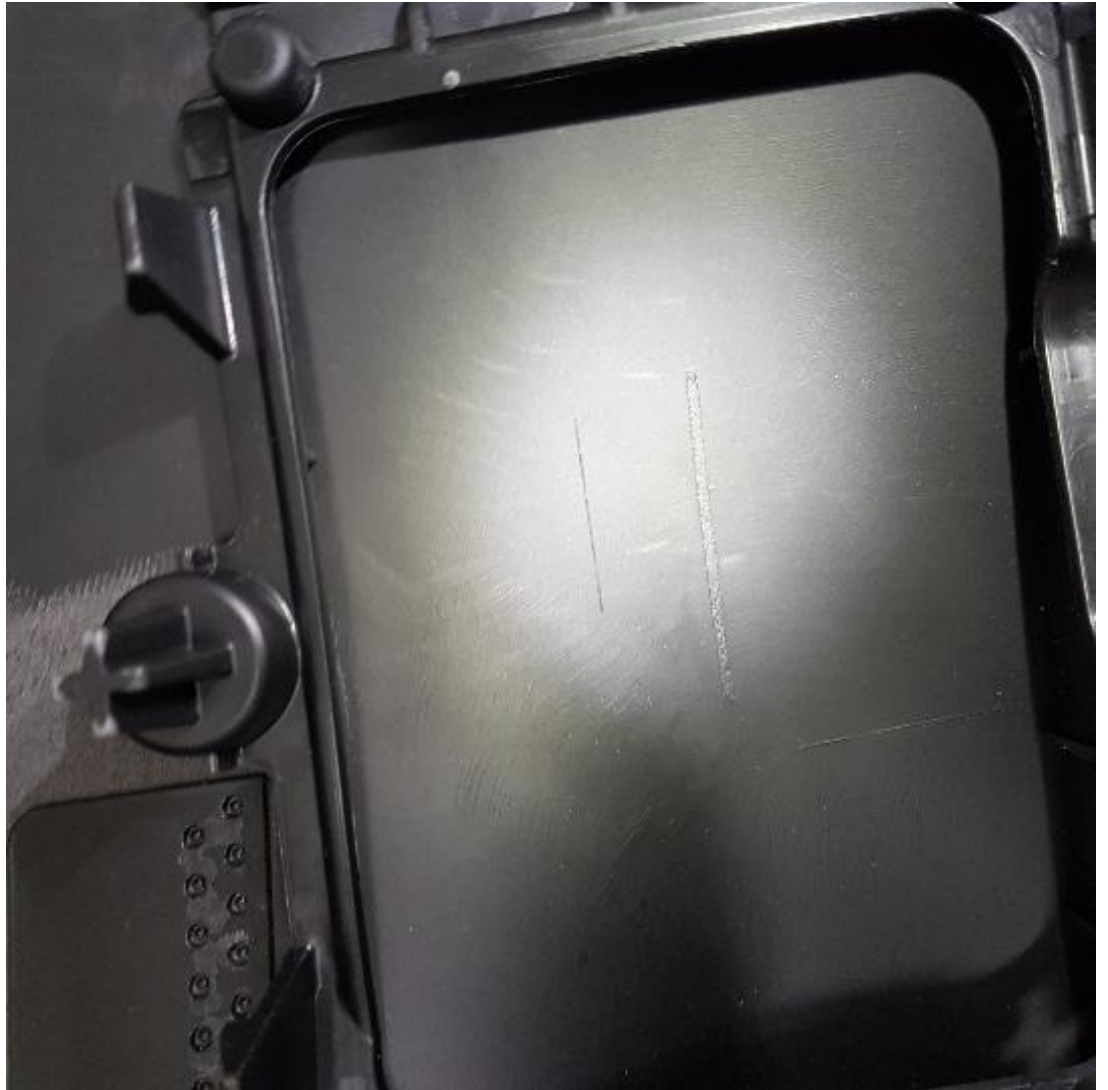
Markierung.jpg:

Certain marks from the manufacturing process are permissible (see picture "Permissible mark") - this is intended to refer to obvious score marks and marks from manual processing.

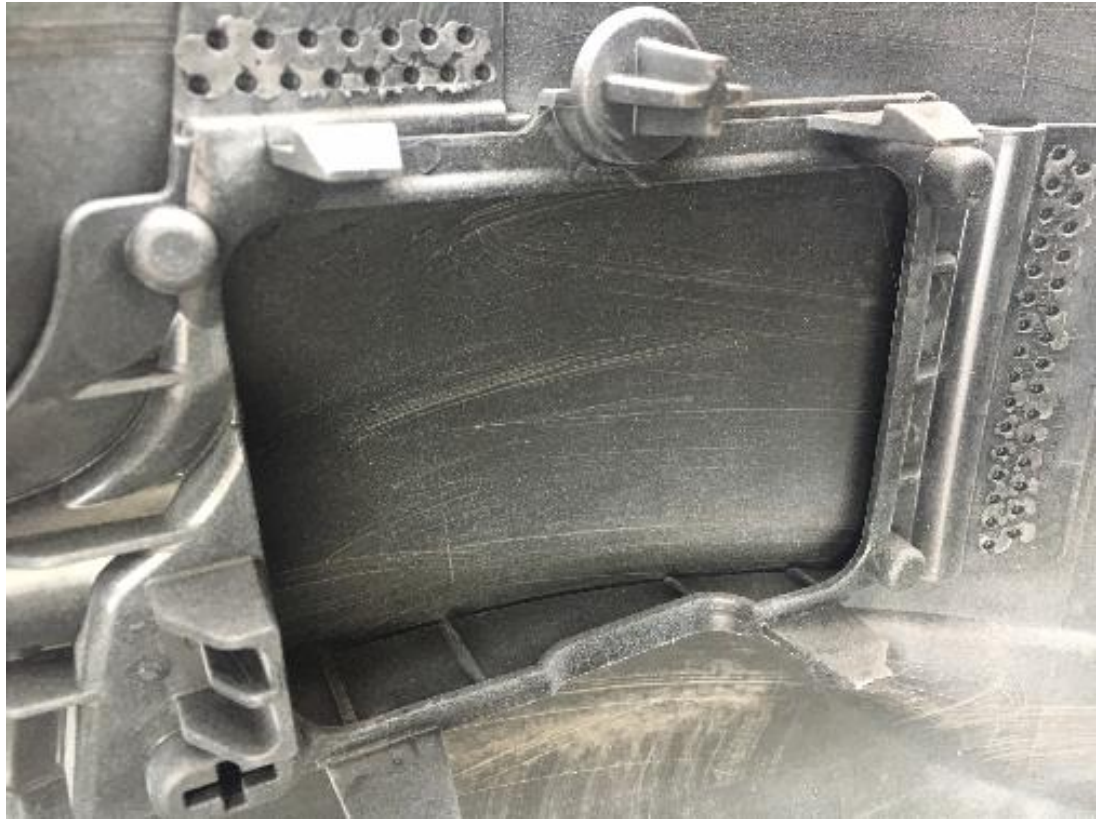
Kratzer.JPG:

Attachments	
File	Description
Beanstandung.png	Example of warning without obvious cause
Kratzer.JPG	Scratch in front of sensor
