TO: Mercedes-Benz Dealer Principals, General Managers, Sales Managers, Service Managers, Parts Managers	FROM: Gregory Gunther, Department Manager, Vehicle Compliance and Analysis, Engineering Services
RE: <b>Service Campaign Launch Notification</b> <b>MY18-19 GLE-Class, GLS-Class, GLE-Coupe Class (166, 292 platform)</b> <b>Check Torsion Bar Linkage, Replace if Necessary</b>	DATE: May 3, 2019

Campaign No. 2019040013, May 2019

SUBJECT: **Model GLE-Class, GLS-Class, and GLE Coupe vehicles (166 and 292 platforms)  
Model Year 2018-2019**

**Check right and left torsion bar linkage, replace if necessary**

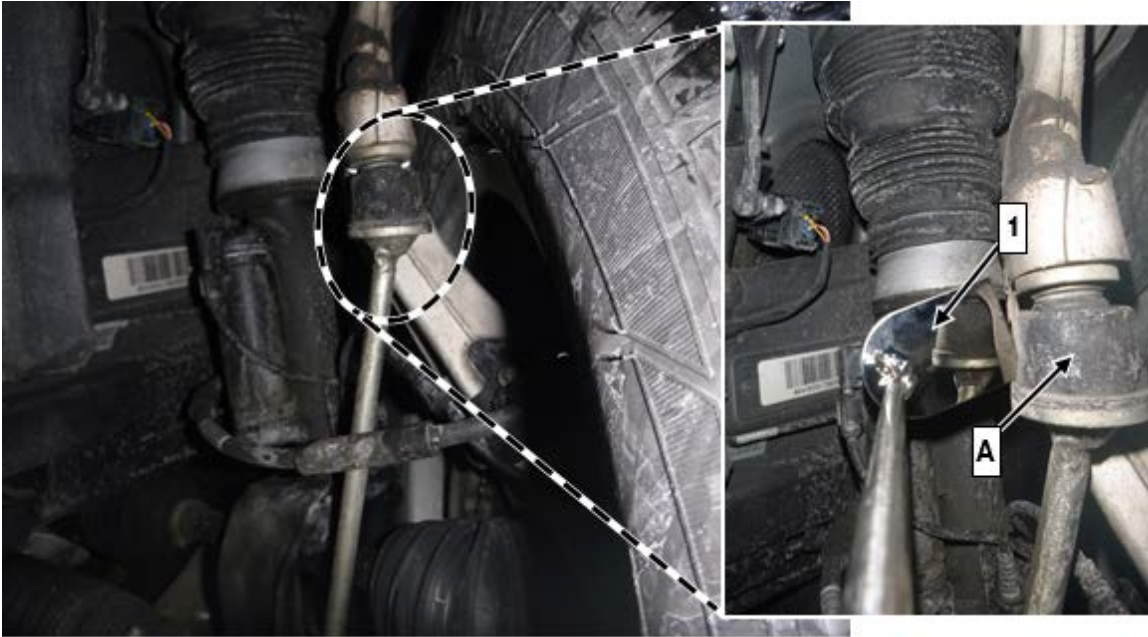
**Figure 1**

1. Turn wheels and check upper boot (**A, Figure 1**) on torsion bar linkage for damage or indentations.

**i** Use mirror (**1, Figure 1**) for check. The check must be performed on both sides.

The upper boot (**A, Figure 1**) on the torsion bar linkage must not be damaged or exhibit any indentations.

- a. If damage or indentations are present on the torsion bar linkage boot:  
Carry out **work procedure**.
- b. If damage or indentations are **not** present on the torsion bar linkage boot:  
**End measure**.

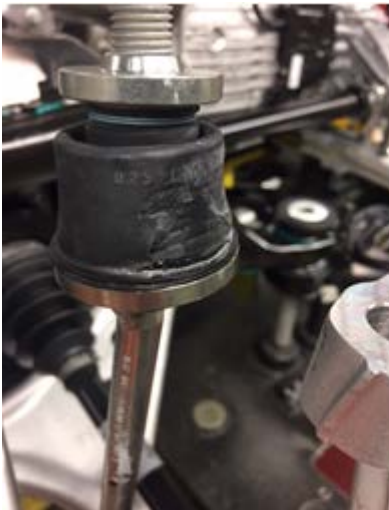
**i** Figure 2 shows indentations and Figure 3 shows damage.

**Figure 2** indentations **NOT OK**

- a. If boot (figure 2) displays indentations or damage (figure 3): Carry out **work procedure**.
- b. If boot is OK: **End measure**.

1. Replace torsion bar linkage on front axle.

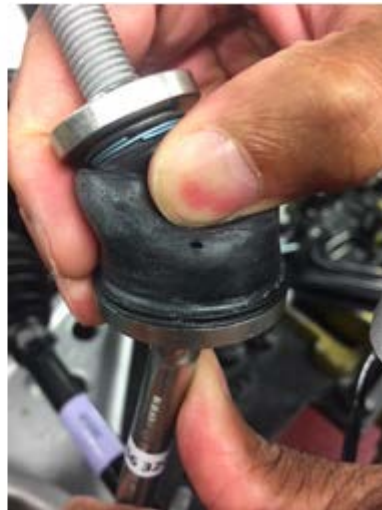
**figure 3** damage **NOT OK**
