TO: Mercedes-Benz Dealer Principals, General Managers, Sales Managers, Service Managers, Parts Managers	FROM: Gregory Gunther, Department Manager, Vehicle Compliance and Analysis, Engineering Services
RE: Service Campaign Launch Notification MY19 A-Class (177 platform) Correct Torque of Threaded Connection	DATE: May 10, 2019

Campaign No. 2019040022, May 2019

SUBJECT: **Model A-Class (177 platform) vehicles**
Model Year 2019

Correct the torque of the threaded connection on the left and right rear axle torsion bar

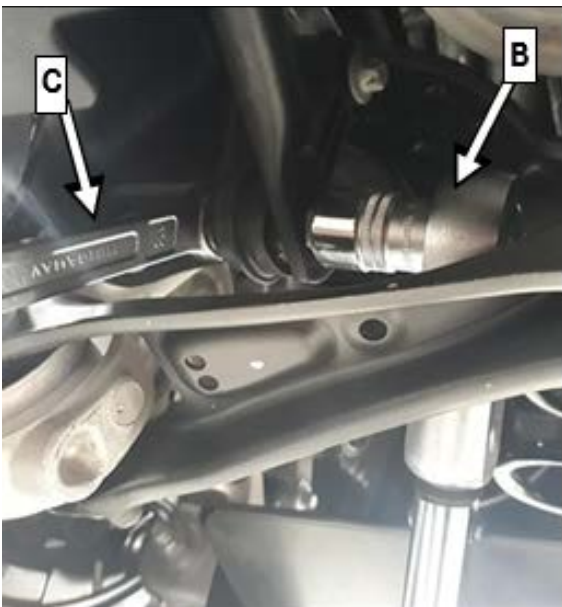
Figure 2

Daimler AG ("DAG"), the manufacturer of Mercedes-Benz vehicles, has determined that on certain Model Year ("MY") 2019 A-Class (177 platform) vehicles, the torque of the threaded connection of the torsion bar on the left and right rear axle does not correspond to current production specifications. As a result, the threaded connection may loosen, resulting in noise. An authorized Mercedes-Benz dealer will correct the torque of the threaded connection on the affected vehicles.

3. Correct torque of threaded connection of torsion bar linkage at left and right (**figure 2**).
 i The threaded connection must ***not*** be unfastened.
 i To correct the torque, a torque wrench (**B**) and a counter wrench (**C**) must be used (**figure 2**).
 i The torque of the threaded connection of the torsion bar linkage on the rear axle is **Nm** **80 +/-8**.
