ESP, BAS, PRE-SAFE - Fault message in instrument cluster

Topic number	LI54.18-P-067550
Version	6
Function group	54.18 Cable harnesses
Date	05-23-2019
Validity	Model 213, 238 and 257
Reason for change	Information on alternative to repair wiring harness
Reason for block

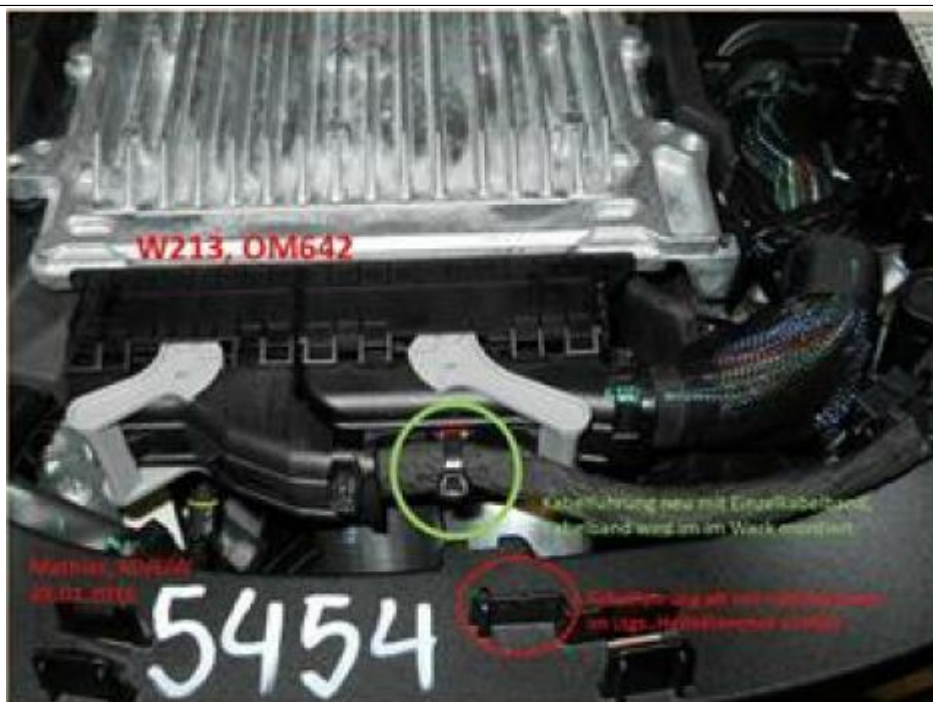
KabelbandSteckerF.JPG:

Check whether the cable strap on the plug housing of the control unit is missing (see photo), and install if necessary.

Attachments	
File	Description
KabelbandSteckerF.JPG	Cable strap on engine control unit on engine model 642.
