"High-voltage battery warning message" in instrument cluster

Topic number	LI83.70-P-064480
Version	4
Function group	83.70 Auxiliary/supplementary heater
Date	05-22-2019
Validity	Model 205 - Hybrid Model 253 - Hybrid Model 222 - Hybrid Model 242 - EV
Reason for change	A TIPS case module does not need to be opened.
Reason for block

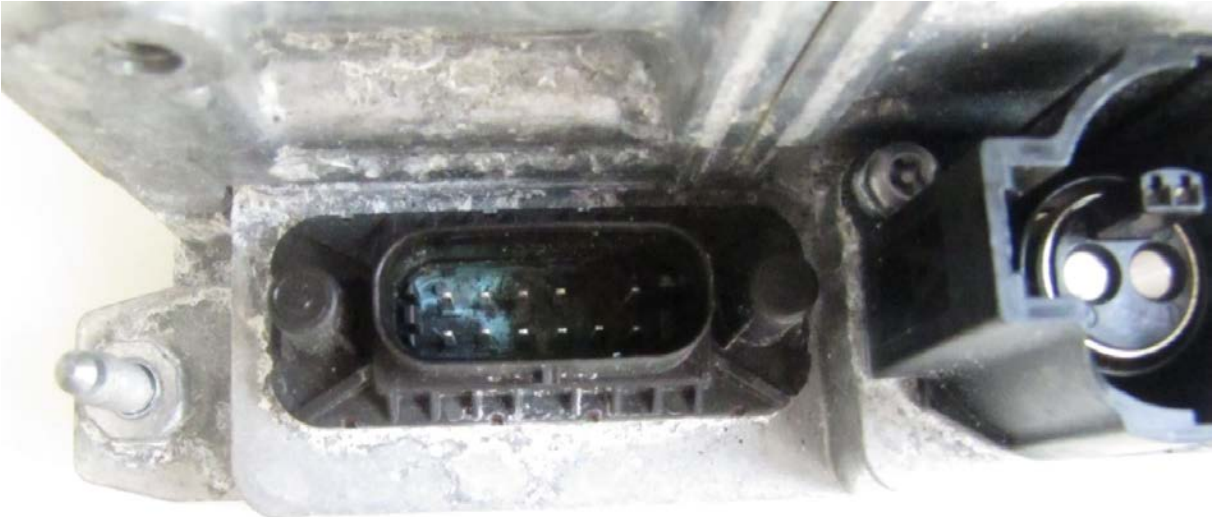
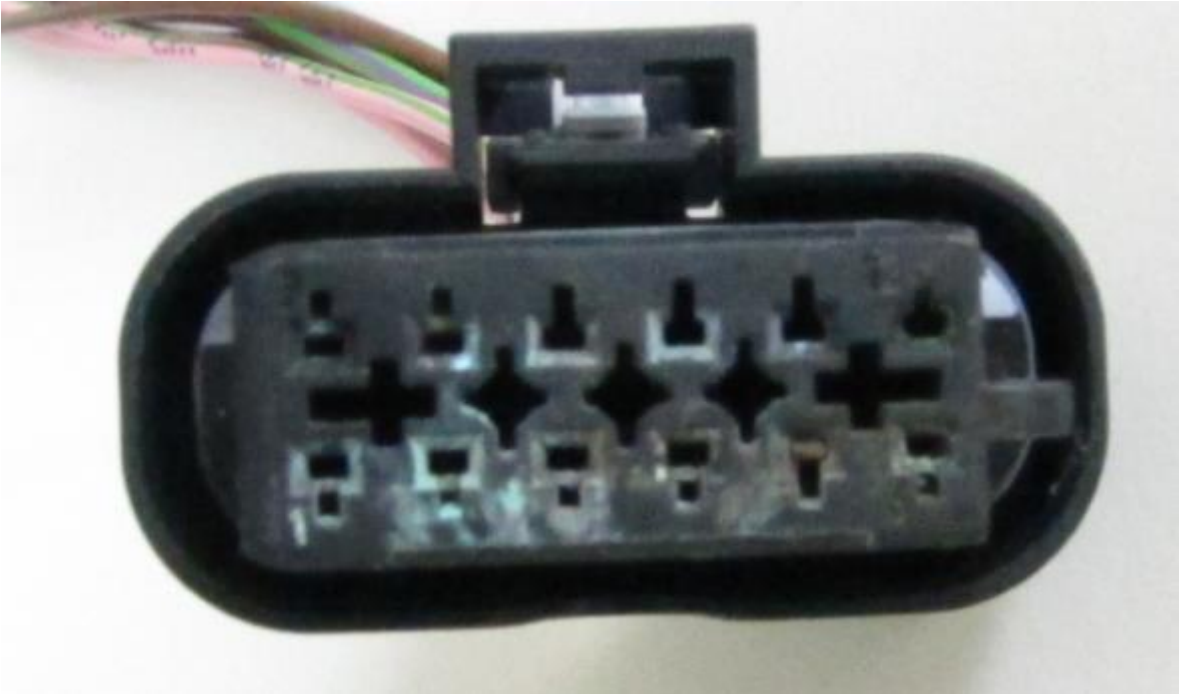
Attachments	
File	Description
1.pdf	Moisture and/or corrosion in high-voltage PTC heater booster female connector

Moisture ingress and/or corrosion (occasionally also foreign objects / dirt) in 12 volt female connector from high-voltage PTC heater booster (component designation: N33/5 - female connector 1).

Inspect the 12V female connector closely for the following:

- Damaged silicone seal (main seal)
- Missing blind plugs
- Damaged individual conductor seals
- Foreign objects (dirt)

Replace high voltage PTC heater booster. The wiring harness can be repaired if needed.
