TO: Mercedes-Benz Dealer Principals, General Managers, Sales Managers, Service Managers, Parts Managers	FROM: Gregory Gunther, Department Manager, Vehicle Compliance and Analysis, Engineering Services
RE: Service Campaign with RETAIL HOLD 2019040031 Launch Notification Check Tire Marking, Replace if Necessary MY19 238 (E-Class Coupe, Cabriolet)	DATE: May 3rd, 2019

Campaign No. 2019040031, May 2019

SUBJECT: **Model E-Class Coupe (238 platform)**
Model Year 2019

Check tires and replace if necessary

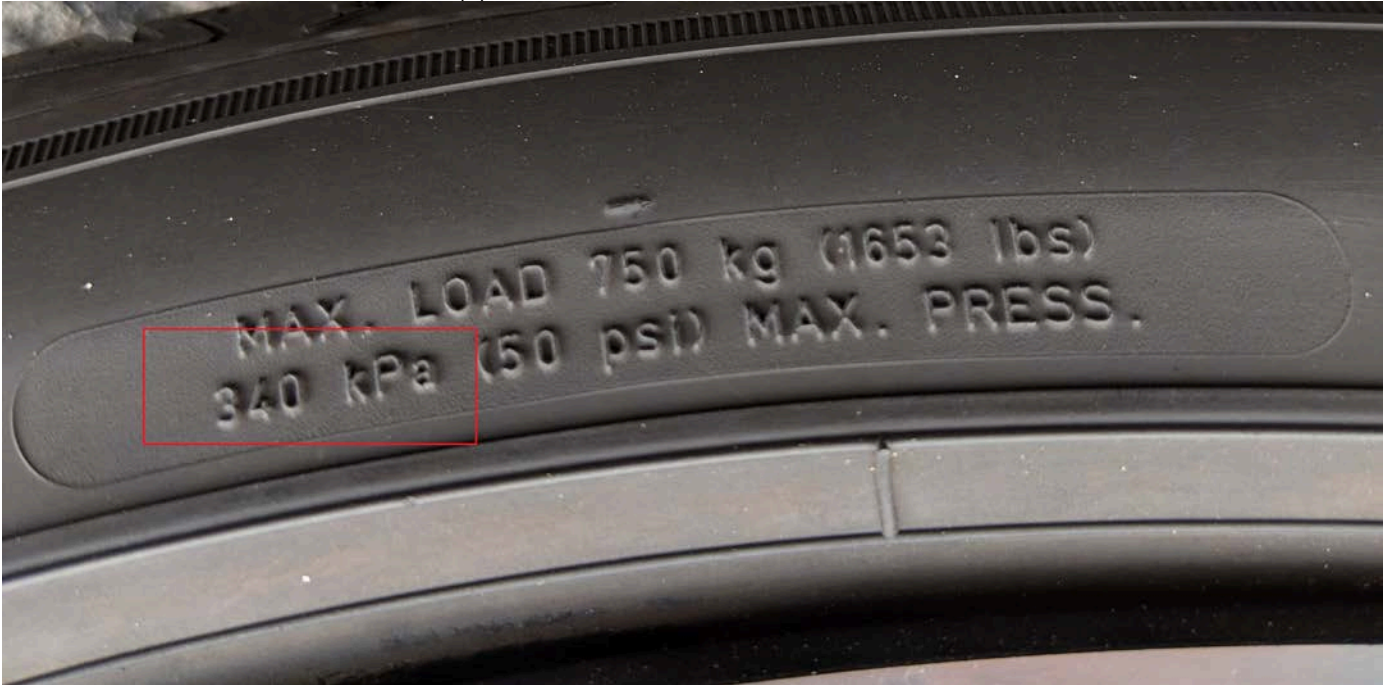
**Figure 1**

1. Confirm tires of the manufacturer **Pirelli** model **Cinturato P7** with the dimension **245 /45 R18 100Y XL MOE** are installed on the vehicle.
2. Check tire sidewall marking for max tire pressure(**figure 1**). If 340 KPa is indicated Perform work procedure(a). If 350 KPa is indicated end measure(b).

- a. Tires installed with 340 KPa: Perform **work procedure**.
- b. Tires **not** installed or **350 KPa**: **End measure**.

1. Replace tires with dimension **245/45 R18 100Y XL MOE**.
 - i** Tires must be replaced in pairs (**both front tires**).
 - i** For basic data, see **AR40.10-P-1030EW**.
 - i** Render the old tires unusable. (**see Tire Drilling Process**)
