WKEO - Retrofitting Relay for Activating Control Unit for Air-Conditioning Blower (Workshop Campaign)

Model line: **Panamera (970)**

Model Year: **As of 2010 up to 2016**

Subject: **Control unit for air-conditioning blower**

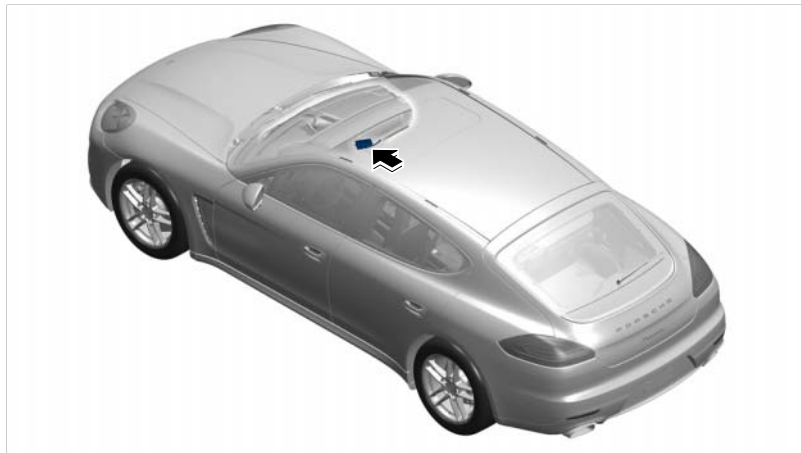
Installation position of control unit for air-conditioning blower

Information: **Optimized control units for the air-conditioning blower that are needed as part of campaign AKA7 are currently not available yet in the quantity required for retrofitting all affected vehicles immediately.**

Remedial Action: As part of the interim measure, the previously installed blower regulator must be additionally sealed using a sealing cord, thereby preventing further moisture from seeping in. An additional relay will also be installed in the electric wire harness for the blower regulator. This will interrupt the power supply for the blower regulator immediately after switching off the ignition, thereby ruling out the possibility of short circuits in the blower regulator when the vehicle is parked.
