TECHNICAL INSTRUCTIONS FOR SPECIAL SERVICE CAMPAIGN K0B MILLIMETER WAVE RADAR SENSOR

**CERTAIN:
2018 – 2019 TACOMA
2018 – 2019 TUNDRA**

Update 4/2/2019: Instructions provided for Tacoma Bar Type grill EPT Sealer application. Correction made to the Tundra TRD Pro grill photo.

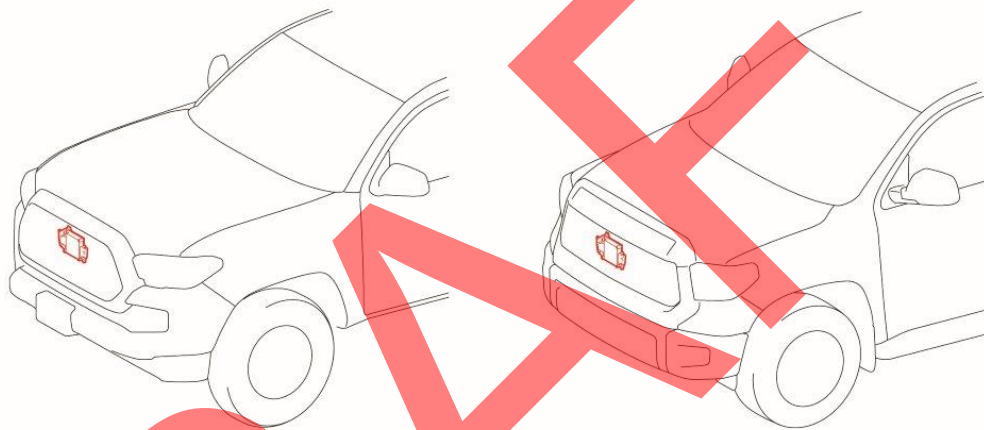
The involved vehicles are equipped with a Pre-Collision System (PCS) that may automatically apply the brakes if the system detects a potential collision. Due to the mounting of one of the system's sensors, it is possible for water to enter the sensor. This can lead to PCS deactivation or inadvertent brake activation resulting in limited deceleration for a short duration of time.
