# Blind Spot Monitor DTC U0232, U0233, C1AC1, C1AC2, C1AB6, or C1AB7

YEAR(S)	MODEL(S)	ADDITIONAL INFORMATION
2016 - 2018	Tacoma

Some 2016 – 2018 model year Tacoma vehicles may exhibit a Blind Spot Monitor System Warning message with any of the following Diagnostic Trouble Codes (DTCs) present.

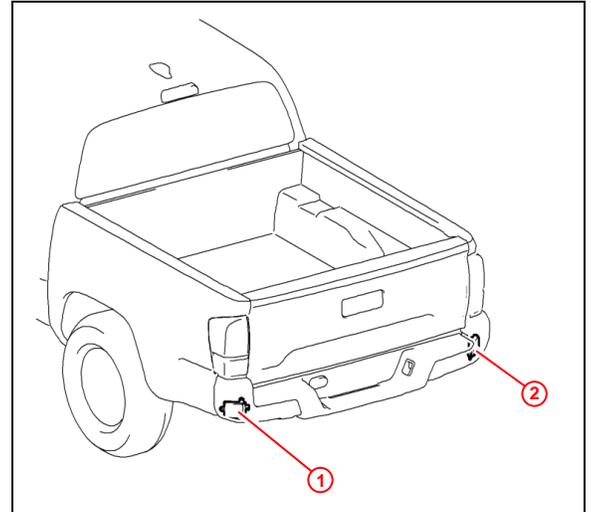
Figure 1.

<b>1</b>	<b>Blind Spot Monitor Sensor LH(Master)</b>
<b>2</b>	<b>Blind Spot Monitor Sensor RH(Slave)</b>

3. Replace both blind spot monitor sensors.
  - A. Remove the blind spot monitor sensor.  
Refer to TIS, applicable model and model year Repair Manual:
    - [2016](#) / [2017](#) / [2018](#) Tacoma:  
*Audio/Visual/Telematics – Park Assist/Monitoring – “Park Assist/Monitoring: Blind Spot Monitor Sensor Removal”*
  - B. Install the blind spot monitor sensor with the three nuts.  
**Torque: 9.0 N\*m (92 kgf\*cm, 80 in\*lbf)**
