Business Class M2  
Cascadia  
108SD/114SD  
> New Cascadia

**Freightliner  
Service Bulletin**

## General Information

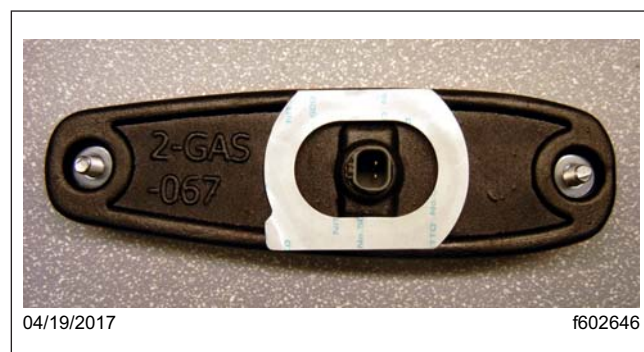
**Fig. 1, Marker Light with Peel-and-Stick Adhesive Gasket**

On November 14, 2016, the New Cascadia marker light was changed in production to include an adhesive gasket. On some New Cascadia vehicles built before November 14, 2016, water may intrude into the cab through a marker light seal. If a leak is detected in a vehicle built before that date, install new peel-and-stick adhesive gaskets on all five marker lights; see [Fig. 1](#).

1. Park the vehicle on a level surface, shut down the engine, and set the parking brake. Chock the tires.
2. Remove the two screws that attach the marker light to the cab roof.
3. Remove and discard the old gasket.
4. Peel the paper from the film adhesive on the lamp-facing side of the new gasket.
5. Install the new gasket on the marker light.

6. Scrape any remaining sealant or gasket material from the cab surface, then using soapy water, clean the cab roof where the marker light will be installed.
7. Make sure the cleaned surfaces are dry, then peel the backing off the roof side of the marker light gasket.

8. Install the marker light, using two screws to fasten it securely. Tighten the screws 31 lbf·in ± 4.4 lbf·in (350 N·cm ± 50 N·cm).

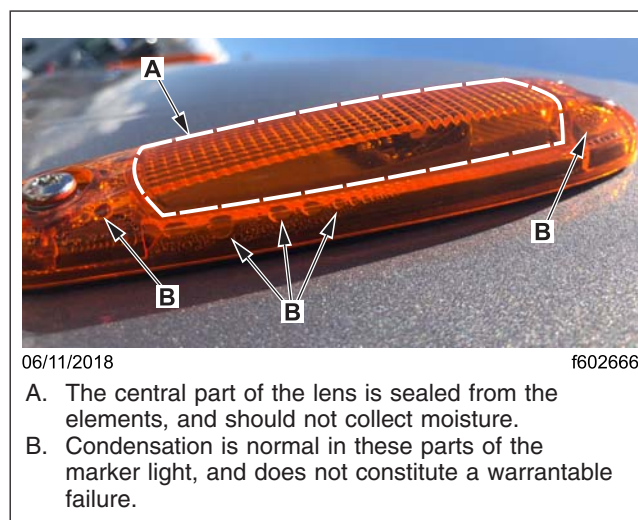
**Fig. 2, Condensation in Marker Light**

NOTE: The roof marker lights may collect moisture between certain portions of the lens and the gasket. This is completely normal and does not constitute a warrantable failure. Only the part of the lens which contains the electronics, in the center of the marker light, is sealed from the elements. See [Fig. 2](#).
