**SUBJECT: SF583 – Campaign Released in Phases**

## **Subject: Freightliner Cascadia Cab Shock Mounts**

**Models Affected:** Specific Freightliner Cascadia vehicles manufactured July 8, 2016, through February 7, 2019, and equipped with a sleeper cab.

Daimler Trucks North America LLC, on behalf of its Freightliner Trucks Division, is initiating Field Service Campaign SF583 to modify the vehicles mentioned above.

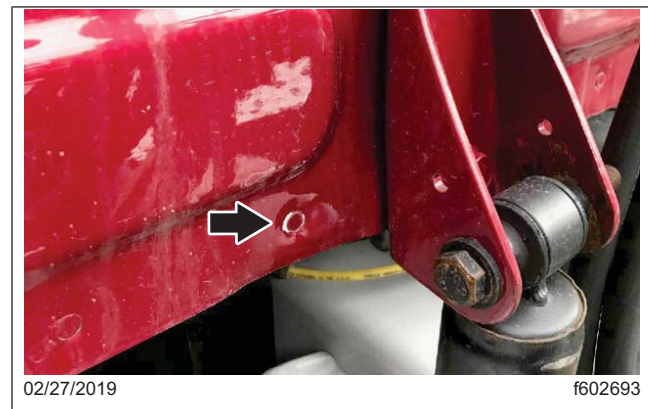
**Fig. 2, Loose Sheet Metal at Henrob**

Henrobs only require replacement if the back wall skin is not held tightly to the back wall frame. Confirm the back wall skin can move independent of each Henrob fastener before deciding to replace the Henrob.

1. After the back wall has been straightened, drill out the Henrob(s) not clamping the surrounding sheet metal tightly. If more detailed instructions are desired, see the *New Cascadia Workshop Manual*, section 60.05.110 "Cab Fasteners."
2. Flatten the panel if there is any deformation around the original hole(s) in the back wall.
3. Install 3/16 in structural blind rivets in place of each Henrob removed.
4. Follow quality auto body practices to paint the rivets, blending the cab paint to provide a seamless repair.
5. Continue with the **Cab Suspension Update for SF583A and SF583B** below to complete the repair.

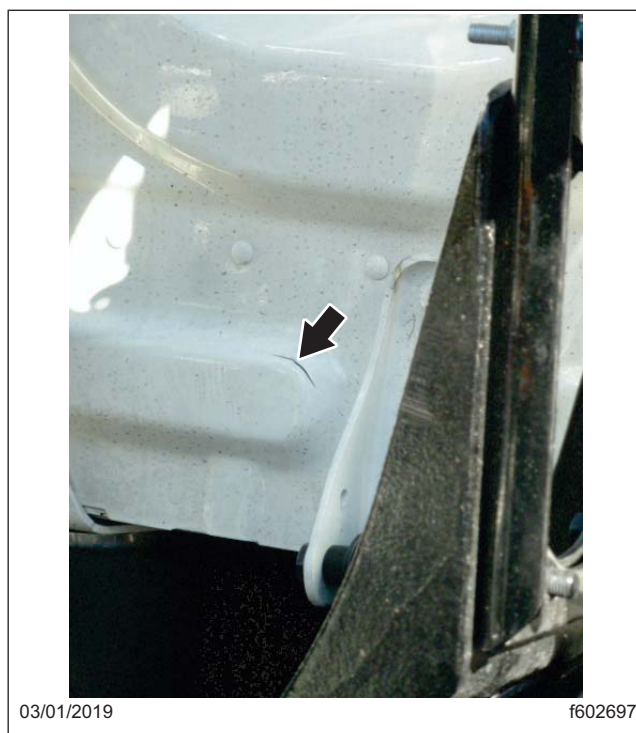
**Fig. 3, Crack in Cab Back Wall**

1. Check the base label (Form WAR259) for a completion sticker for SF583 (Form WAR261) indicating this work has been done. The base label is usually located on the passenger-side door, about 12 inches (30 cm) below the door latch. If a sticker is present, no work is needed. If there is no sticker, proceed with the next step.
2. Park the vehicle on a level surface, shut down the engine, and set the parking brake. Chock the tires.
3. Inspect the lower edge of the cab back wall to determine if any of the following conditions exist:
  - Bending at the cab shock brackets. See [Fig. 1](#).
  - Loose sheet metal around Henrob fasteners that attach the outer skin to the lower cab frame. See [Fig. 2](#).
  - Cracking of the outer skin of the cab back wall. See [Fig. 3](#).

If any of these conditions exist, based on the findings, review the Cab Back Wall Repair Options in the next section and assess the situation to determine the appropriate back wall repair. Estimate the time required to repair through welding, and compare it to the time required to replace the back wall (repair vs. replacement). The repair that returns the truck to service faster is the better option.
