May 2019  
INT FL806-01/02  
NHTSA #19V-066  
Transport Canada #19-054  
**INTERIM RECALL BULLETIN**  
SECOND REVISED NOTICE

## **Subject: Freightliner Cascadia Steering Wheel Airbags**

**Models Affected: Specific Freightliner Cascadia vehicles manufactured August 3, 2017, through January 30, 2019.**

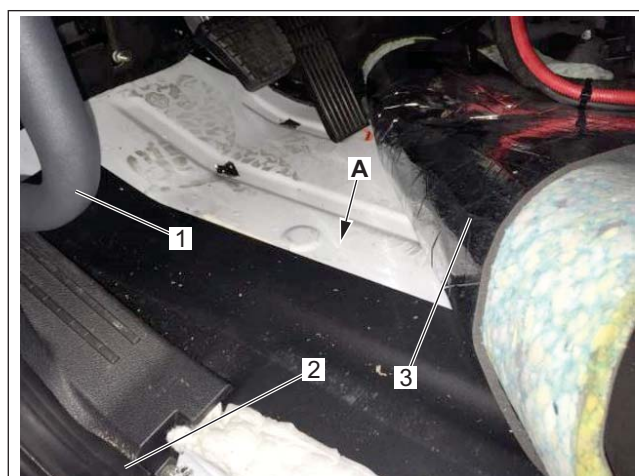
**Fig. 3, GNDP Floor Stud Location**

- A. Location of the GNDP floor stud, approximately 5/16 inch (7.9 mm) from the edge of the rivet.
1. Grab Handle (for reference)
  2. Lower A-Pillar Cover
  3. Floor Mat

- 10.1 Remove the driver's-side sill cover, the lower A-pillar cover, and the lower steering wheel cover. See [Fig. 3](#).
- 10.2 Roll back the driver's-side floor mat far enough to access the center floor area above the stud, where the bolt is installed.
- 10.3 Locate the mounded area on the floor, directly above the GNDP stud location.
- 10.4 Locate and mark a spot directly between the mound and the closest rivet. The center will be approximately 5/16 inch (7.9 mm) from the edge of the rivet. Verify the area below the floor is clear, and drill a 5/16 inch (7.9 mm) hole through the aluminum floor at the spot marked. See [Fig. 4](#).
