Replace LH Front Drive Unit Clevis Mount and Both Front Halfshafts

Classification	Repair Bulletin	Section/Group	39 - Front Drive Unit	Country/Region	All
Year	2014 - 2019	Model	Model S, Model X	Version	Dual Motor

This Service Bulletin supersedes SB-19-39-001 R1, dated 5-Jun-19. Each content change is marked by a vertical line in the left margin. Discard the previous version and replace it with this one.

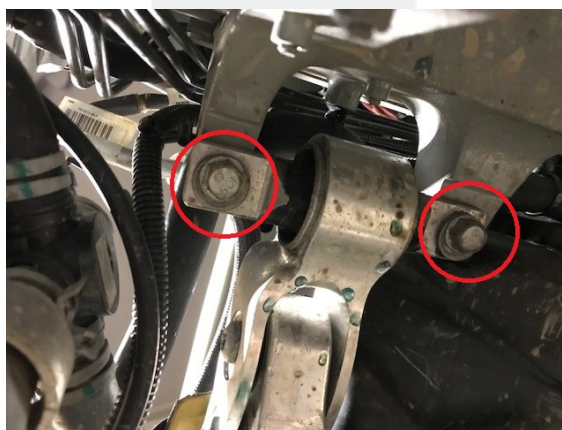
Figure 12

30. Remove and discard the bolts that attach the LH front drive unit clevis mount to the LH front rail (torque 65 Nm) (Figure 12).

33. Install the new bolts that attach the clevis mount to the LH front rail (torque 65 Nm) (Figure 12).

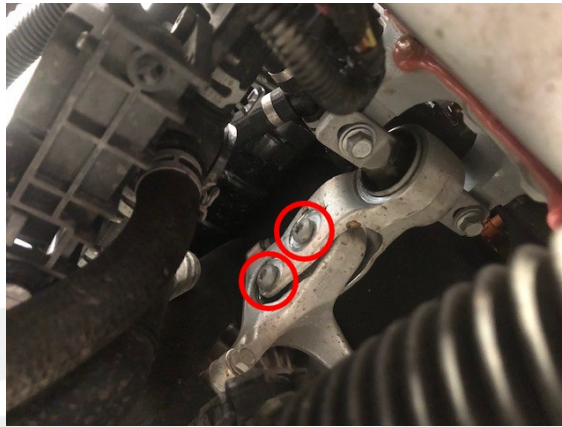
Figure 13

31. Remove and discard the bolts and patched nut plate that attach the LH front drive unit clevis mount to the isolator (torque 50 Nm) (Figure 13), and then remove the clevis mount from the vehicle.

32. Position the new LH front drive unit clevis mount on the vehicle, and then install the new bolts that attach the clevis mount to the isolator (torque 50 Nm) (Figure 13).

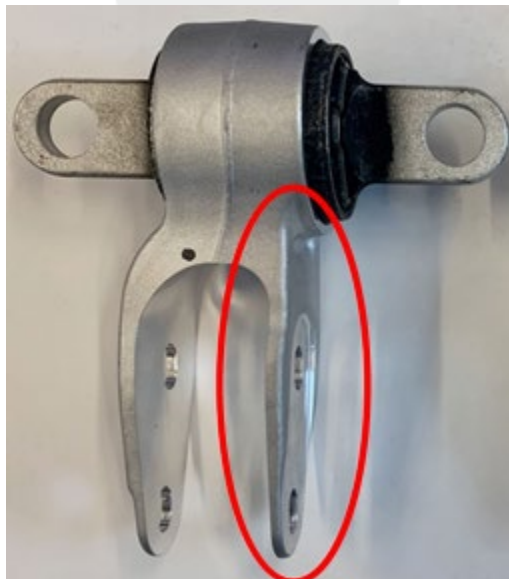
Figure 14

NOTE: The flat side of the clevis mount (Figure 14, circled) faces the rear of the vehicle.
