REFERENCE:	Nova Bus Manuals
SECTION:	16: Electrical system
RS N°:	MQR 7621-1331
EFFECTIVE IN PROD.:	LB45 (2018AL)

SUBJECT:	Throttle pedal sensors (TPS) cable replacement for 60-ft buses			
JUSTIFICATION:	Cummins code 1242 for throttle pedal sensor circuit			
LEVEL	DESCRIPTION	DIRECT CHARGES		TIME
		LABOUR	MATERIAL	
1	Install the throttle pedal sensor bypass cable.	Client	Client	2.75 h
2	Install the throttle pedal sensor front to back cable.	Client	Client	16 h

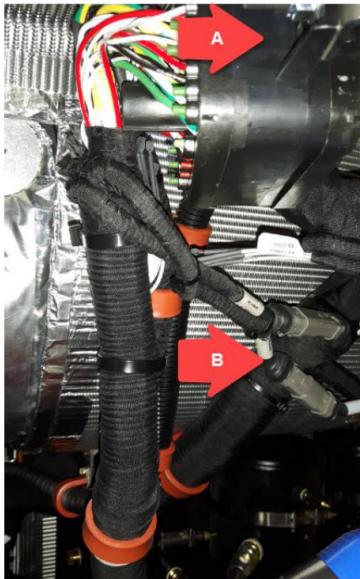
**DCP-504300**

**FUEL PEDAL – EMI interference close to Alternator**

Instructions Spéciales/ Special Instruction		
#	Action	Commentaires / Comments
	Déplacer	<p>Les x2 connecteurs (MT-X9564E) sont situés trop près de l'alternateur, ce qui altère le signal d'accélération de la pédale à carburant (EMI). Déplacer les connecteurs de la localisation A à la localisation B.</p> <p>The 2 connectors (MT-X9564E) are located too close to the alternator and create EMI to the fuel pedal signal. Need to move connector from location A to location B (see picture)</p>

- If DCP-504300 was not properly implemented, relocate the two TPS cable connectors further away from the alternator by following the instructions provided.

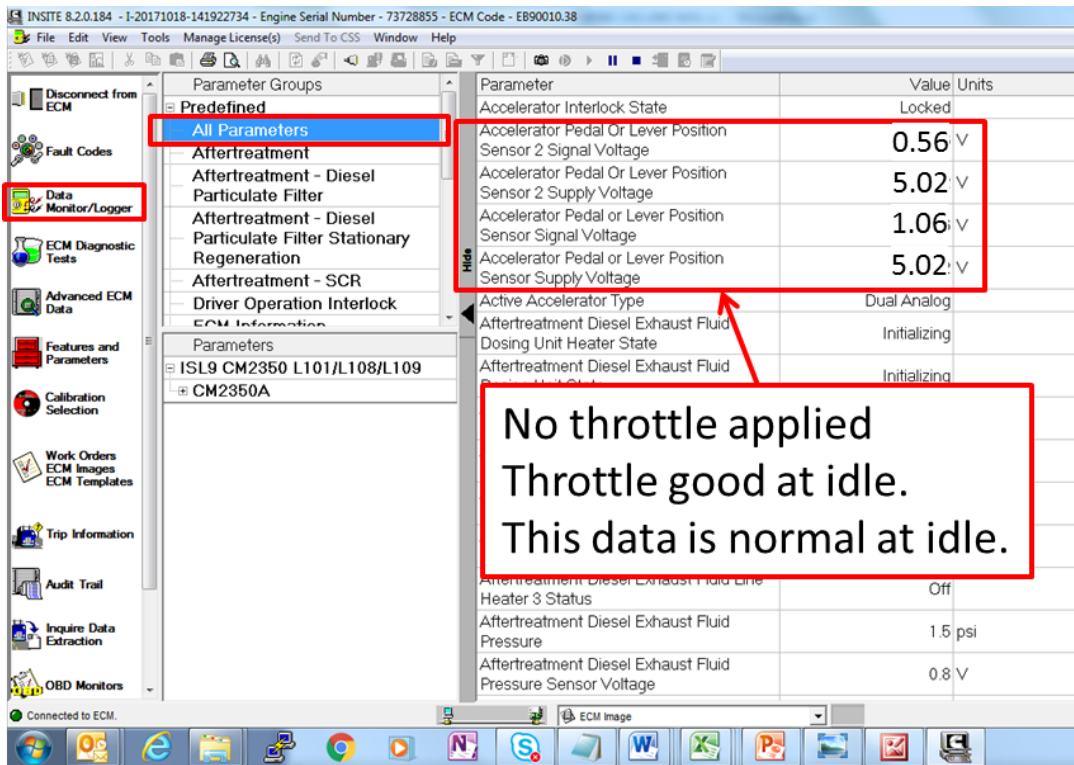
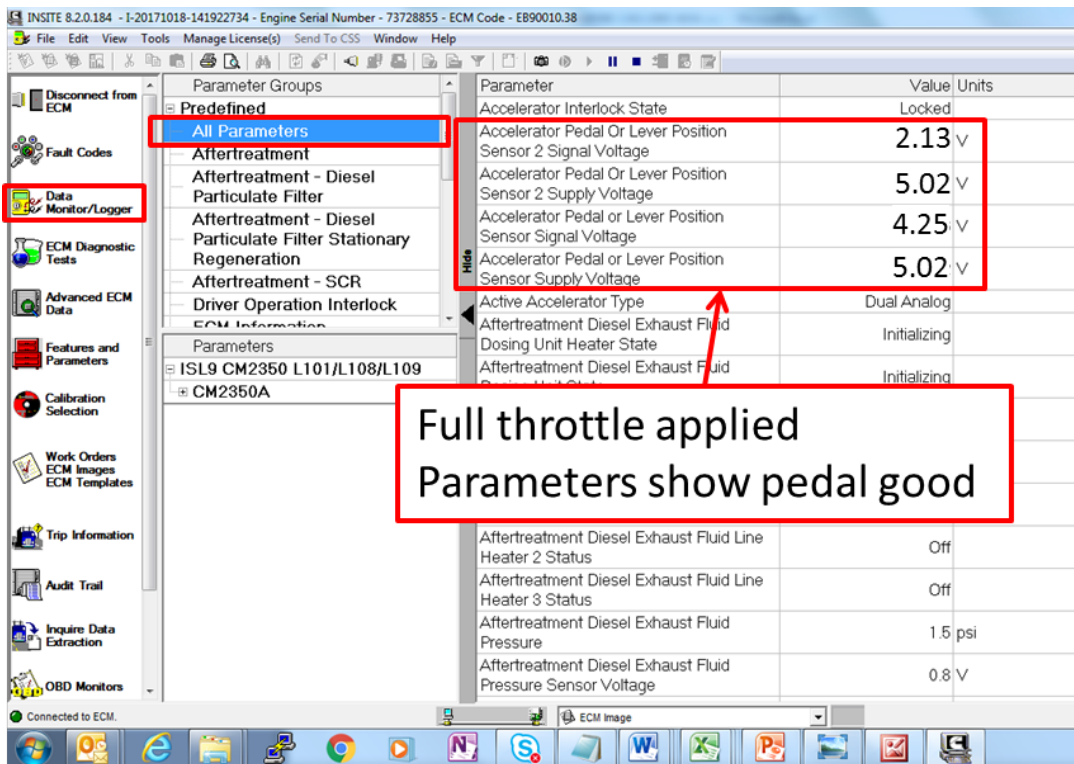
Figure A3.2. Example of INSITE Normal (PASS) Readings at Idle and Full Throttle Positions

- APS 1 and APS 2 signal readings should vary smoothly according to the throttle pedal angular position.
- APS 1 and APS 2 signal readings should be stable when the throttle pedal position does not change.
- The APS 1 signal reading should always be twice as much as the APS 2 signal reading.

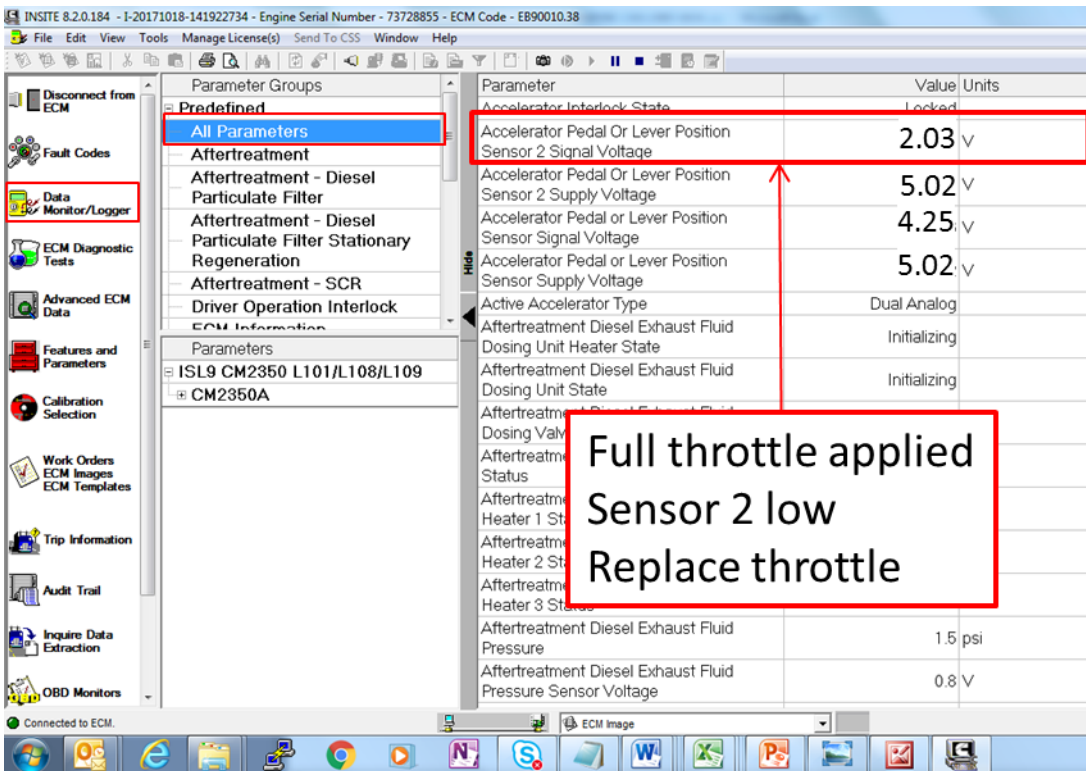
Figure A3.3. Example of INSITE Abnormal (FAIL) Readings at Full Throttle Pedal Position

- **Good APS 1 (PASS condition):**
  - Reading is 4.25 V and steady when throttle pedal fully depressed.
- **Bad APS 1 (FAIL condition):**
  - Reading is unstable with throttle pedal being held steady.
- **Bad APS 1 (FAIL condition):**
  - Reading is around 4.19 V (low).
- **Good APS 2 (PASS condition):**
  - Reading is 2.13 V and steady when throttle pedal fully depressed.
- **Bad APS 2 (FAIL condition):**
  - Reading is unstable with throttle pedal being held steady.
- **Bad APS 2 (FAIL condition):**
  - Signal 2 is about 2.03 V (low).

Note: Any of the abovementioned bad APS readings (FAIL condition) should normally lead to 1242 FC activation.

4. Test the throttle pedal operation (see Appendix 3 for the throttle pedal testing procedure).
    - If the throttle pedal test fails with the 1242 FC, then replace the throttle pedal with a new or spare unit (previously tested / known-good unit), test drive the bus and finally return it to service if the 1242 FC does not return.
